# Executive Summary

## Engineer's Inspection Review

123 Main St, Your City, TX, 12345

### 0.0 - Background and Purpose

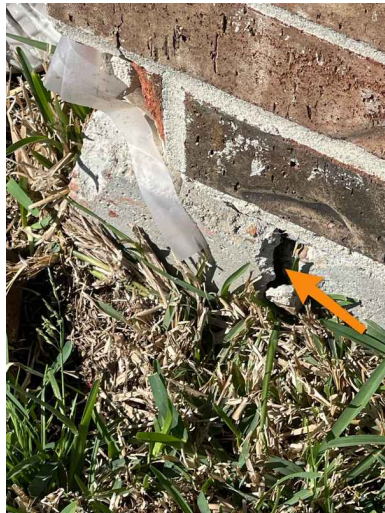
Back Right

Corner cracks are visible in the foundation slab but are of minimal structural concern. Shrinkage is a natural part of the curing process of concrete and cracks located in corners of structures are common. Recommend patching the corner cracks to prevent moisture/pest intrusion. Also recommend monitoring to confirm the cracking does not worsen.

Recommendation: Recommend monitoring.

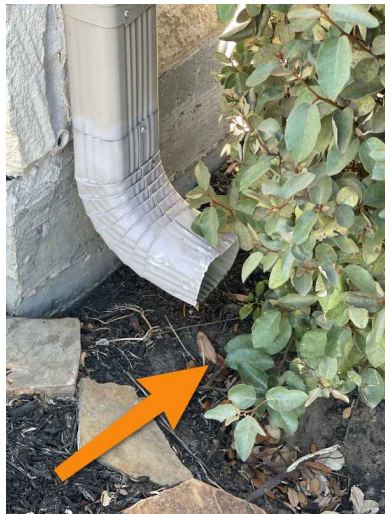
Partial property

Some or all of the gutter downspouts are missing splashblocks. Splashblocks help to disperse the water away from the foundation and prevent erosion of soils. Recommend installation.

Recommendation: Recommended DIY Project

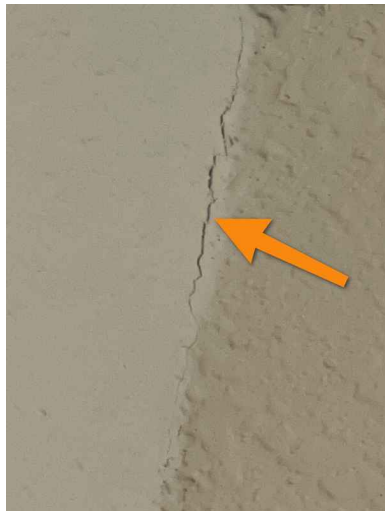
Right Middle Bedroom

Minor cracking was observed in wall structure. This is common in structure this age and is often determined to be cosmetic. That said, cracking is a first sign of foundation failure and cracks can grow over time; recommend monitoring. The best way to monitor a crack is to patch it (with mortar or caulk) and repaint it, to see if the crack reappears.

Recommendation: Recommended DIY Project

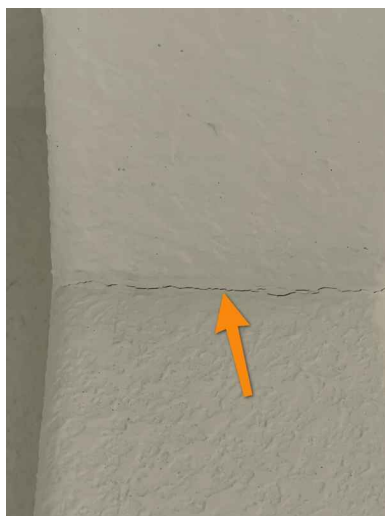
Back entry

Minor sheetrock cracking was observed on the ceiling. This is common in structures this age and is often determined to be cosmetic, most often the separation of drywall tape joints. Recommend patching, repainting, monitoring these locations for further cracking.

Recommendation: Contact a qualified painting contractor.

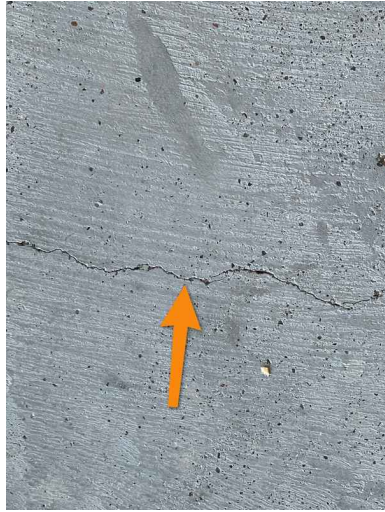
Garage

**2: Flooring - cracks minor**

Recommendation: Contact a qualified flooring contractor

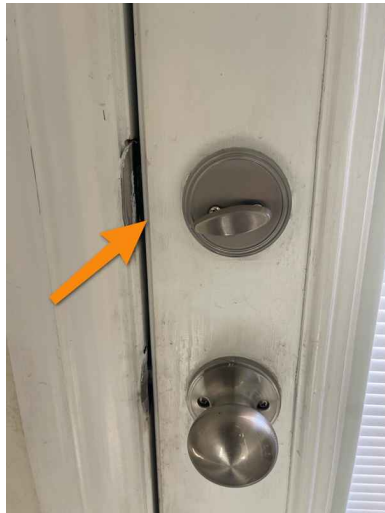
Back door deadbolt

Door doesn't latch to close properly. Recommend handyman repair door, latch, frame, and/or strike plate.

Recommendation: Contact a qualified handyman.

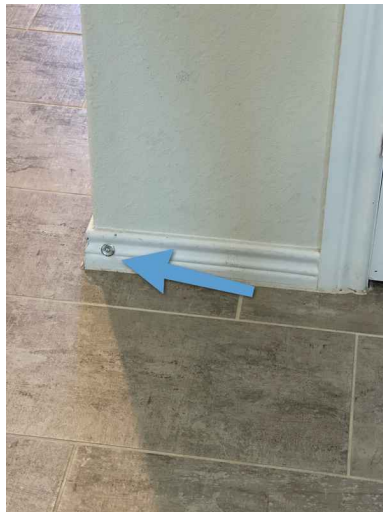
One or more doors have no doorstop. Without a doorstop, the doorknob can be lodged into the sheetrock and create a hole. Recommend installation of a doorstop.

Recommendation: Recommended DIY Project

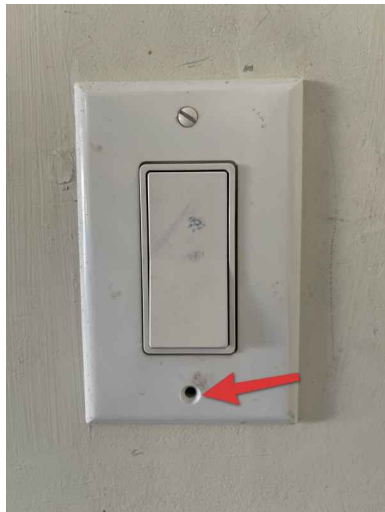
Garage

One or more electrical receptacles are missing a cover plates, or the plate is damaged. This causes short and shock risk. Recommend replacement of the damaged or missing cover plate.

Recommendation: Contact a qualified electrical contractor.

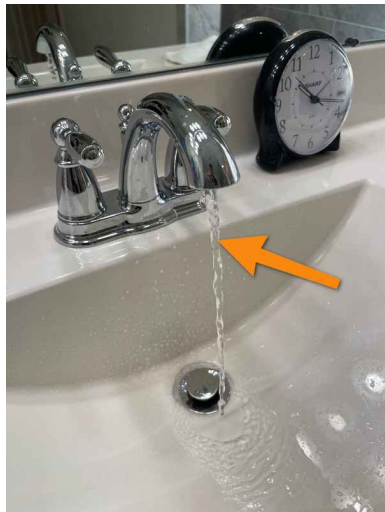
Primary bathroom right sink

Low water pressure / flow to one or more faucets. This may be due to a clogged water supply pipe, a clogged inline filter, or a broken fixture. Recommend further investigation by a plumbing contractor.

Recommendation: Contact a qualified plumbing contractor.

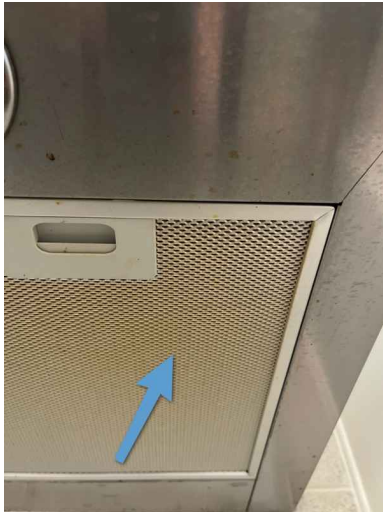
The vent hood filter is dirty and/or old. It needs to be cleaned or replaced.

Recommendation: Recommended DIY Project

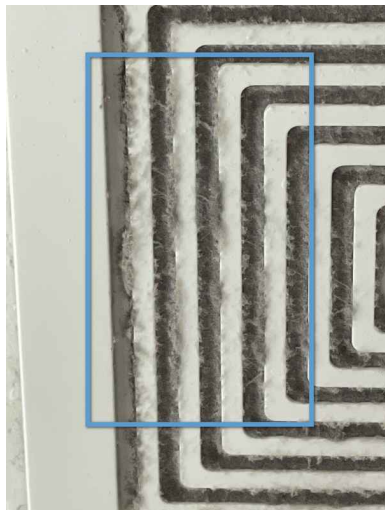
Primary Bathroom

The vent fan appears to be clogged and will not perform effectively. Recommend cleaning the grate and clearing the clog.

Recommendation: Recommended DIY Project
