Thermography Report 248 Steelcase Rd. E., Markham

Inspection Date: February 10, 2026

Company:
Arbutus Real Estate
333 Denison St.
Markham, ON
L3R 2Z4

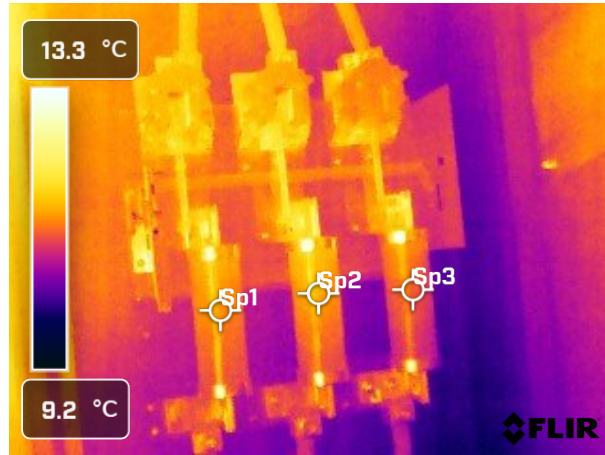
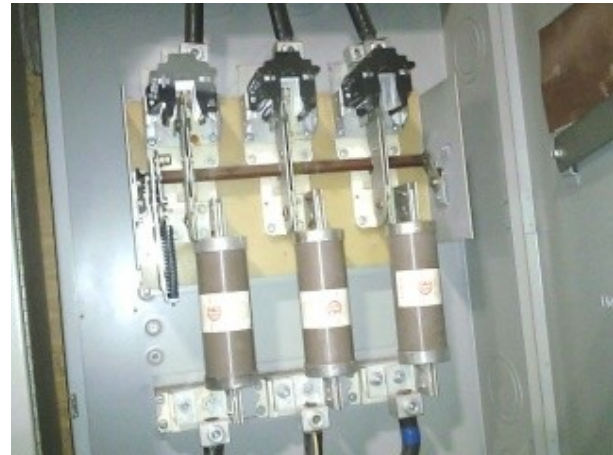
Location: warehouse - Main Distribution - Main Disconnect									
Equipment	<i>Federal Pioneer 600V 400A disconnect fused at 400A</i>								
Minimum temp.	9.9 °C								
Maximum temp.	16.5 °C								
Measurements:	No hot spots detected

Measurements		Sp1	11.5 °C	Sp2	11.6 °C	Sp3	11.2 °C
Measurements									
Sp1	11.5 °C								
Sp2	11.6 °C								
Sp3	11.2 °C								
Visual Inspection Notes:	Visual examination of the disconnect revealed the presence of orange and white rust on the line and load lugs, as well as associated internal hardware, indicating ongoing or previous moisture ingress within the enclosure. Corrosion of current-carrying components can increase contact resistance, contribute to localized heating, and compromise the long-term reliability and safety of the equipment. Refer to the following images for supporting visual documentation.								
Corrective Action:.	Clean and mechanically remove all corrosion from lugs and hardware where possible; replace any components exhibiting significant pitting, deterioration, or loss of material integrity. After corrective work, perform torque verification to manufacturer specifications and re-test contact resistance as required to confirm proper electrical continuity and safe operation.								
Created	2026-02-10 10:23:46 AM

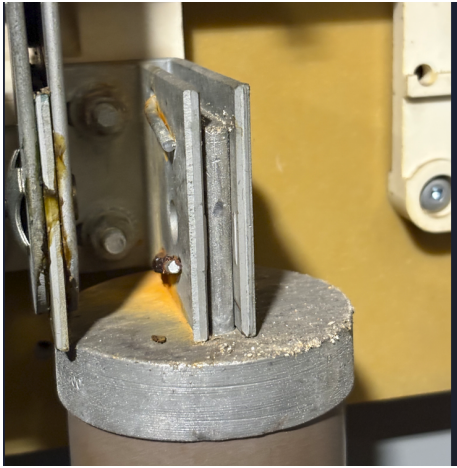
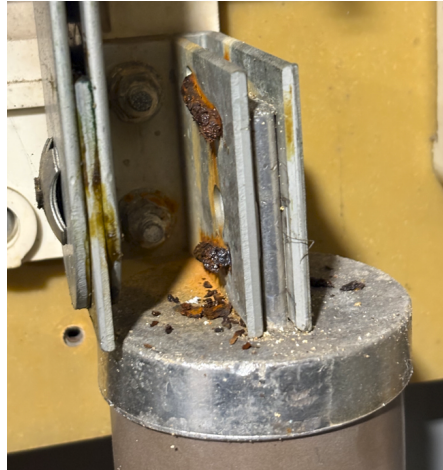
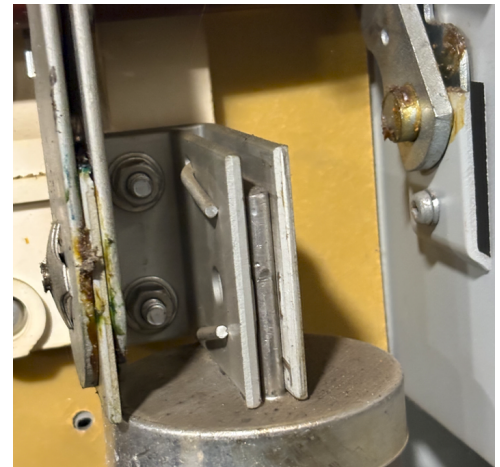
Main 400A disconnect line side

Visual examination of the disconnect revealed the presence of orange and white rust on the line and load lugs, as well as associated internal hardware, indicating ongoing or previous moisture ingress within the enclosure. Corrosion of current-carrying components can increase contact resistance, contribute to localized heating, and compromise the long-term reliability and safety of the equipment. Refer to the following images for supporting visual documentation.

Investigate and eliminate the source of moisture intrusion if any, ensure the enclosure is properly sealed, and verify environmental conditions are suitable for the equipment rating. Clean and mechanically remove all corrosion from lugs and hardware where possible; replace any components exhibiting significant pitting, deterioration, or loss of material integrity. After corrective work, perform torque verification to manufacturer specifications and re-test contact resistance as required to confirm proper electrical continuity and safe operation.

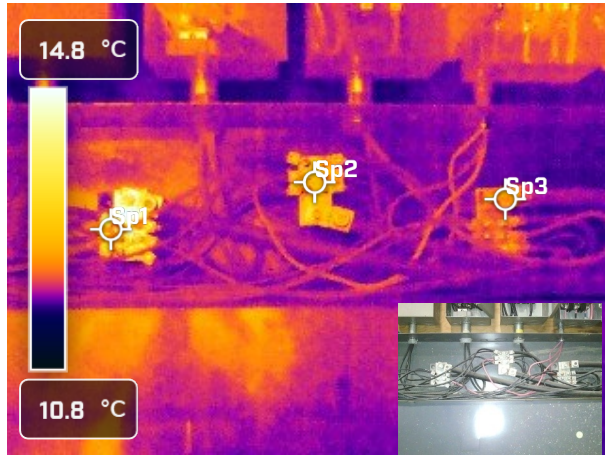
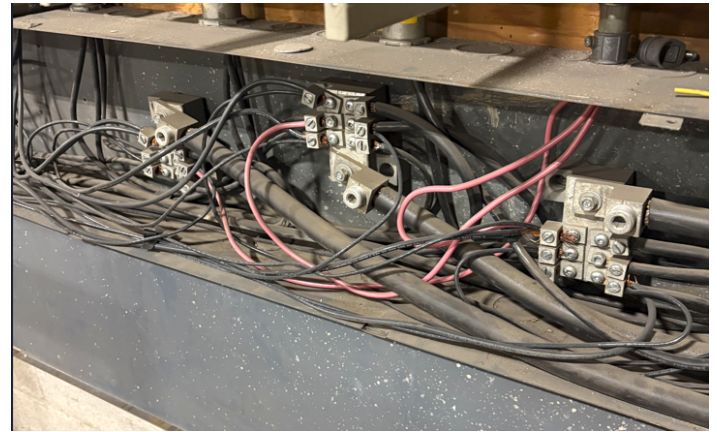
Location: Warehouse - Main Distribution - Splitter									
Equipment	<i>BEL 600V 400A splitter</i>								
Minimum temp.	11.4 °C								
Maximum temp.	16.2 °C								
Measurements:	No hot spots detected

Measurements		Sp1	12.3 °C	Sp2	12.6 °C	Sp3	12.3 °C
Measurements									
Sp1	12.3 °C								
Sp2	12.6 °C								
Sp3	12.3 °C								
Visual Inspection Notes:	During the inspection, dust and debris were found inside the splitter. This accumulation can negatively impact the performance and safety of the equipment by: Reducing insulation properties, increasing the risk of arcing. Obstructing mechanical components, causing improper operation. Accelerating wear and potential overheating.								
Corrective Action:	Perform a thorough cleaning of the splitter to remove all dust and debris. inspect the disconnect's components for signs of damage, wear, or overheating								
Created	2026-02-10 10:24:20 AM

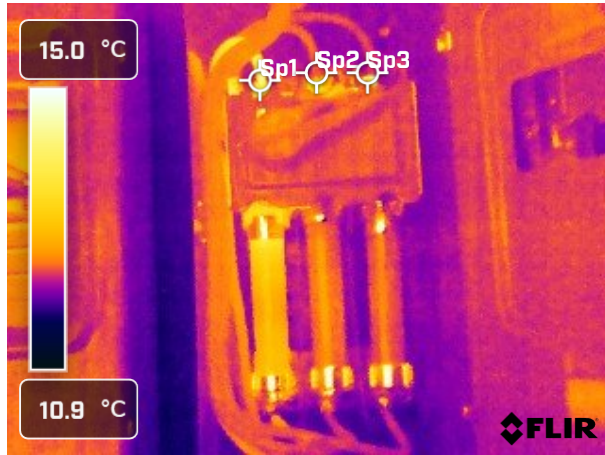
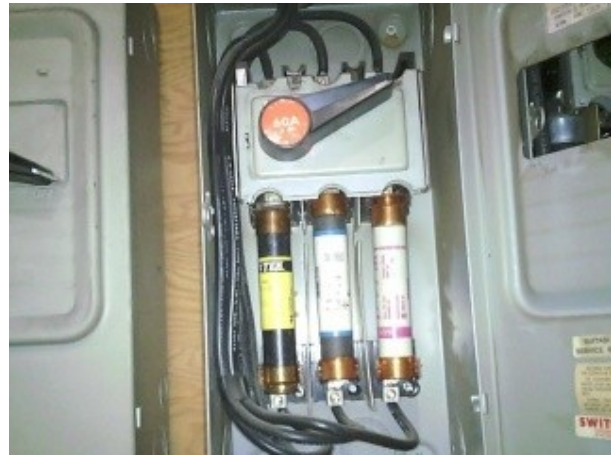
Location: Warehouse - Main Distribution - Trans LP A

Equipment	<i>Federal Pioneer 600V 60A disconnect fused at 60A</i>		
Minimum temp.	11.6 °C		
Maximum temp.	17.7 °C		
Measurements:	Load measurements		
	Phase A 7A	Dt1	
	Phase B 5A	Sp1-Sp3	2.0 °C
	Phase C 5A	Sp1	14.4 °C
		Sp2	12.4 °C
	Sp3	12.4 °C	
Visual Inspection Notes:	Thermographic analysis indicates that although the temperature differential is currently within low severity criteria, Phase A shows a localized heating pattern on the line side of the disconnect consistent with a connection deficiency rather than a load imbalance condition (refer to close-up thermogram on the following page). The measured load is minimal at 7A on a 60A rated disconnect, confirming that the elevated temperature is not load-related. Under increased loading conditions, this connection issue could result in significantly higher temperatures and potentially reach a critical state.		
Corrective Action:	De-energize the disconnect and inspect the Phase A line-side termination for loose connections, improper torque, corrosion, or conductor damage. Clean all contact surfaces, re-terminate and torque to manufacturer specifications, and replace any damaged lugs or hardware as required. After repairs, perform load testing and contact resistance testing to confirm proper connection integrity.

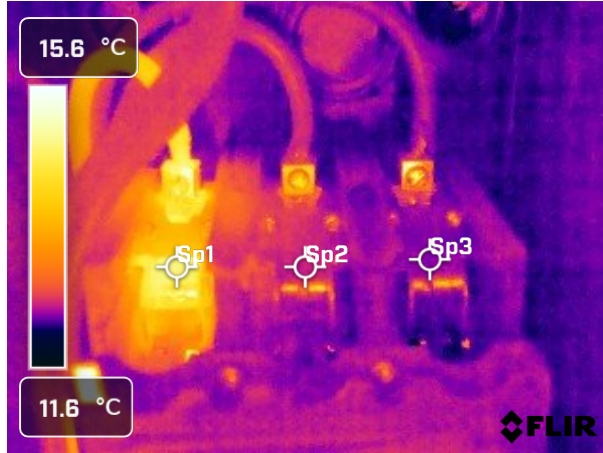
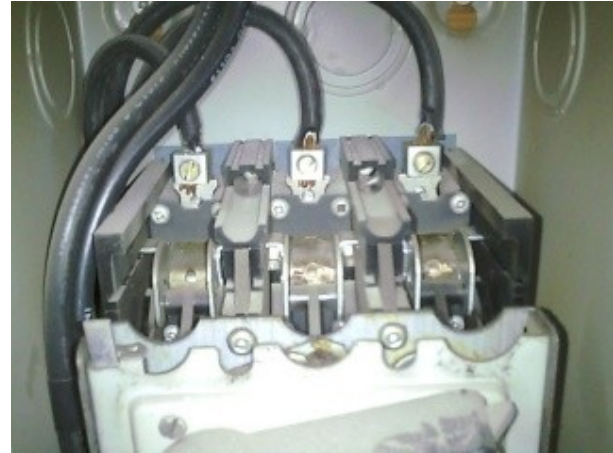
Location: Warehouse - Main Distribution - Trans LP A Line Side close up picture		
Equipment	<i>Federal Pioneer 600V 60A disconnect fused at 60A</i>	
Minimum temp.	11.2 °C	
Maximum temp.	17.3 °C	
Measurements:	Measurements	
	Dt1	
	Sp1-Sp3	2.5 °C
	Sp1	14.8 °C
	Sp2	12.5 °C
Sp3	12.3 °C	
Visual Inspection Notes:	Thermographic analysis indicates that although the temperature differential is currently within low severity criteria, Phase A shows a localized heating pattern on the line side of the disconnect consistent with a connection deficiency rather than a load imbalance condition.	
Corrective Action:	De-energize the disconnect and inspect the Phase A line-side termination for loose connections, improper torque, corrosion, or conductor damage. Clean all contact surfaces, re-terminate and torque to manufacturer specifications, and replace any damaged lugs or hardware as required. After repairs, perform load testing and contact resistance testing to confirm proper connection integrity.

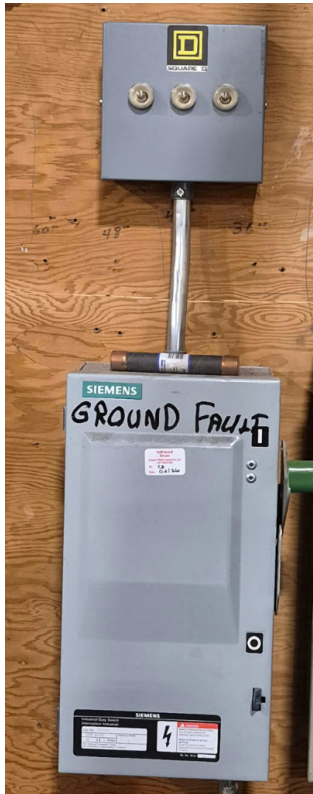
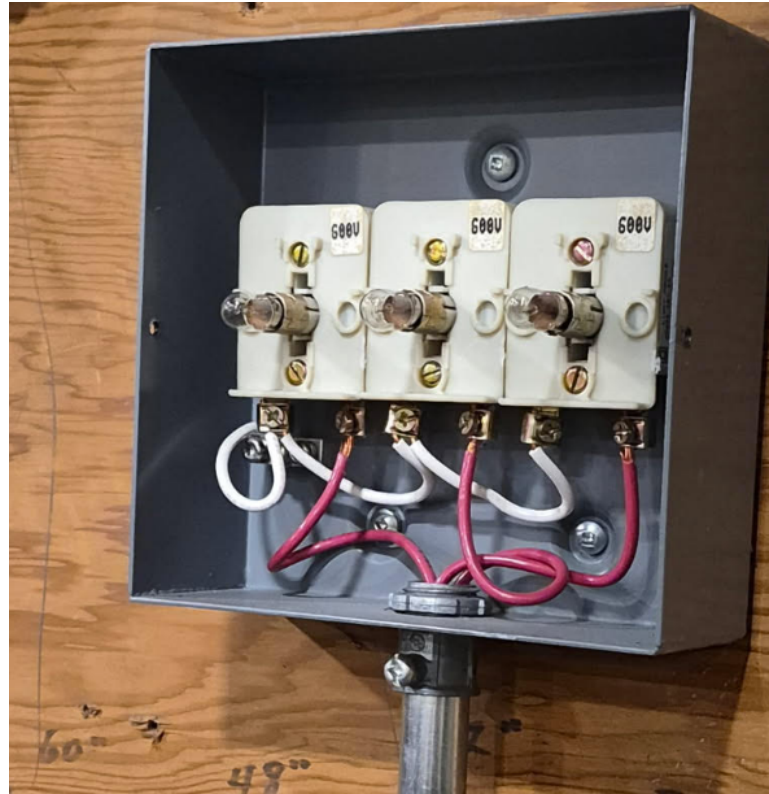
Location: Warehouse - Main Distribution - Ground Fault Protection Indicator

During inspection, the ground fault protection indicator was found to be malfunctioning. The indicator light bulbs were removed and tested separately and were confirmed to be in proper working condition.

Since the bulbs are functional, the malfunction is likely due to an internal failure within the ground fault protection system or an actual ground fault, which may include:

- Faulty indicator circuit wiring
- Defective relay or ground fault module
- Loss of control voltage to the indicator circuit
- Internal component failure due to age, wear, or previous fault conditions

- Perform diagnostic testing of the ground fault protection relay/module and associated control wiring.
- Verify presence and stability of control voltage supplying the indicator circuit.
- Repair or replace the defective ground fault protection components as required.
- Function test the complete ground fault protection system to confirm proper operation and indication after repairs.

Proper operation of the ground fault indication system is required to ensure safe monitoring and compliance with electrical safety standards.

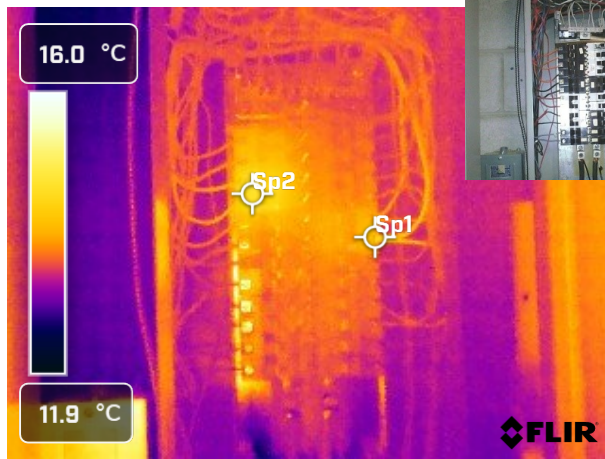
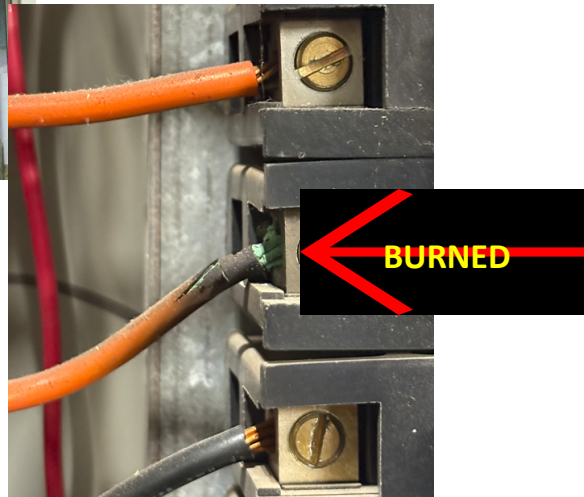
Measurements		No hot spots detected		Sp1	14.3 °C	Sp2	14.6 °C
Measurements									
No hot spots detected									
Sp1	14.3 °C								
Sp2	14.6 °C								
Visual Inspection Notes:	<p>CCT #10, 12 - double tapped. Standard single-pole breakers are designed to handle only one circuit.</p> <p>Although thermographic inspection did not indicate active overheating at the time of scanning, visual examination revealed that the conductor on CCT 7 shows signs of previous short-circuit damage and insulation burning. A conductor subjected to a short circuit may have compromised insulation integrity and potential annealing or weakening of the conductor strands, which can reduce its current-carrying capacity and mechanical strength. This condition increases the risk of future faults, arcing, equipment damage,</p>								
Corrective Action:	<p>Assign each circuit its own breaker in accordance with the Canadian Electrical Code. conduct a thorough inspection of the affected conductor along its entire accessible length. Replace the damaged section or the entire conductor as required to ensure insulation integrity and proper ampacity rating. Inspect associated terminations, overcurrent protection devices, and connected equipment for additional damage. Verify that the overcurrent device is properly rated and functioning, and perform insulation resistance testing prior to re-energization to confirm safe operation</p>								
Created	2026-02-10 11:05:34 AM

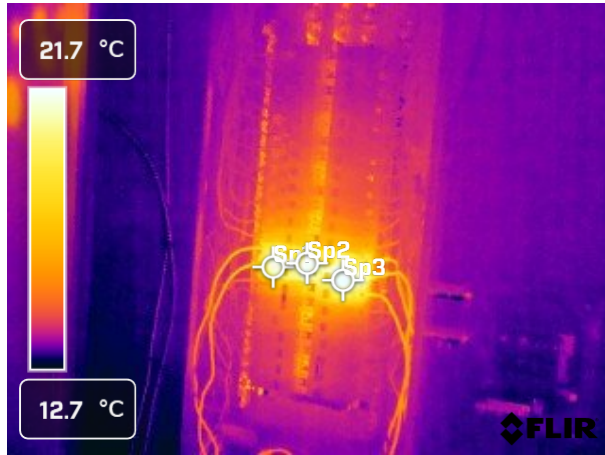
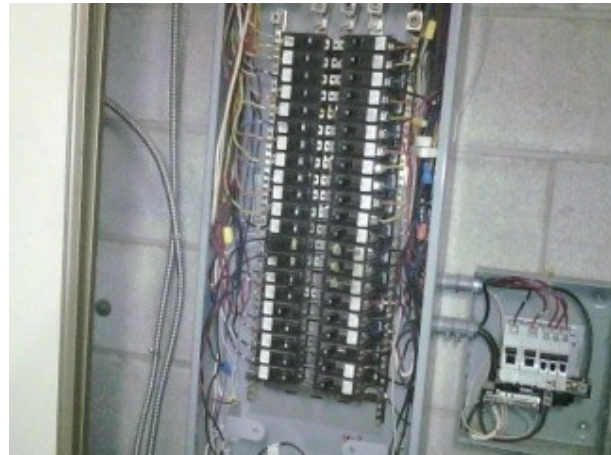
Measurements		Dt1		Sp2-Sp1	6.8 °C	Sp1	21.2 °C	Sp2	28.0 °C	Sp3	22.5 °C
Measurements															
Dt1															
Sp2-Sp1	6.8 °C														
Sp1	21.2 °C														
Sp2	28.0 °C														
Sp3	22.5 °C														
Visual Inspection Notes:	Thermographic imaging indicates that overall breaker temperatures are consistent with the applied heater load; however, localized heating is present at SP2 on the bus mounting bracket/bolt connection. This pattern suggests a high-resistance connection at the mechanical joint rather than a load-related condition. Localized resistance heating at bolted bus connections can lead to progressive deterioration, increased oxidation, and potential failure if not addressed.														
Corrective Action:	De-energize the equipment and inspect the SP2 bus mounting bolt and bracket assembly for looseness, corrosion, or improper contact surface condition. Clean all mating surfaces, replace any compromised hardware, and reassemble using manufacturer-specified torque values. After corrective work, perform a follow-up thermographic scan under normal load to confirm that the abnormal heating condition has been resolved.														
Created	2026-02-10 11:18:04 AM

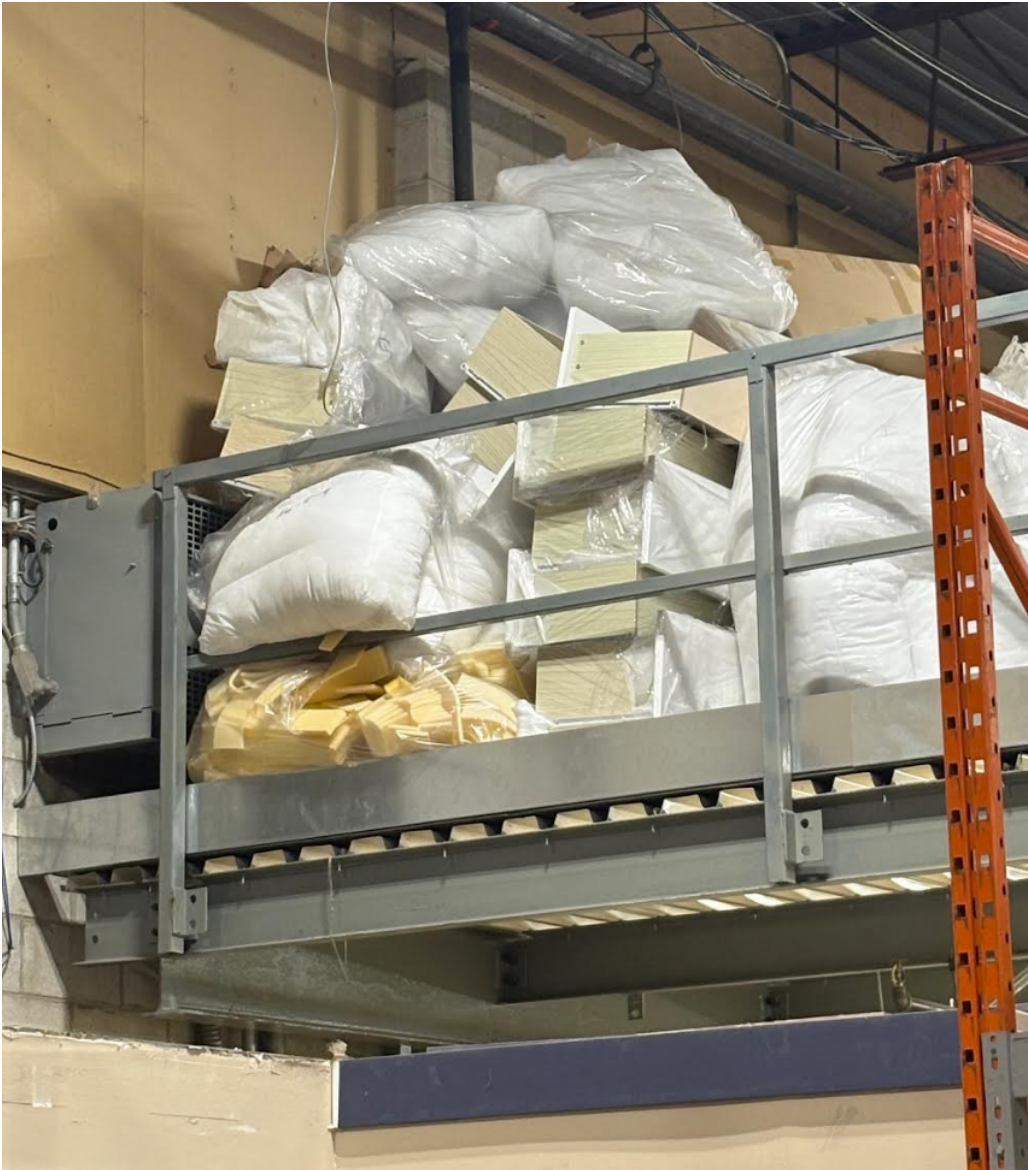
Observation: Transformer on mezzanine is partially covered with stored materials, including pillows and shelving units.

Code Reference: OESC Rule 2-306 – working space and clearances must be maintained around electrical equipment.

Hazard: Restricted access and airflow creates risk of overheating, fire, and prevents safe maintenance or emergency shutdown.

Corrective Action: Remove all stored materials immediately. Maintain minimum clearances around transformer per OESC and manufacturer guidelines. Ensure area remains clear of combustible or conductive items. Inspect transformer for potential damage caused by prior obstruction.
