Jul 28th, 2026

294 Addison Drive, Kissimmee, FL, 34759

# Home Inspection Report

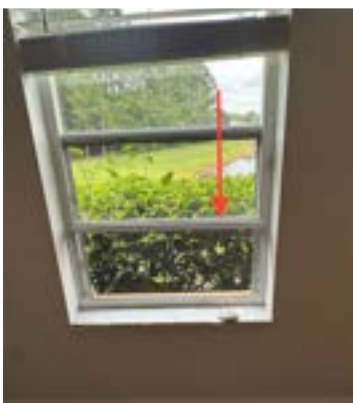
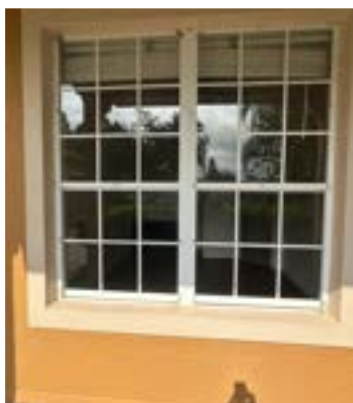
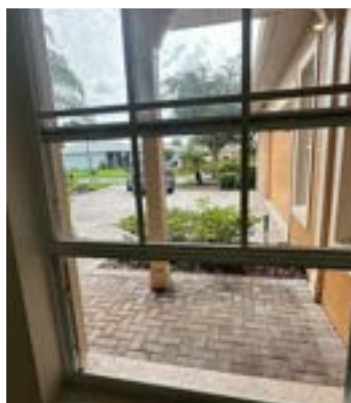
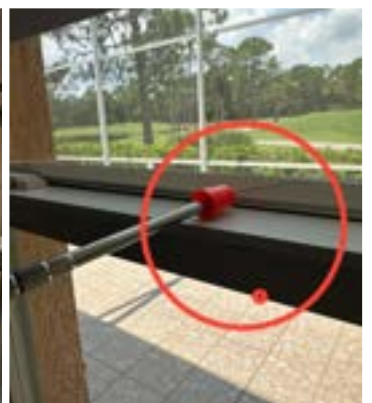
No Screening
