SUMMARY

1234 Main Street Cherry Hill NJ 08002

Buyer Name
03/22/2026 9:00AM

Brian Maute
InterNACHI Certified & NJ Licensed Home
Inspector
Vivid Home Inspections
(609) 922-7456
inspectionsbyvivid@gmail.com

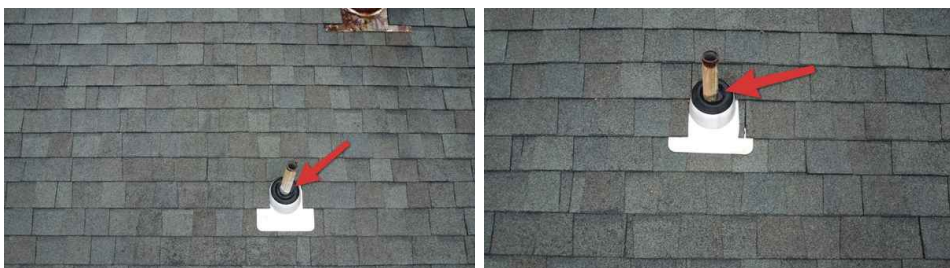
The vent boot exhibited a visible dip along the upper (rear) portion of the flashing assembly. The upper section of the boot is intended to lie flat and remain properly integrated with the surrounding roofing material to direct water away from the penetration. A depression in this area can allow water to collect or flow toward the penetration rather than away from it. This condition may increase the potential for moisture intrusion if not corrected.

Recommendation
Contact a qualified roofing professional.

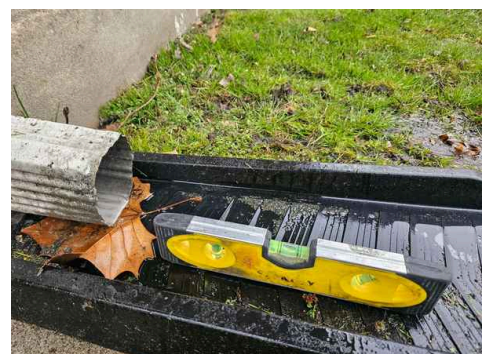
3.3.1 Roof Drainage Systems
DOWNSPOUT EXTENSION – IMPROPERLY SLOPED

The downspout extension did not appear to be properly sloped away from the structure. Extensions are intended to direct roof runoff away from the foundation in a controlled manner. When slope is inadequate or reversed, water may pool or flow back toward the foundation area. This condition can contribute to localized moisture exposure if not corrected.

Front - Not sloping away from the foundation causing water to pool near the foundation

Recommendation
Contact a qualified gutter contractor

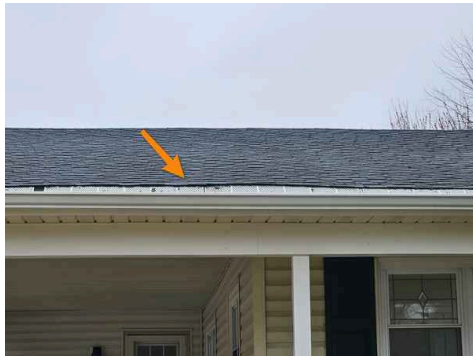
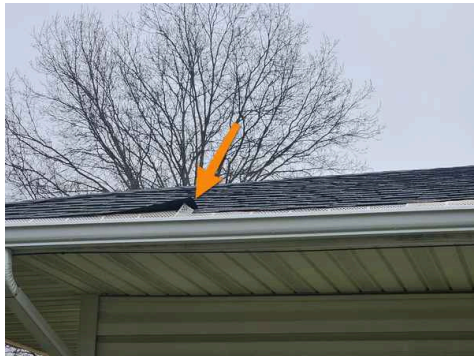
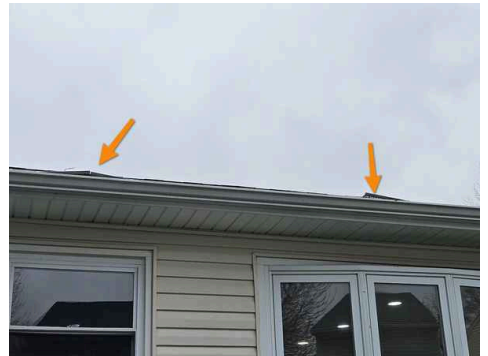
GUTTER GUARDS – IMPROPERLY INSTALLED OR DAMAGED

The gutter guards were observed to be improperly installed or damaged. Gutter protection systems are intended to allow water to enter the gutter while limiting debris accumulation. When improperly fitted or deteriorated, they may restrict water flow or allow debris to bypass the system. This condition can reduce overall drainage performance and may contribute to overflow if not corrected.

Pushing the shingles up preventing water from discharging off the roof.

Recommendation
Contact a qualified gutter contractor

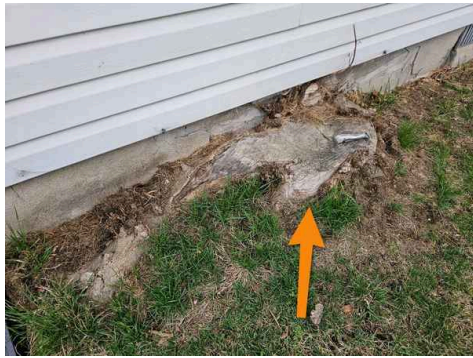
Right Front

Evidence was observed indicating that a tree was previously located in close proximity to the structure. Tree roots near foundations can affect soil stability and may contribute to localized settlement or movement over time. Although the tree has been removed, remaining root systems may continue to decompose and influence soil conditions. Monitoring of the surrounding soil and foundation area is recommended to identify any future changes.

Recommendation
Contact a qualified landscaping contractor

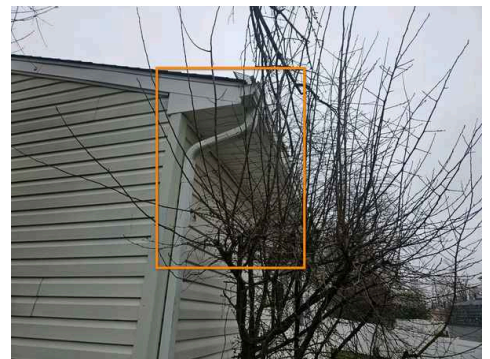
Tree branches were observed in contact with the exterior wall surfaces. Vegetation contact can abrade siding materials during wind conditions and may retain moisture against the wall assembly. Branches in contact with the structure can also provide pathways for pest activity. Maintaining clearance can help preserve exterior finishes and support proper monitoring of wall components.

Rear - Recommend trimming the branches back

Recommendation

Contact a qualified tree service company.

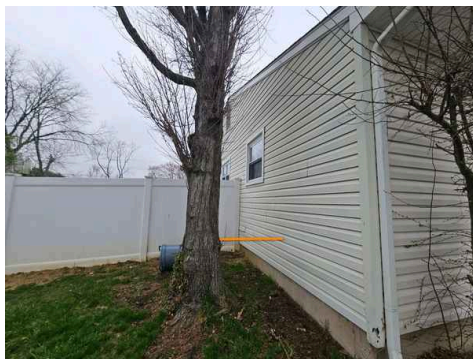
Right Rear

A tree was observed located in close proximity to the structure. Trees situated near foundations and exterior walls can influence soil moisture conditions and may contribute to root-related soil movement over time. Overhanging limbs may also deposit debris on roof surfaces and increase maintenance requirements. Maintaining appropriate distance between trees and the structure can help reduce potential impact on exterior components and drainage patterns.

Recommendation

Contact a qualified tree service company.

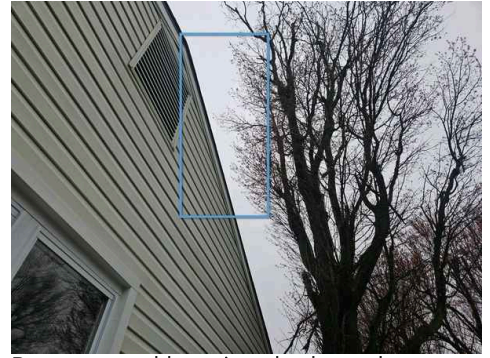
Tree limbs were observed overhanging the roof and exterior portions of the structure. Overhanging branches can deposit leaves and organic debris onto roof surfaces and within gutters, increasing maintenance requirements. Limbs positioned above the structure may also contact roofing materials during wind conditions. Maintaining proper clearance can help reduce wear on roofing components and support effective drainage.

Recommend keeping the branches trimmed back.

Recommendation

Contact a qualified tree service company.

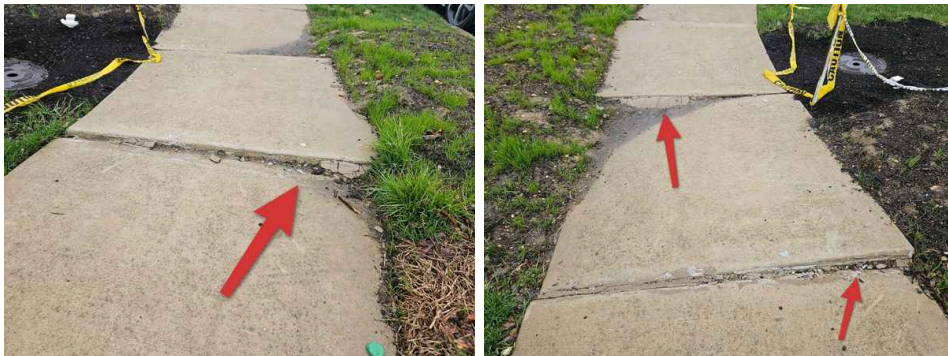
WALKWAY TRIP HAZARD

The walkway had uneven sections that created a trip hazard along the walking surface. Changes in elevation were observed between adjacent sections, resulting in an irregular path of travel. Such conditions increase the potential for loss of footing during normal use. Uneven areas may worsen over time due to settlement, surface wear, or seasonal movement.

Recommendation

Contact a qualified concrete contractor.

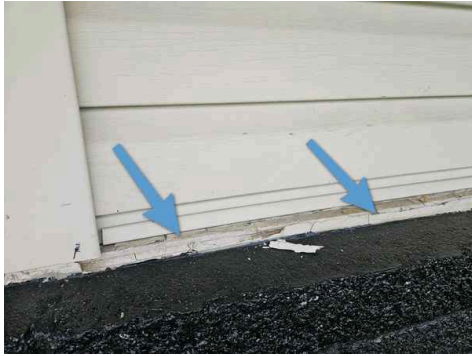
Front

CAULKING MAINTENANCE NEEDED AT SIDING AND TRIM

Sealant at various siding and trim joints was observed to be cracked, separated, or deteriorated. Gaps were visible at certain transitions around penetrations and trim interfaces. Deteriorated caulking can allow moisture and air intrusion at exterior wall assemblies. Routine maintenance of sealant joints helps preserve the performance of siding and trim materials over time.

Recommendation

Contact a handyman or DIY project

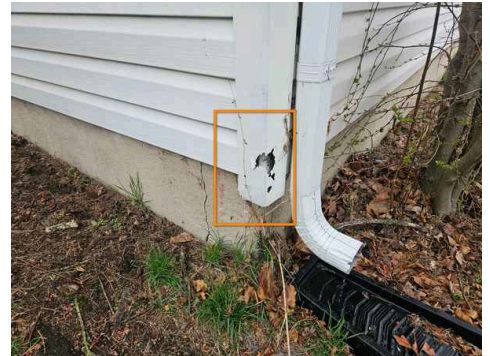
Right Rear

DAMAGED EXTERIOR WALL-COVERING MATERIAL

The exterior wall-covering material exhibited visible damage in one or more areas. Sections appeared cracked, punctured, or otherwise compromised. Damaged cladding can allow moisture to enter the wall assembly if not properly maintained. Continued exposure to weather conditions may contribute to further deterioration over time.

Recommendation

Contact a qualified siding specialist.

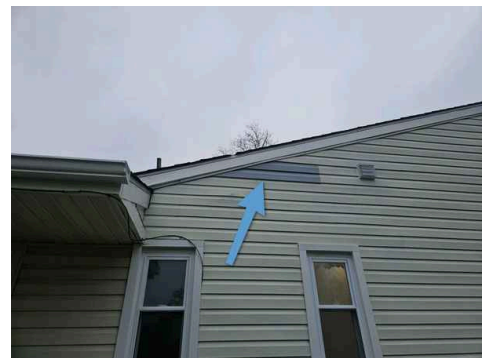
Right

EVIDENCE OF PREVIOUS EXTERIOR REPAIRS

Evidence of prior repairs was observed at the exterior siding and/or trim areas. Patch materials, sealants, or replacement sections were visible in localized areas. The quality and extent of the repairs could not be fully determined at the time of inspection. Monitoring of these areas is recommended to ensure continued performance and stability over time.

Recommendation

Contact a qualified siding specialist.

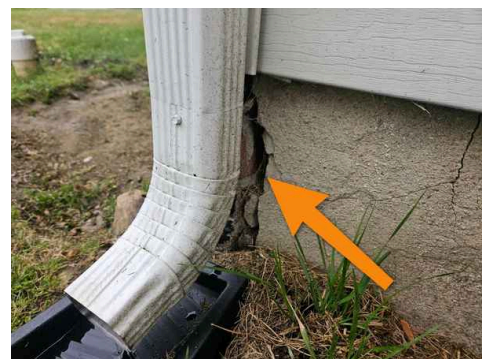
Right Front

GAP OBSERVED BEHIND BRICK VENEER

A visible gap was observed behind sections of the brick veneer at the exterior wall. The separation was noted between the veneer and the underlying structure in localized areas. Gaps of this nature may allow moisture or debris to enter the wall cavity if not properly managed. Monitoring and corrective action, if necessary, can help maintain the integrity of the exterior wall assembly over time.

Recommendation

Contact a qualified masonry professional.

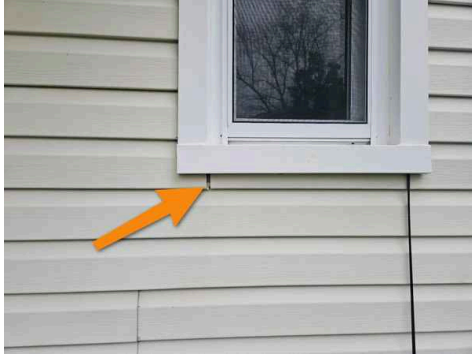
Right

Gaps were observed between sections of the exterior siding material. Open seams and separation were visible at certain joints and transitions. Gaps in siding can allow moisture, air, or pests to enter the wall assembly if not properly sealed or overlapped. Continued exposure at these openings may contribute to deterioration of underlying materials over time.

Recommendation

Contact a qualified siding specialist.

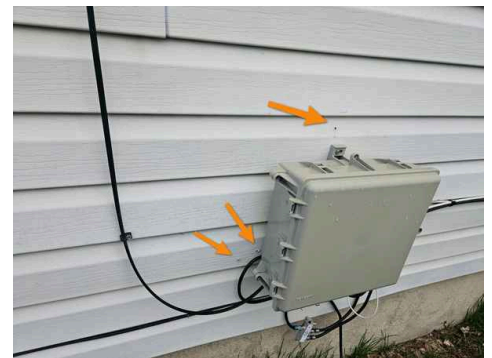
Right

Holes were observed in the exterior siding in one or more locations. The openings penetrated through the cladding and exposed underlying wall components. Such openings can allow moisture, air, and pests to enter the wall assembly if not properly sealed. Continued exposure may contribute to deterioration of the underlying materials over time.

Recommendation

Contact a qualified siding specialist.

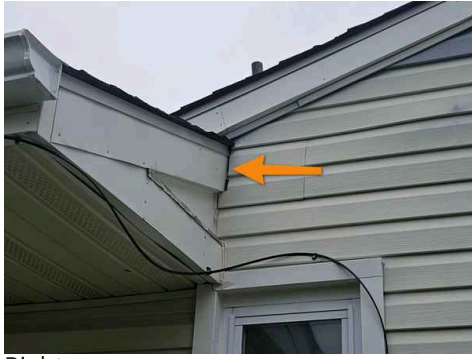
Right

J-CHANNEL – MISSING

J-channel trim was not observed at one or more siding termination points where it is typically installed. The siding edges appeared unfinished or not properly secured at openings or transitions. Missing J-channel can allow moisture to enter behind the siding and may affect the overall fit and appearance of the cladding. Proper termination components help manage water and support the siding system.

Recommendation

Contact a qualified siding specialist.

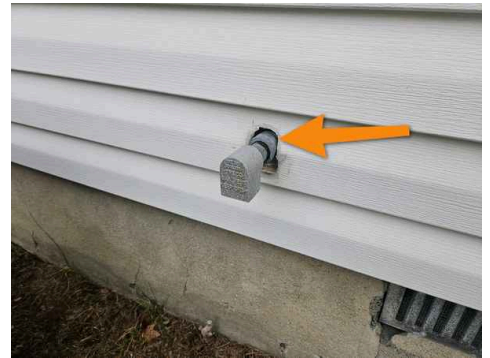
Rear

One or more penetrations through the exterior siding were observed to be unsealed. Visible gaps were present around utility lines, conduits, or mounted fixtures where they passed through the wall covering. Unsealed openings can allow moisture, air, or pests to enter the wall assembly. Proper sealing helps maintain the weather resistance and durability of the exterior wall system over time.

Recommendation

Contact a handyman or DIY project

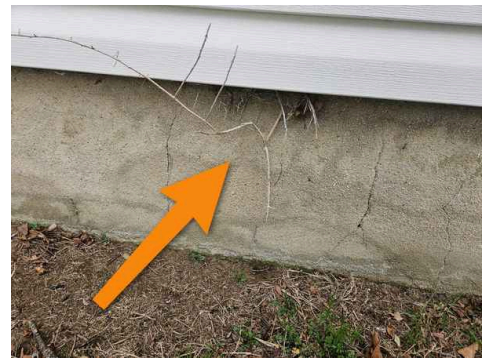
Rear

Vegetation was observed growing through or out of the exterior siding in one or more areas. Plant growth was visible at joints and/or small openings in the cladding. Vegetation in these locations may indicate retained moisture or accumulated debris behind the siding. Continued growth can contribute to material deterioration and may affect the performance of the wall assembly over time.

Recommendation

Contact a qualified professional.

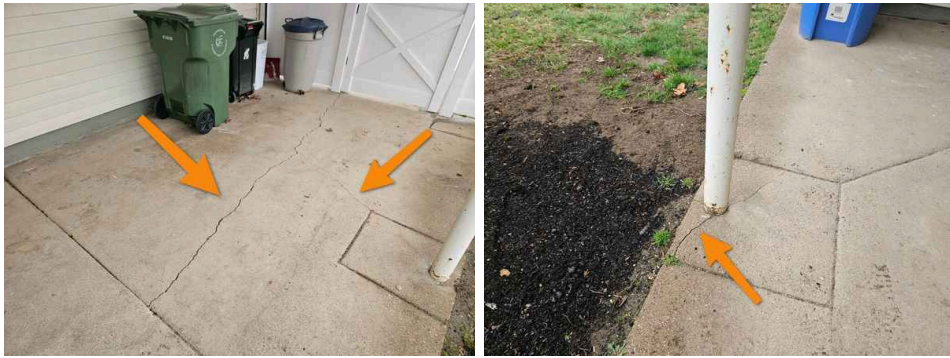
SETTLEMENT CRACKS AT PORCH OR PATIO

Cracks consistent with settlement were observed at the porch or patio surface. The cracking pattern indicated differential movement between sections of the slab. Settlement can occur due to soil compaction issues, changes in moisture conditions, or natural ground movement. Continued movement may result in widening cracks or uneven transitions over time.

Recommendation

Contact a qualified concrete contractor.

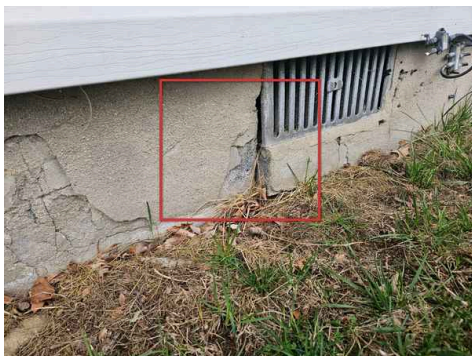
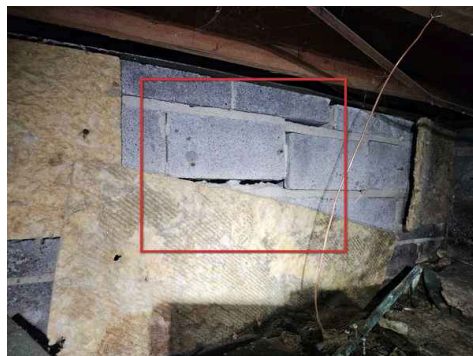
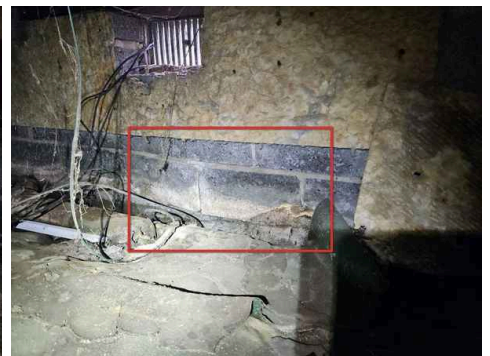
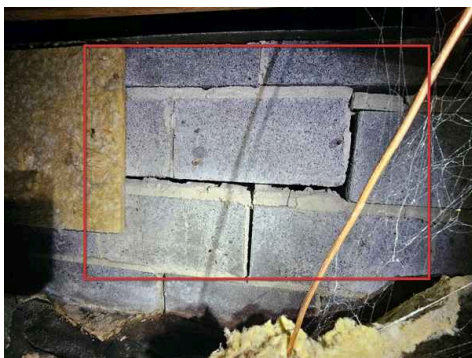
Right

CONCRETE BLOCK FOUNDATION HEAVING

Portions of the concrete block foundation wall were observed to exhibit signs of heaving. Sections of the wall appeared displaced or elevated relative to adjacent areas. Heaving can occur due to soil movement, moisture conditions, or frost-related expansion beneath the foundation. Movement of this nature may affect the structural stability and alignment of the foundation wall over time.

Recommendation
Contact a foundation contractor.

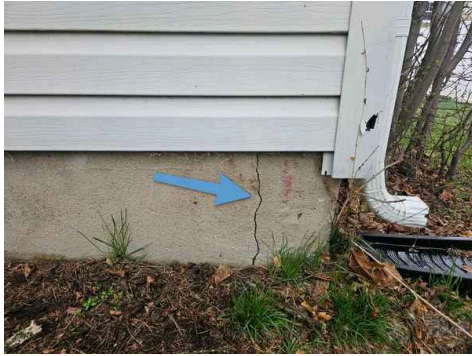
Right Rear

FOUNDATION PARGING – CRACKED AND CHIPPING

The parging material on the foundation wall was observed to be cracked and chipping in several areas. Sections of the surface coating showed flaking and localized material loss. Parging serves as a protective and cosmetic finish over masonry surfaces. Deterioration of this layer may expose the underlying masonry to increased weathering over time.

Recommendation
Contact a qualified masonry professional.

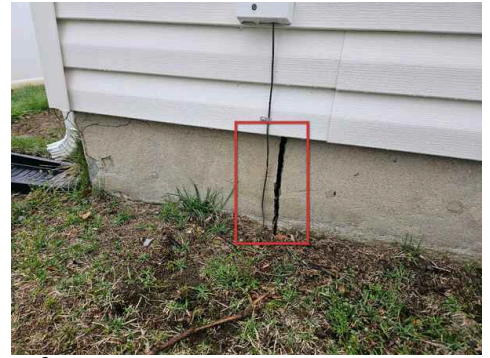
Left Rear

SIGNIFICANT FOUNDATION MOVEMENT OBSERVED

Significant movement was observed at the foundation during the inspection. Noticeable displacement, cracking, and/or misalignment were present in affected areas. The extent of movement exceeded what is typically associated with minor settlement or shrinkage. Continued movement of this nature may impact structural stability and the alignment of building components over time.

Recommendation
Contact a qualified structural engineer.

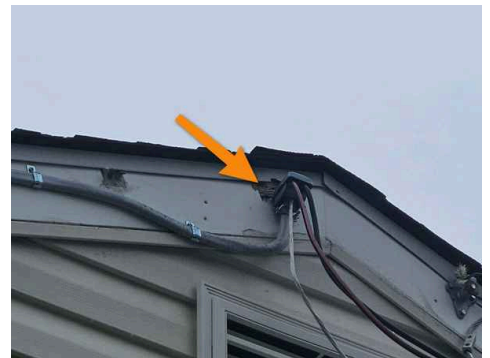
DAMAGED FASCIA

The fascia board was observed to be damaged at the time of inspection. Visible deterioration was noted along the edge of the roof overhang. Damage to the fascia can affect support for the gutter system and may allow moisture to impact adjacent materials. Repair or replacement is recommended to maintain proper function and protection at the roof edge.

Exposed wood behind the metal flashing

Recommendation
Contact a qualified roofing professional.

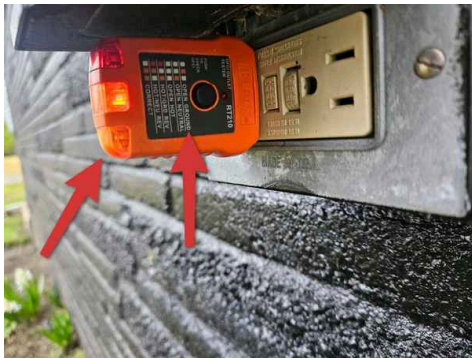
Front

OPEN GROUND CONDITION AT EXTERIOR OUTLET

The exterior receptacle tested with an open ground condition at the time of inspection. This result indicates that the equipment grounding conductor was not properly connected or present. An open ground can affect the safe operation of connected devices and may limit the effectiveness of protective features. Evaluation and correction are recommended to restore proper grounding continuity.

Recommendation

Contact a qualified electrical contractor.

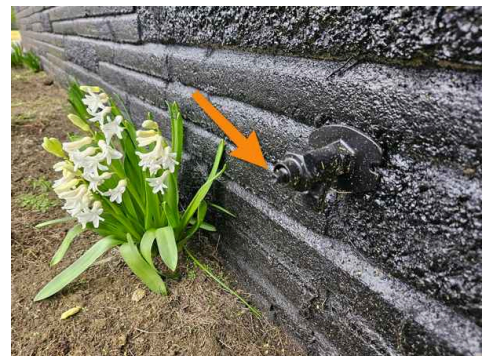
DAMAGED / BROKEN COMPONENTS AT EXTERIOR WATER SPIGOT

Components of the exterior water spigot were observed to be broken at the time of inspection. Visible damage was noted at the handle and/or body of the fixture. Damaged components may affect normal operation and can contribute to leakage or reduced durability over time. Repair or replacement is recommended to restore proper function and reliability.

Front - missing handle

Recommendation

Contact a qualified plumbing contractor.

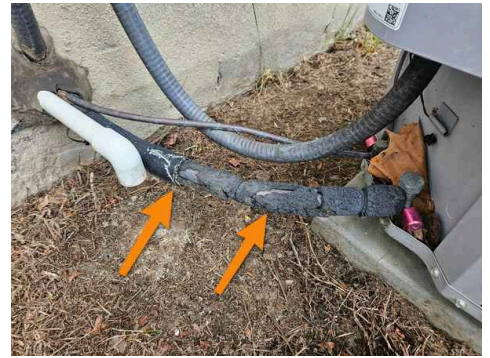
REFRIGERANT LINE INSULATION – MISSING OR DAMAGED

Insulation on the refrigerant suction line was missing or deteriorated. This insulation helps reduce energy loss and prevents condensation from forming on the refrigerant line. When insulation is missing or damaged, system efficiency may be reduced and moisture may develop on the line. Replacing the insulation can help maintain proper system operation.

Recommendation
Contact a qualified HVAC professional.

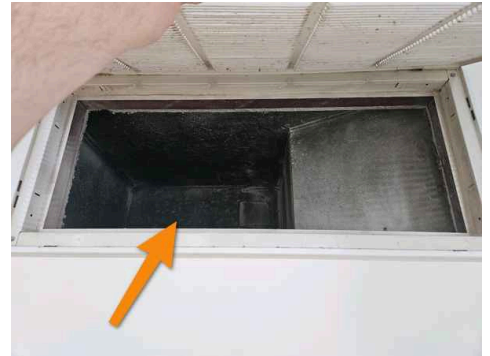
HVAC AIR FILTER – MISSING

An air filter was not observed in the HVAC system at the time of the inspection. Air filters are intended to capture dust and debris before the air enters the heating and cooling equipment. Without a filter, dust and debris may accumulate within system components over time. Installing an appropriate air filter can help protect the HVAC equipment and improve system performance.

Recommendation
Recommended DIY Project

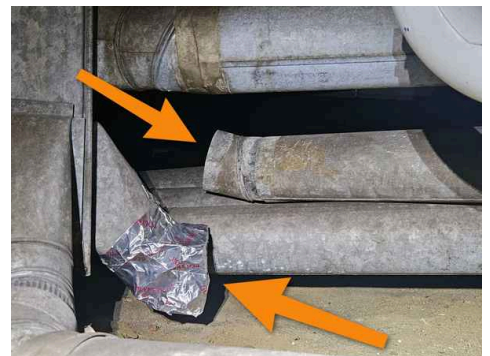
DUCTWORK – DISCONNECTED

Recommendation
Contact a qualified HVAC professional.

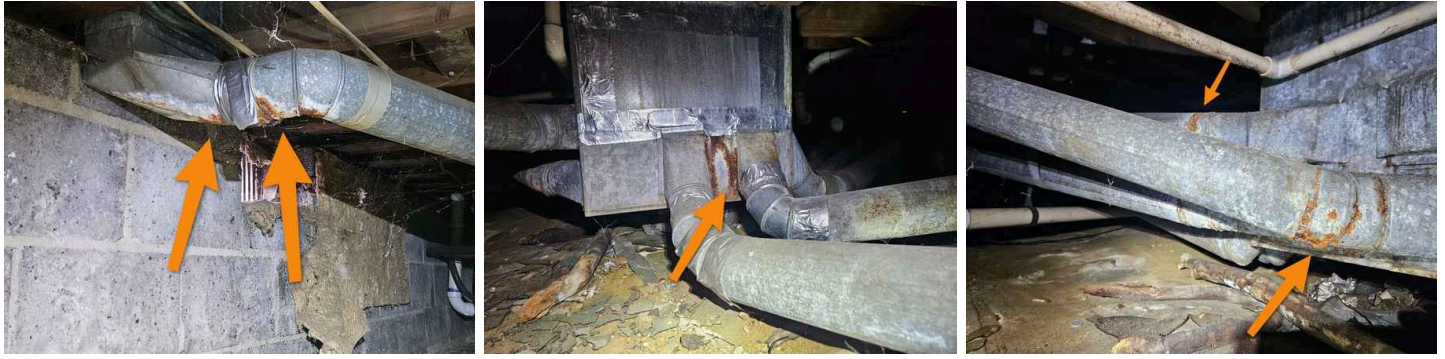
HVAC DUCTWORK – DETERIORATED OR CORRODED

Recommendation
Contact a qualified HVAC professional.

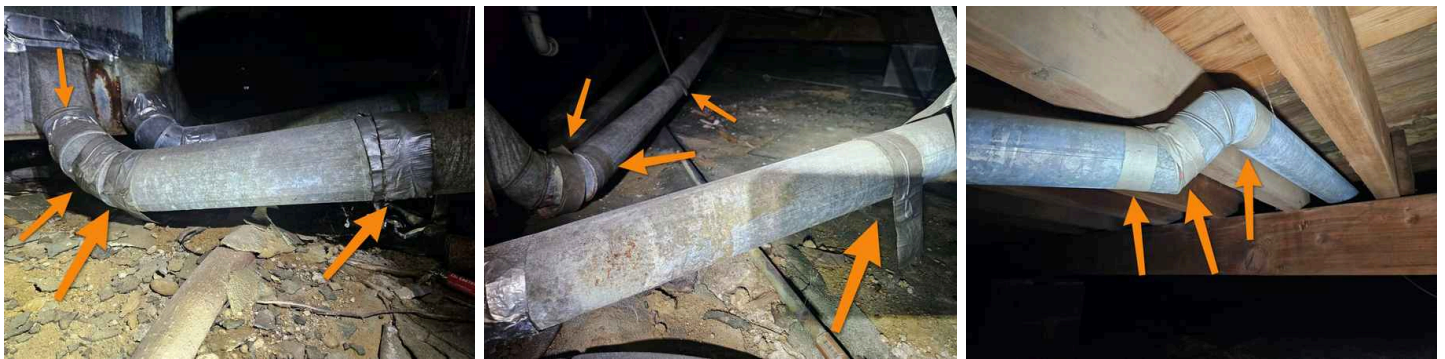
HVAC DUCTWORK – NOT PROPERLY SEALED

Recommendation

Contact a qualified HVAC professional.

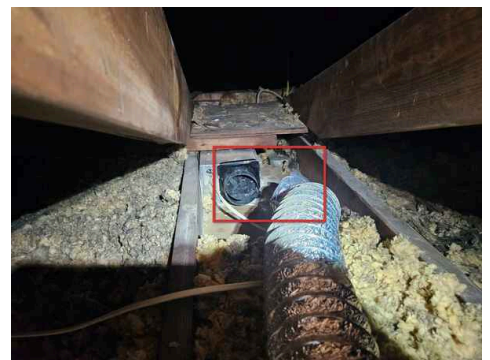
BATHROOM FAN EXHAUSTS INTO ATTIC

Recommendation

Contact a qualified general contractor.

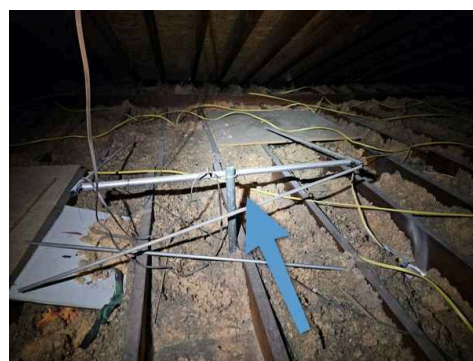
An old antenna was observed abandoned in the attic. Abandoned equipment and materials left in attic spaces can contribute to clutter and may interfere with access, maintenance, or the installation of insulation and ventilation components. Older antenna wiring or mounting hardware may also become loose or deteriorated over time.

Recommendation

Contact a handyman or DIY project

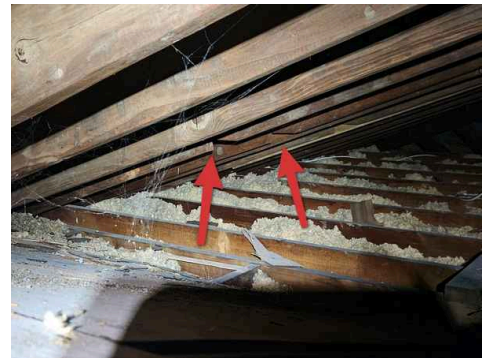
6.2.2 Roof & Attic Structure
IMPROPERLY NOTCHED ROOF RAFTER

Appears the cut rafters have not been repaired.

Recommendation
 Contact a qualified structural engineer.

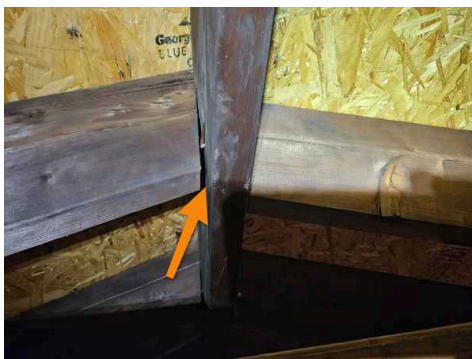
6.2.3 Roof & Attic Structure
RAFTER SEPARATING FROM RIDGE BEAM

All rafter appeared to be separating from the ridge beam. Recommend installed rafter ties to prevent more movement and separation.

Recommendation
 Contact a qualified structural engineer.

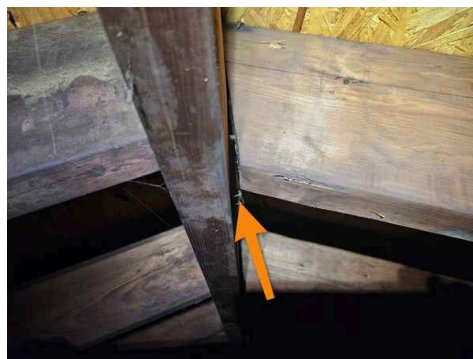
All rafter appeared to be separating from the ridge beam. Recommend installed rafter ties to prevent more movement and separation.

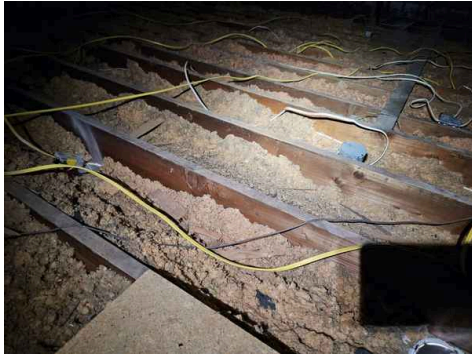
INSUFFICIENT ATTIC INSULATION

Blown in insulation appeared to be compressed and inadequate throughout the entire attic.

Recommendation
Contact a qualified insulation contractor.

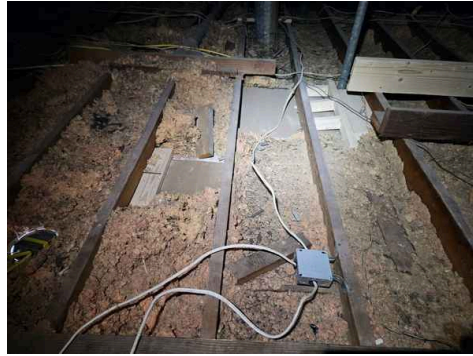
Blown in insulation appeared to be compressed and inadequate throughout the entire attic.

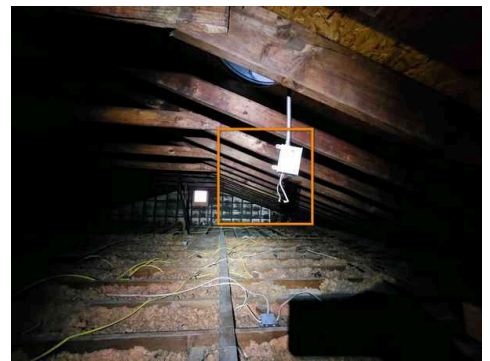
Attic fan installed and not connected to a source of power.

Recommendation
Contact a qualified electrical contractor.

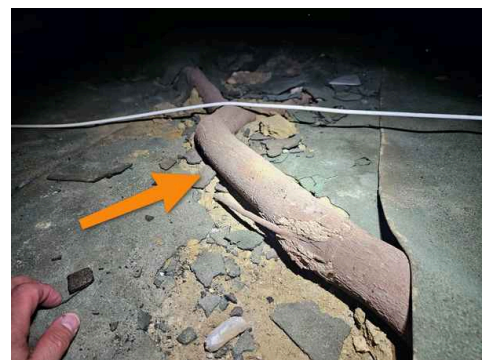
There were roots throughout the crawlspace from the old trees that have been removed around the perimeter of the house.

Recommendation
Contact a qualified landscaping contractor

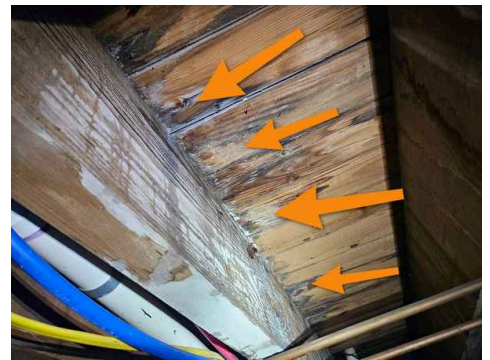
7.1.3 General
**POSSIBLE MICROBIAL GROWTH
OBSERVED IN CRAWLSPACE**

Areas of discoloration consistent with possible microbial growth were observed on surfaces within the crawlspace at the time of the inspection. Such conditions are commonly associated with elevated moisture levels or prolonged dampness in enclosed areas. The presence of suspected growth may indicate that moisture conditions have existed that allow biological material to develop on wood or other surfaces. Further evaluation may help determine the extent of the condition and whether corrective actions are appropriate to address moisture and affected materials.

Swab sample taken

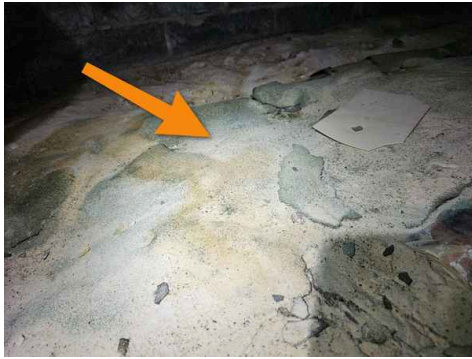
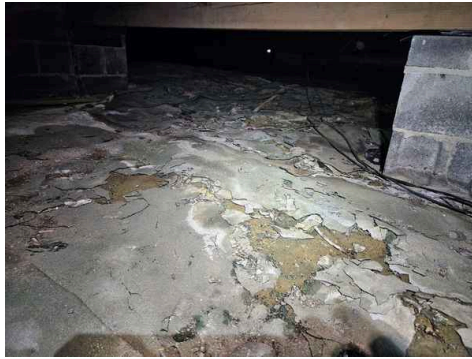
IMPROPER VAPOR RETARDER MATERIAL IN CRAWLSPACE

Asphalt material used in which it had dried and became brittle. Recommend having a waterproofing company remove the old vapor barrier and install new 6 mil poly vapor barrier.

Recommendation

Contact a qualified waterproofing contractor

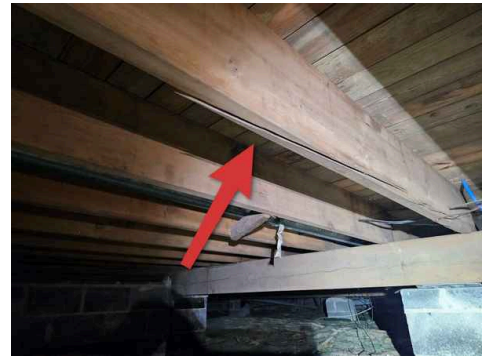
7.3.1 Homes Floor Structure
FLOOR JOIST SPLITTING OBSERVED

Near the front portion of the house.

Recommendation

Contact a qualified structural engineer.

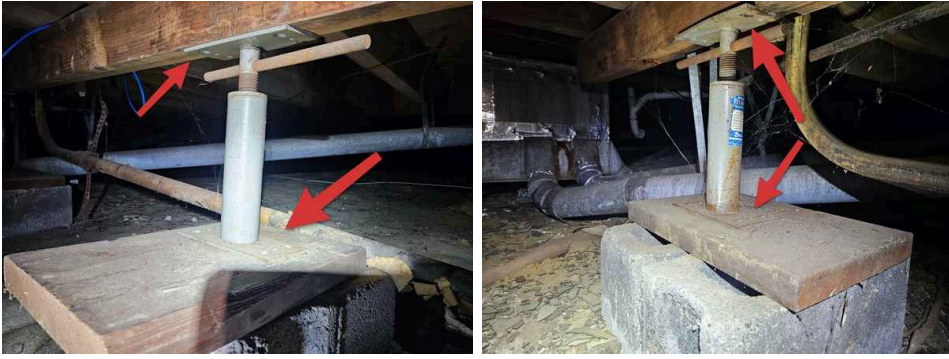
7.3.2 Homes Floor Structure
JACK POST NOT SECURED

Recommendation

Contact a qualified structural engineer.

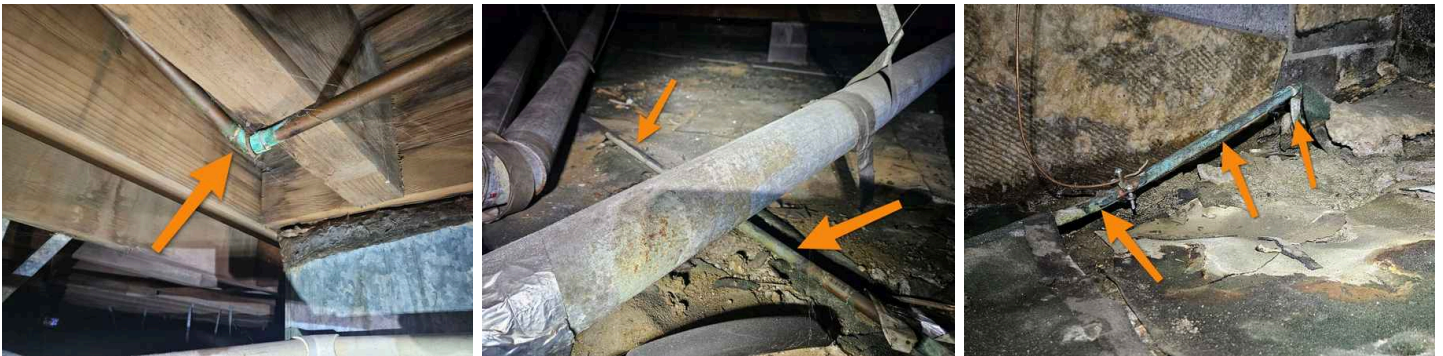
8.2.1 Water Supply & Distribution Systems **CORRODED WATER SUPPLY PIPING**

Recommendation

Contact a qualified plumbing contractor.

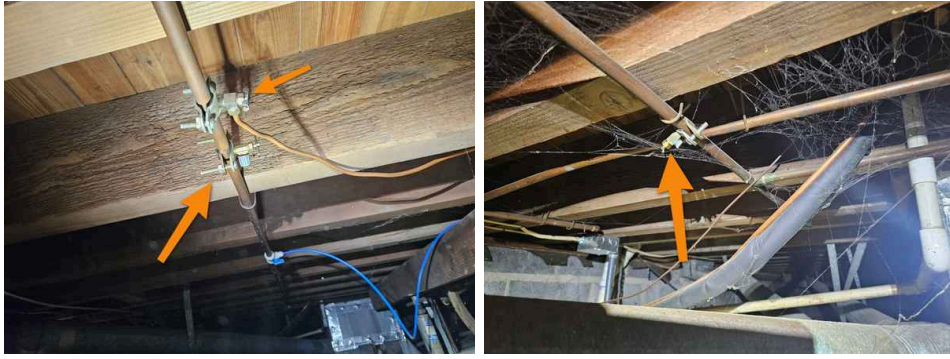
8.2.2 Water Supply & Distribution Systems **SADDLE VALVE INSTALLED ON WATER SUPPLY LINE**

Recommendation

Contact a qualified plumbing contractor.

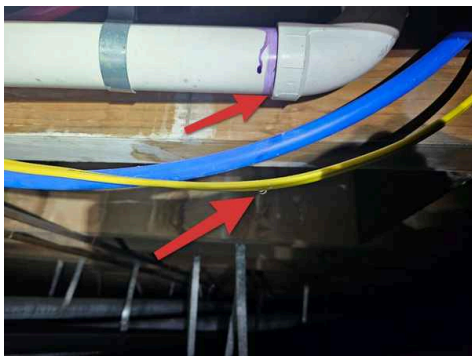
8.3.1 Drain, Waste, & Vent Systems
DRAIN PIPE – ACTIVELY LEAKING

See video

Recommendation
 Contact a qualified plumbing contractor.

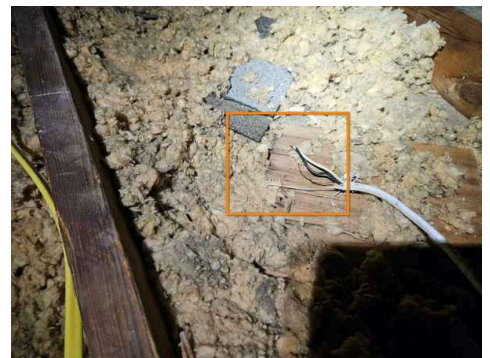
Wires should terminate in a junction box and wires capped off

Recommendation
Contact a qualified electrical contractor.

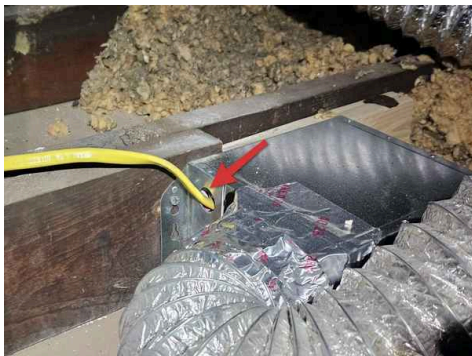
10.6.6 Lighting Fixtures, Switches & Receptacles
MISSING WIRE CLAMPS AT TERMINATION

Wires should be secured by the proper clamp to prevent movement. The vibration of the fan and the sharp metal of the box will eventually "cut" through the sheathing of the wire lead to possible electrical shock.

Recommendation
Contact a qualified electrical contractor.

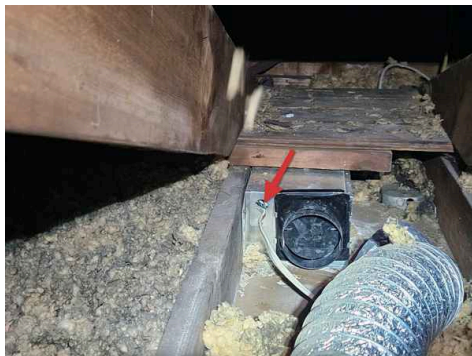
Wires should be secured by the proper clamp to prevent movement. The vibration of the fan and the sharp metal of the box will eventually "cut" through the sheathing of the wire lead to possible electrical shock.

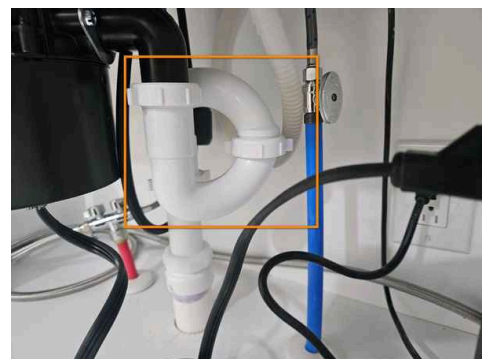
11.2.1 Kitchen Sink
SINK – IMPROPER DRAIN CONFIGURATION (S-TRAP)

Recommendation
Contact a qualified plumbing contractor.

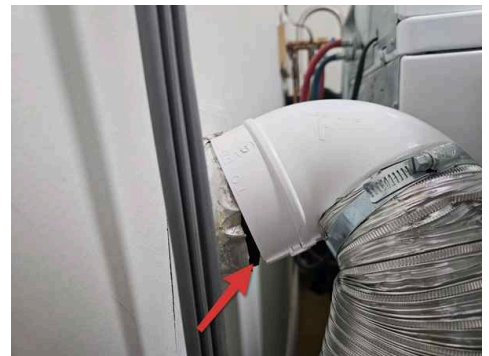
The dryer vent was observed to be disconnected at the time of inspection. This condition allows lint, moisture, and warm air to discharge into the surrounding area rather than being directed outside. Accumulation of these materials can contribute to deterioration of nearby surfaces over time. The system is not functioning as intended in its current condition. Reconnection and proper securing of the vent are recommended.

Recommendation

Contact a handyman or DIY project

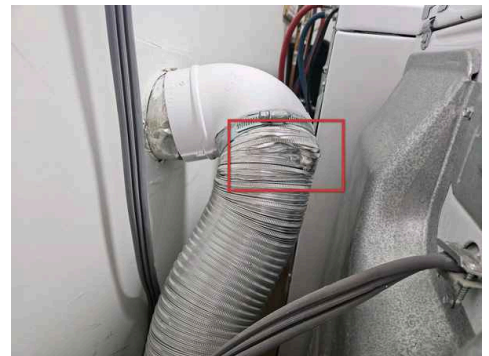
The dryer vent duct was observed to be crushed or kinked. This condition restricts airflow and can lead to overheating during operation. Restricted airflow may also cause lint to accumulate within the duct system. This condition reduces efficiency and may increase the risk of damage over time. Correction is recommended.

Recommendation

Contact a handyman or DIY project
