Inventory & Check In Report

Pure Inventra Sample Report

Inventory & Check In

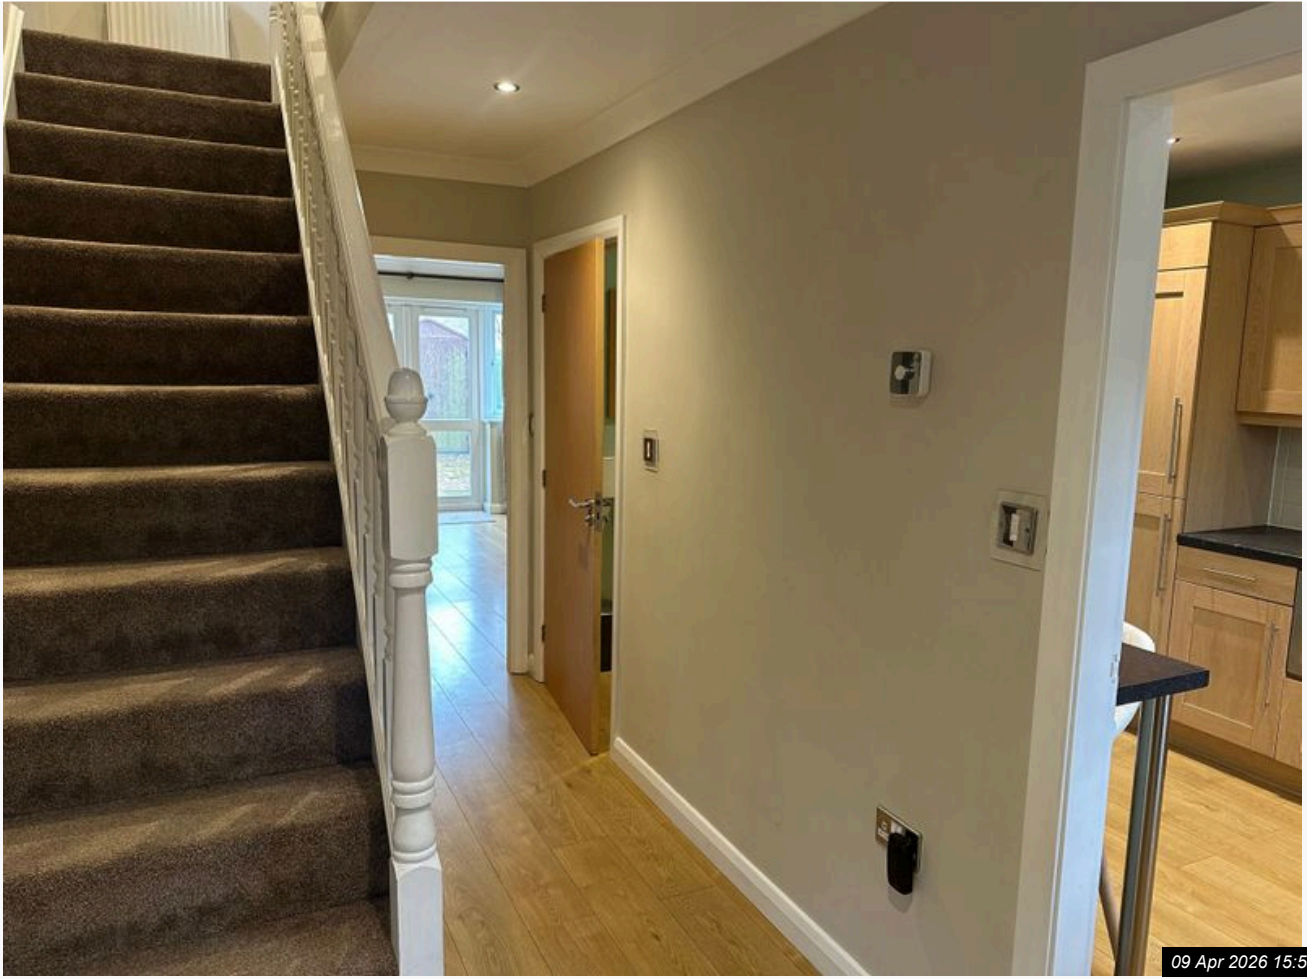
Ref #6

6.5	Walls	Painted plaster walls in a light neutral tone throughout the hallway / landing areas	In overall good order Uneven finish visible Minor scuff marks noted near the staircase

6.6	Skirting and Woodwork	White painted skirting boards with white painted staircase banister and balustrade	In overall good order Minor scuffs to skirting noted

6.7	Flooring	Combination of light wood laminate to parts of the hallway and brown / beige carpet to the hallway / landing and staircase	In overall good order Laminate with no visible damage Carpet in good order Some general wear and no major stains

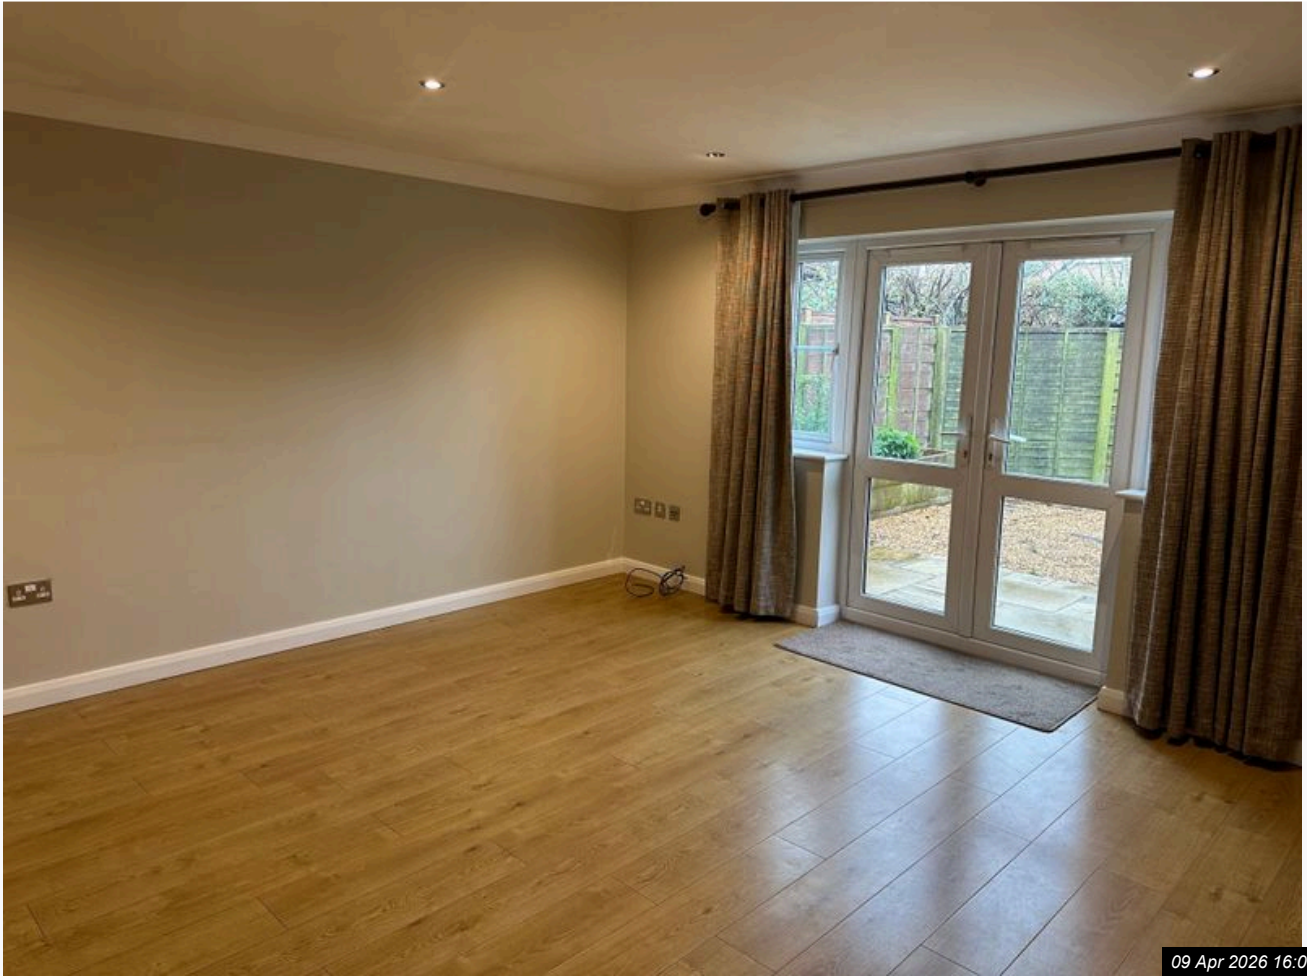
Ref #7

Ref	Name	Description	Condition
7.1	Door	Light wood laminate internal door with visible grain and silver chrome lever handle	In overall good order Light scuff marks noted near the edge Otherwise no visible damage

7.2	Ceiling	Smooth white painted plaster ceiling	In overall good order No stains or cracks Minor paint touch-up / uneven finish visible
7.3	Lighting	Recessed ceiling spotlights with white / brushed metal trims, evenly distributed	As fitted In overall good order All appear intact and functional No visible damage

7. RECEPTION (CONT.)			
7.6	Flooring	Light oak effect laminate flooring installed throughout	In overall good order Clean with a few light scuffs / marks No significant damage

7.8	Sockets and Switches	Multiple double power sockets in polished / brushed metal finish at skirting level Some sockets include USB ports and phone / TV connections	As fitted In overall good order Not fully tested Clean with no damage Minor marks noted around 1 socket

7.10	Curtains and Blinds	Full-length textured curtains in beige / dark grey tones on a dark / black curtain pole with metal eyelets above the patio doors	In overall good order 1 small tear visible Otherwise no stains or damage

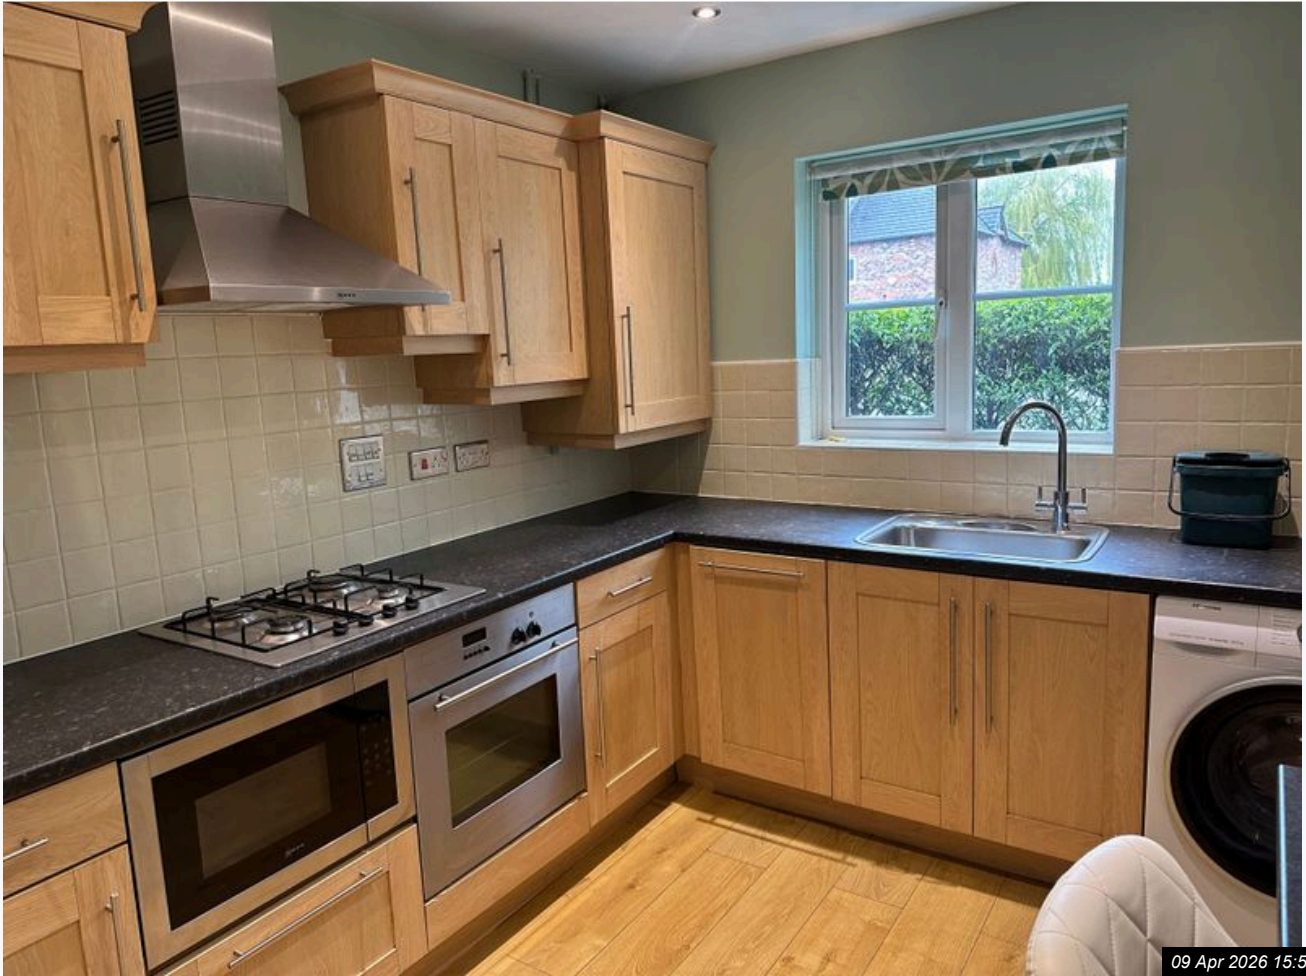
Ref #8

8.4	Walls	Pale / light green painted walls with a cream / beige tiled splashback around the kitchen area Includes a textured feature section with horizontal stripes	In overall good order Minor scuffs / indentations noted in places

8.13	Work Surface	Dark stone-effect / black laminate countertop extending across units and the breakfast bar Breakfast bar section supported on stainless steel legs	In overall good order Some light wear / fine scratches from use No major damage

8.14	Sink	Stainless steel double sink with mixer tap and integrated drainer located beneath the window	In overall good order Clean with light water marks and fine surface scratches

8.15	Furnishings and Appliances	Integrated stainless steel oven	In overall good order Oven shows cosmetic scratches Clean
8.15.1	-	Integrated stainless steel gas hob	In overall good order Clean with no visible damage

8.15.4	-	2 white / cream bar stools with padded seats and wooden legs	In overall good order Clean 1 bar stool with minor seat wear

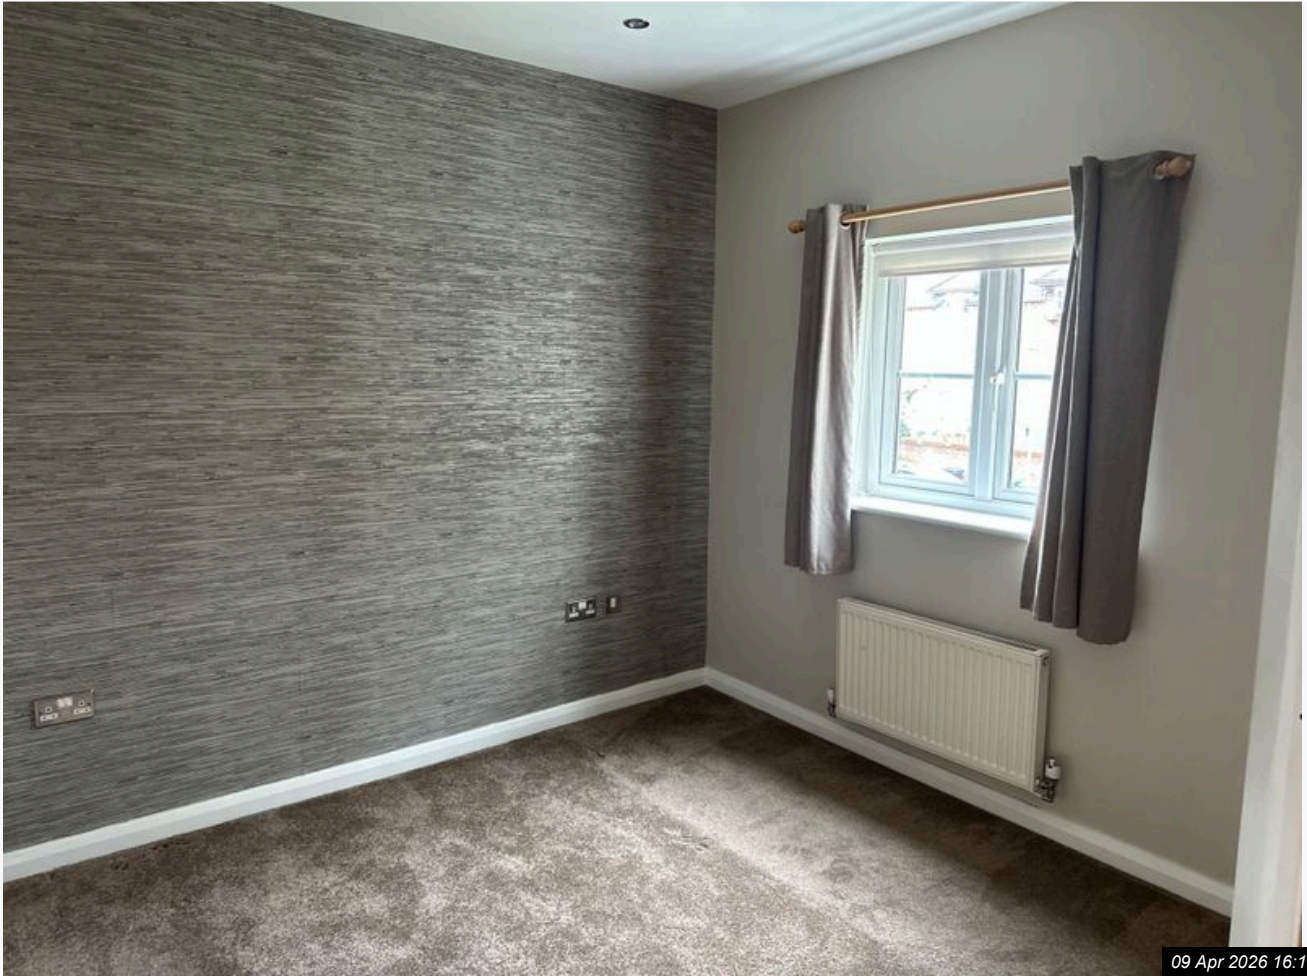
Ref #10

10. BEDROOM 1 (CONT.)			
10.6	Flooring	Brown / light brown textured carpet laid wall-to-wall	In overall good order Some noticeable wear and slight discolouration in higher traffic areas No obvious stains

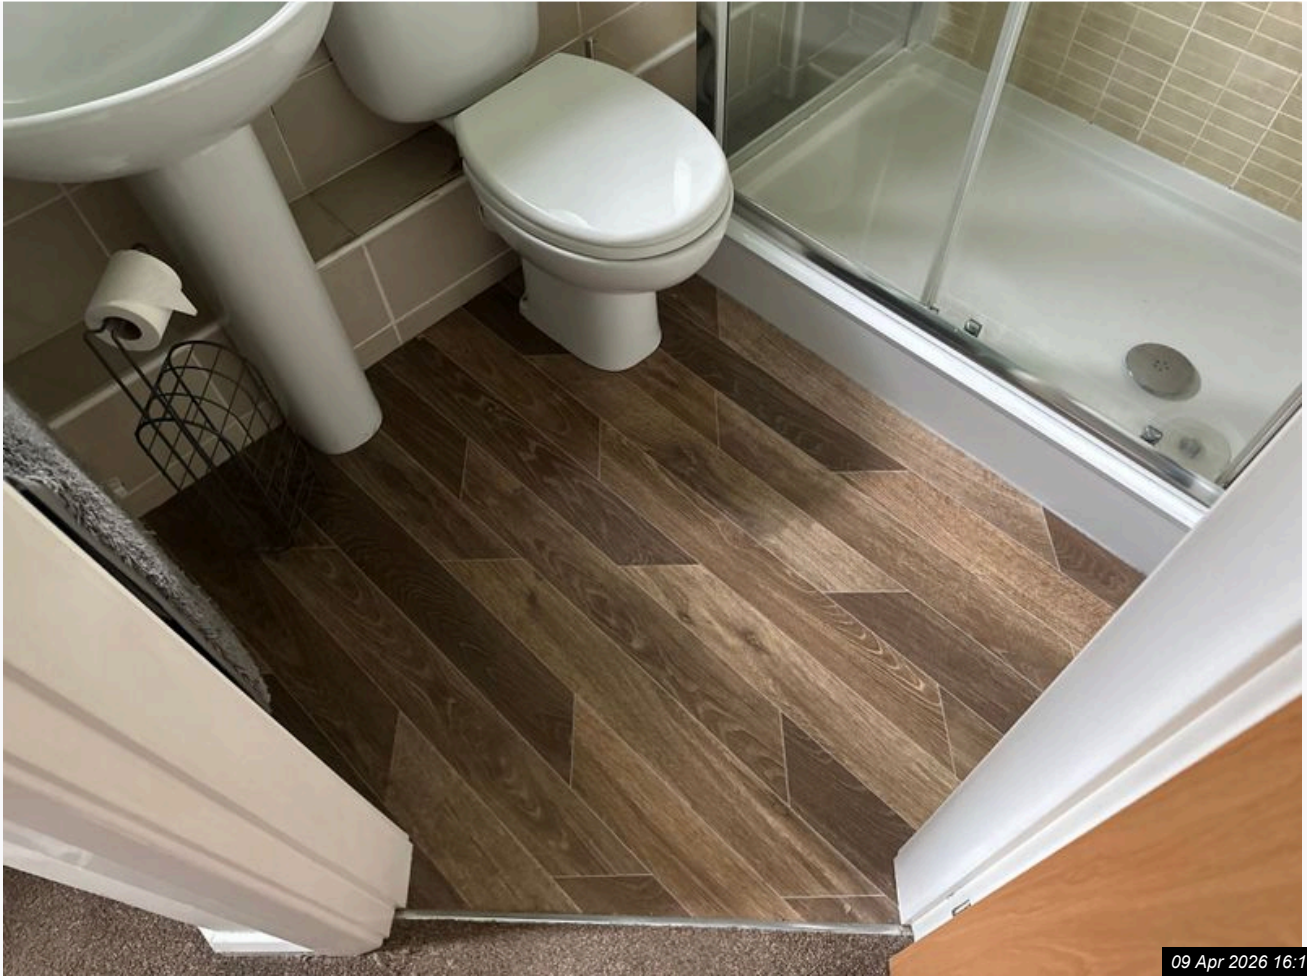
Ref #11

11.4	Walls	Combination of light green painted walls and cream tiled sections around sink, toilet and shower areas	In overall good order Painted area shows minor cracking Tiles sound with no visible damage Minor hairline cracks visible on 1 painted section Tiles clean with neat grout lines

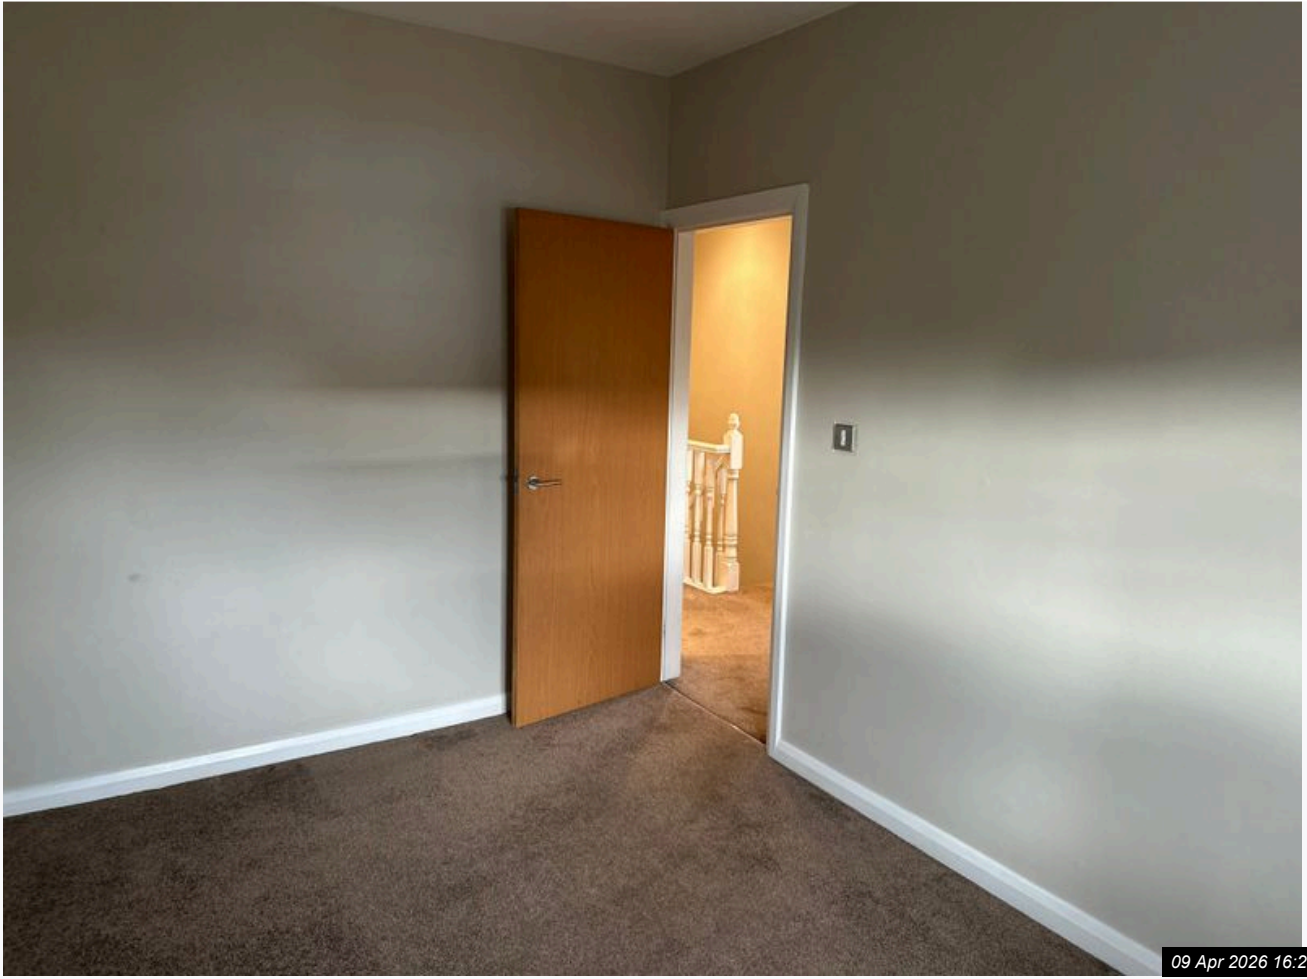
Ref #13

Ref	Name	Description	Condition
13.1	Door	Light wood laminate door with a silver chrome lever handle	In overall good order Clean with no visible marks or damage
13.2	Ceiling	Smooth white painted plaster ceiling	In overall good order Clean with no visible stains, marks, or damage
13.3	Lighting	4 recessed ceiling spotlights with chrome finish	As fitted In overall good order All lights appear functional
13.4	Walls	Light grey painted walls with a smooth finish	In fair order Wear evident in noted areas Scuff marks and minor discolouration visible near the centre area
13.5	Skirting and Woodwork	White painted skirting boards around the perimeter	In overall good order Minor scuffs in places and slight discolouration noted
13.6	Flooring	Brown carpet covering the entire floor area	In fair order Noticeable wear with slightly darker traffic areas

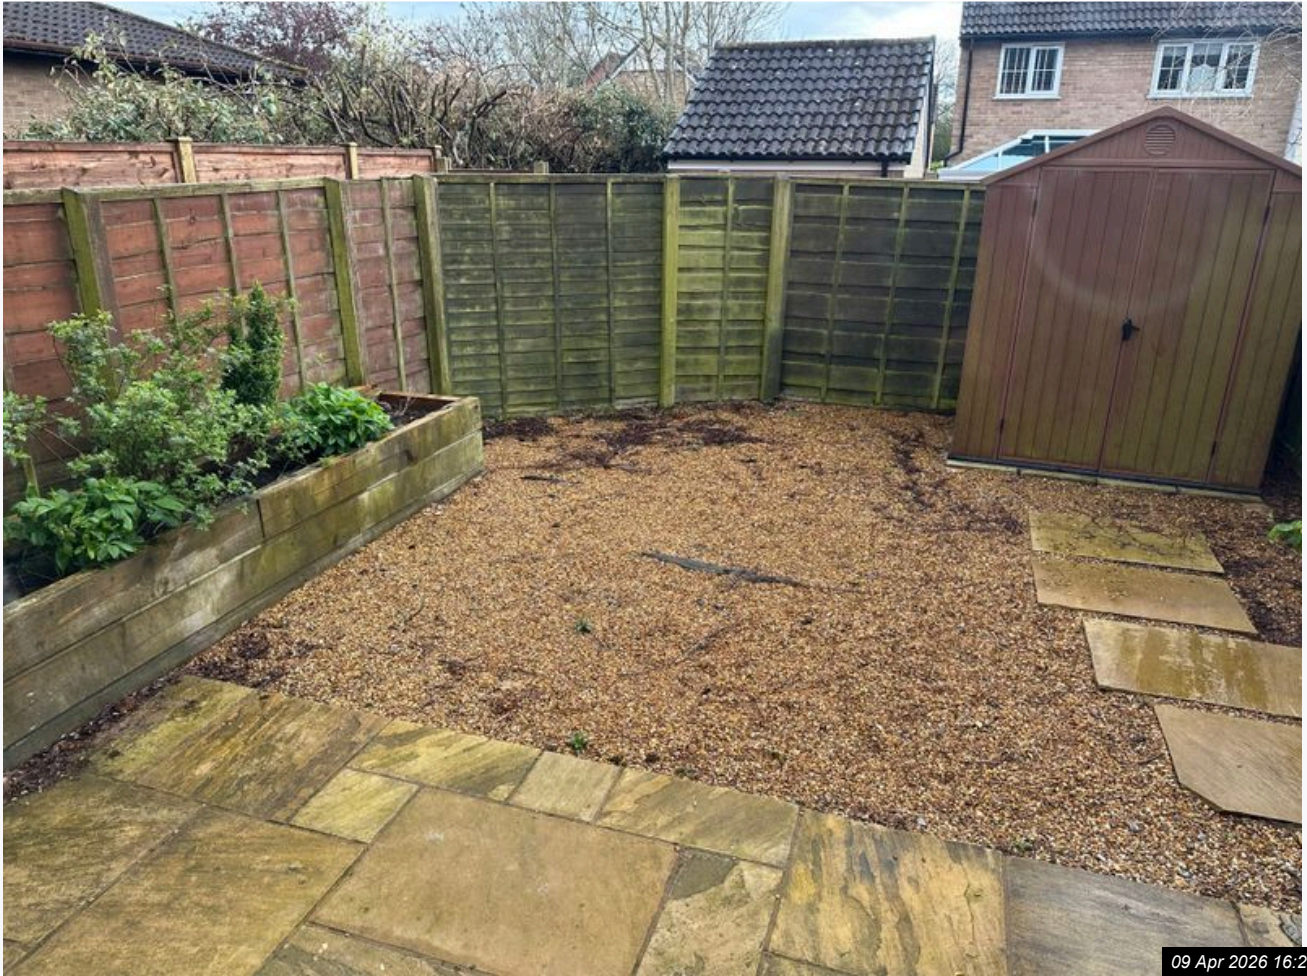
Ref #15

Ref	Name	Description	Condition
15.1	Walls / Fence	Wooden paneled fencing	In fair exterior order Fence behind shed heavily discoloured Weathered throughout
15.2	Flooring	Stone and gravel flooring Pale stone slabs in the foreground transitioning to an area filled with light brown gravel	In overall good exterior order Minor weathering visible on stone slabs
15.3	Contents	Raised wooden planter along one side of the area containing small shrubs and plants	In overall good exterior order Some natural weathering on wood
15.3.1	-	Garden shed constructed from wood with a pitched roof and single door	In overall good exterior order Minor weathering visible on the wood surface
15.4	Additional Photos
