MS AN EXAMPLE

4 Bedroom

Taylor Wimpey

16 Mar 2021

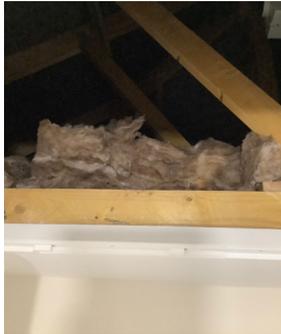
General observations

All the below points were inspected with no issues found:

- Rodding eye inspection
- Foul drain inspection
- Rain water drain inspection
- Fire alarm test
- Loft inspection
- Boiler inspection
- Outside electrical socket inspected

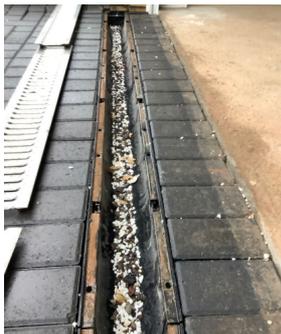
Aco drainage

Drainage blocked by waste material- blockage to be cleared
Other material to be cleared from Channel

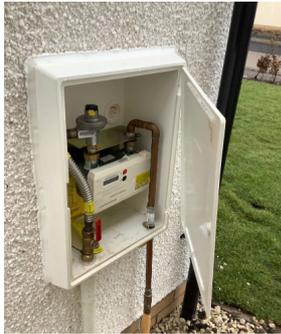
Electrical cupboard

Broken door to be fixed

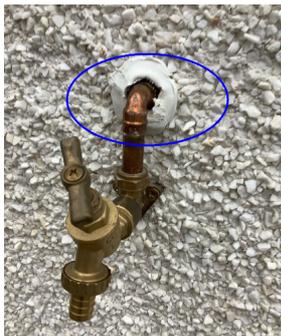
Outside tap

Incorrectly sealed. There is a requirement to reseal.

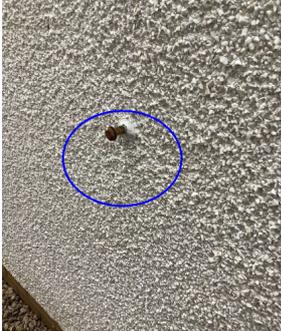
Missing cage

Cage to be placed over vent, also some movement on the pipe.

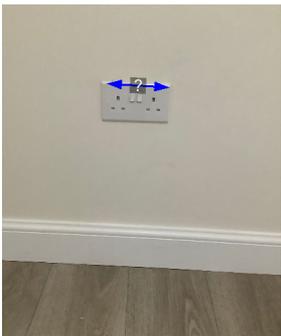
Electrical sockets

The electrical socket fitting is not level. Also finishing around the socket needs re done.

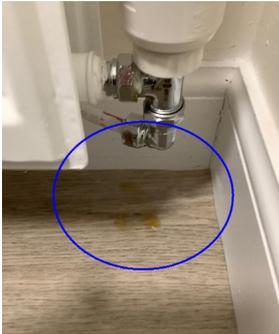
Radiator

Description
Leak from pipe to be addressed.

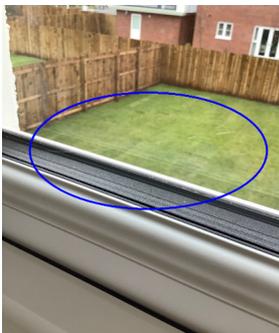
Window glass

Description
Scratches on glazing. This unit will need replaced.

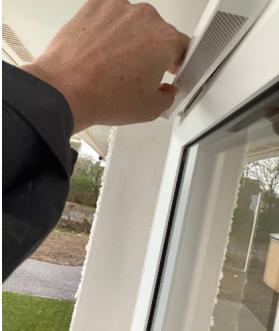
Window vent

Vent fixing is broken on one side. This will need replaced as this could cause ventilation issues.

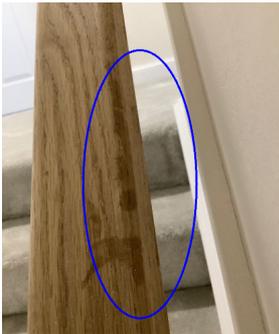
Stair banister

Adhesive marks and damage to banister.

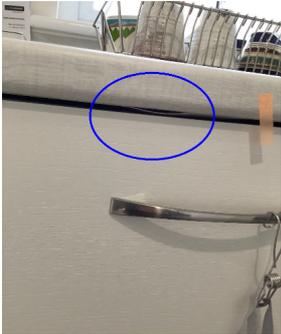
Kitchen worktop

Damage to worktop, this needs to be repaired or most likely replaced.

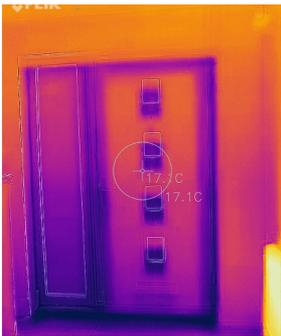
Thermal imaging

Heat loss found from front door. Have installation checked by builder.
