4.2 LOAD-BEARING TESTS.

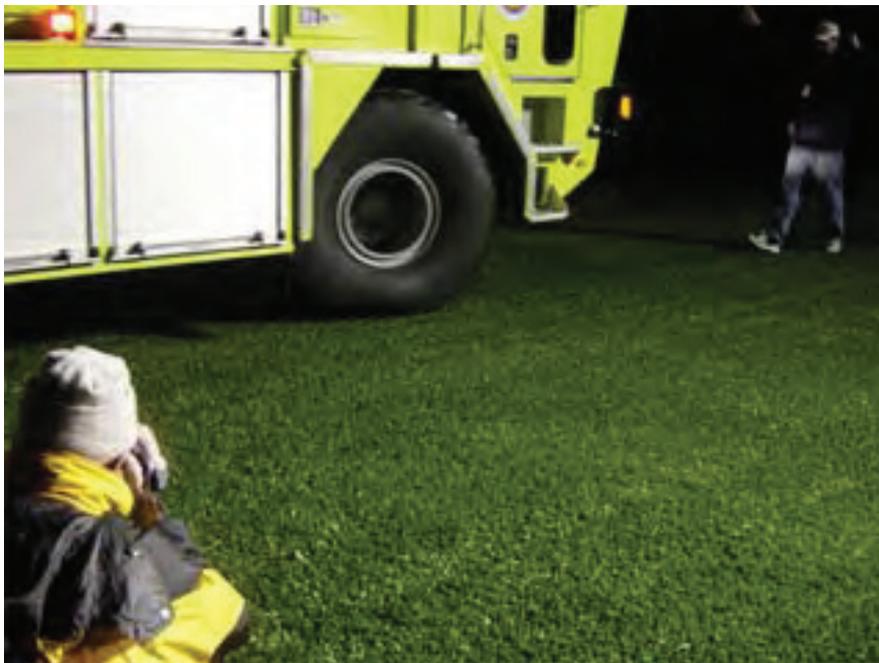
To determine if the artificial turf would shift or be dislodged by a turning vehicle, an ARFF vehicle, shown in figure 4-1, was slowly driven on the turf surface while constantly turning. No damage was noted, and the same ARFF vehicle, shown in figure 4-2, was directed to gain speed on an adjacent taxiway then veer onto the turf surface and veer off. No movement of the turf or displacement of the anchoring system was noted. No problems with traction or maneuverability were noted by the vehicle operator.

FIGURE 4-1. AN ARFF VEHICLE CONSTANTLY TURNING WHEELS ON ARTIFICIAL TURF SURFACE (BOS)

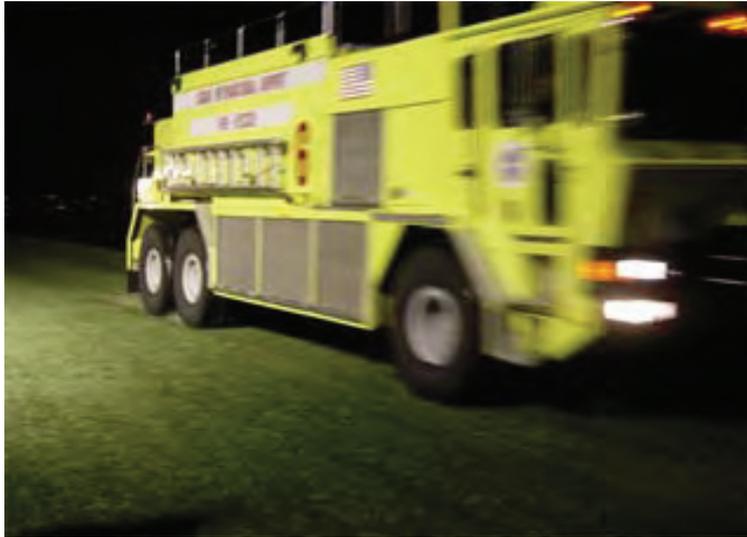
FIGURE 4-2. AN ARFF VEHICLE PERFORMING A HIGH-SPEED PASS (BOS)

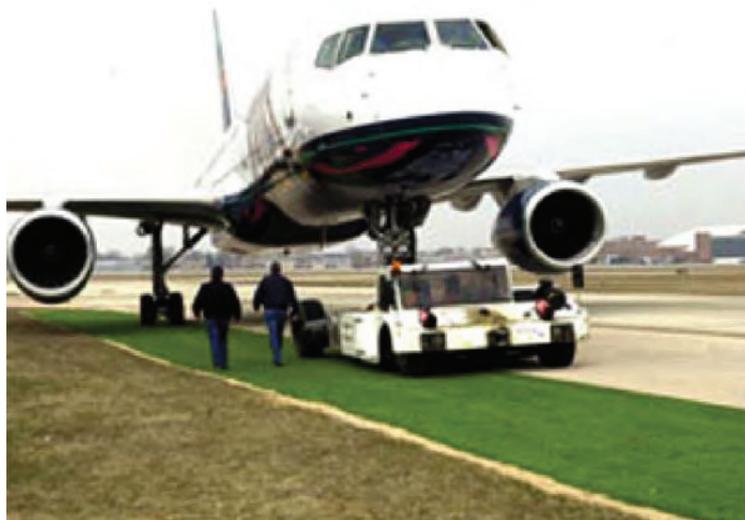
Another load test that was performed by airport operations staff at MDW was to use the right main gear of a B-757 with full fuel tanks (see figure 4-3) to taxi across the edge of the artificial turf installation. The aircraft was able to taxi across the entire surface without incident. Minimal rutting occurred, but this was easily repaired by using a heavy roller to smooth out the surface.

FIGURE 4-3. FULLY FUELED B-757 TAXIING ACROSS ARTIFICIAL TURF SURFACE (BOS)
