Customer Information		Report#: 21520-RE	Date: 4/21/2026
File #: 850 Jerrys Lane	Customer: Austin Trust Company	Location: Residential 850 Jerrys Lane Buda TX 78610	
Attention: Tawanda Bishop	Phone: 512-478-2121 x 125

Type of Service		
Inspection		Estimated Repair Cost
Trust Residential Property Assessment – Whole House (TREC)	<input type="checkbox"/> Clear <input checked="" type="checkbox"/> Not Clear	\$10,400.00

TRUST PROPERTY PRELIMINARY LIMITED VISUAL ENVIRONMENTAL SURVEY

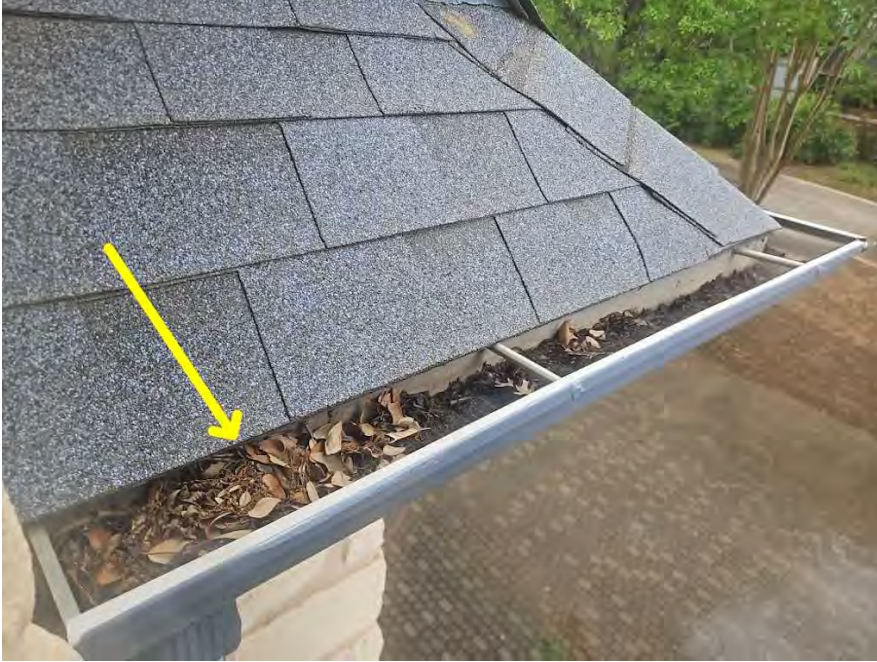
Description:
Gutters are filled with debris.

1. Qualified contractor to correct as determined necessary, but not limited to, the conditions below:

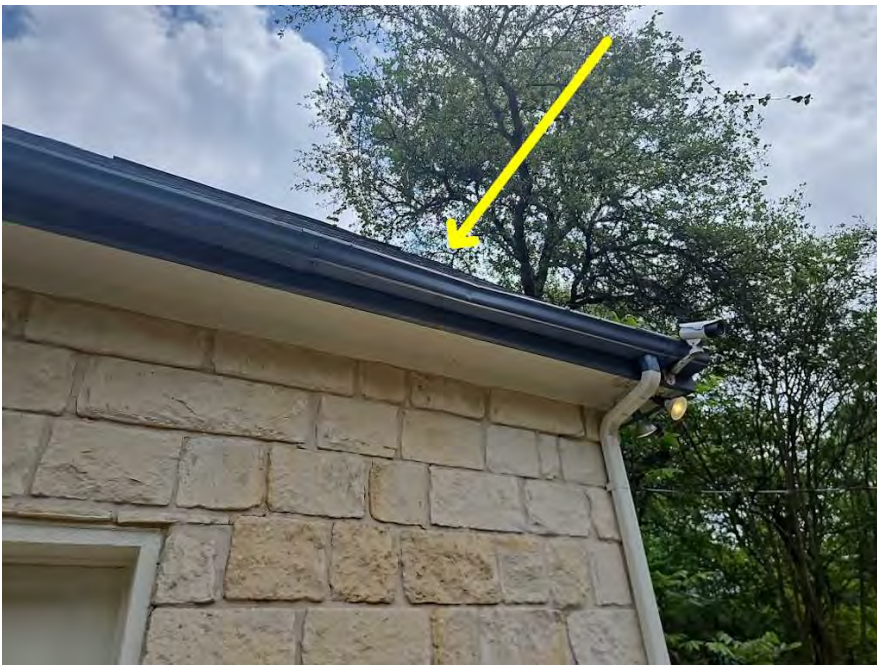
Description:
Damaged gutters observed.

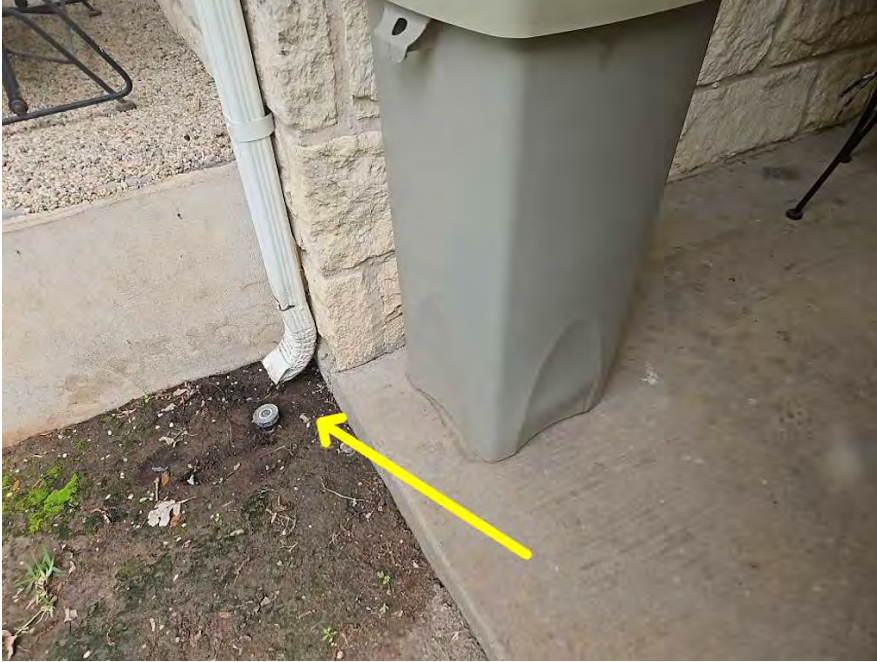
Description:
Downspouts terminate too close to the foundation.

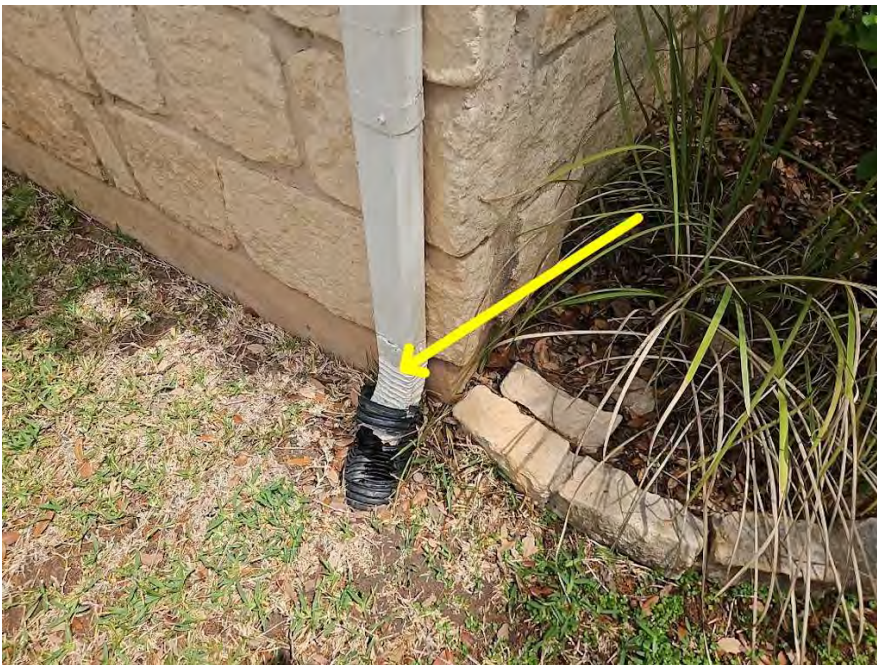
Description:
Damaged downspouts observed.

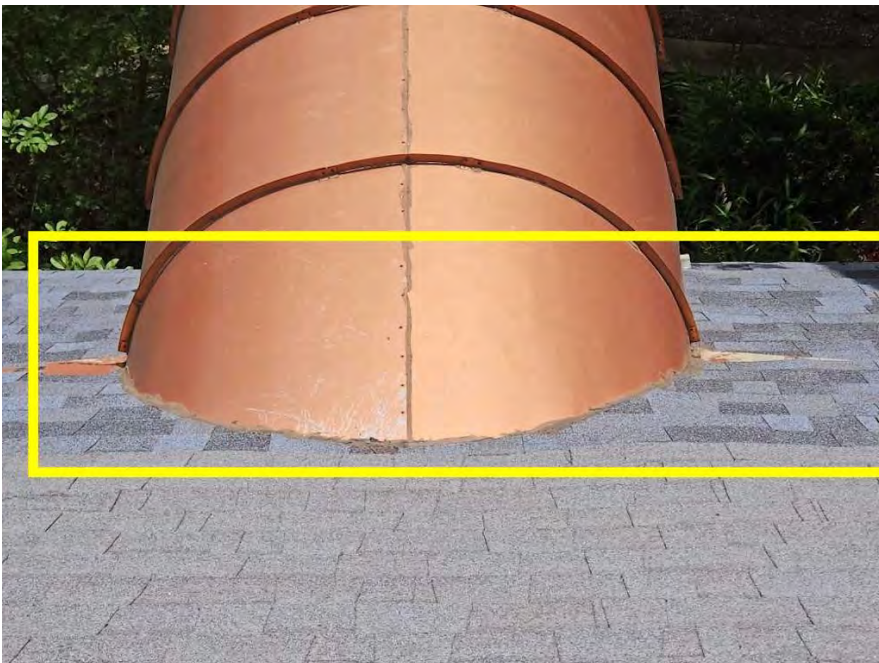
Description:
Previous repairs observed at the roof.

1. Further evaluation of the roof system by a qualified roofing contractor is needed due to, but not limited to, the conditions below: TBD

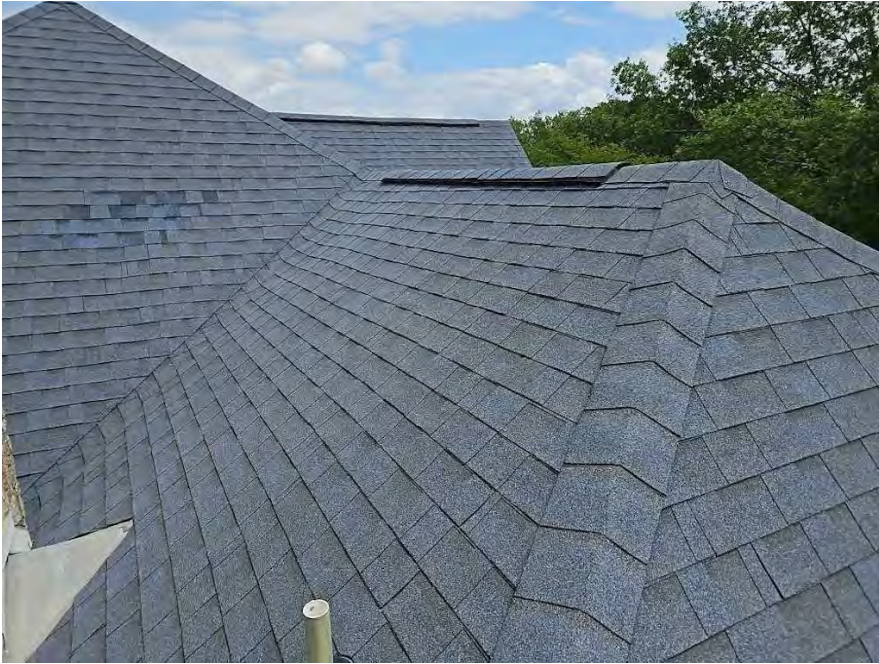
Description:
Previous repairs observed at the roof.

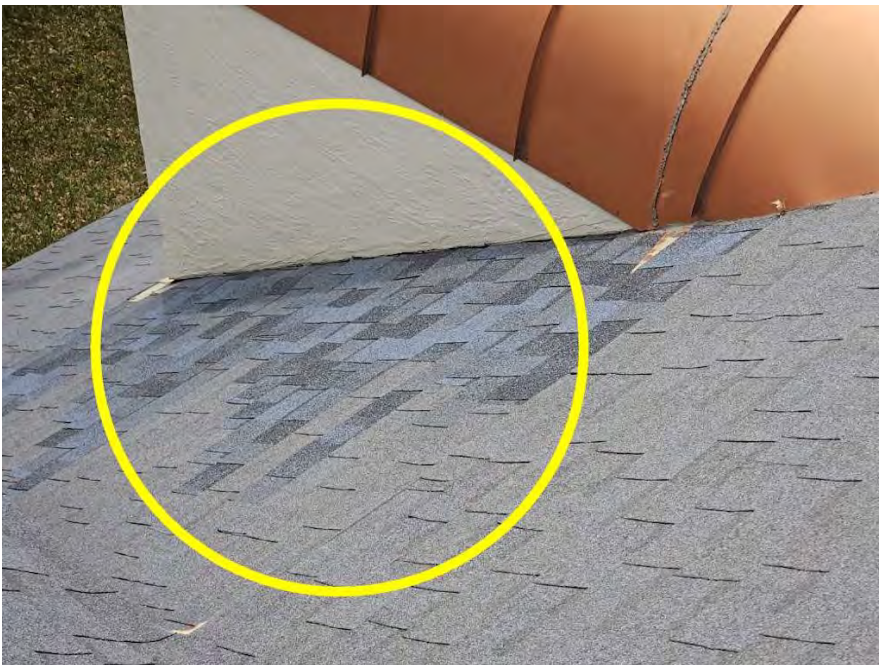
Description:
Previous repairs observed at the roof.
Stucco appears moisture damaged at the
roof line.

4. Further evaluation of the EIFS by a qualified stucco specialist is needed due to, but not limited to, the following noted concerns: Stucco is in contact/too close to the roof surface, is stained, and stucco appears moisture damaged at the roof line. This type of siding has a potential for hidden damage. Performance of EIFS and the underlying conditions are unknown and cannot be determined without a more detailed evaluation including invasive testing measures, which fall outside the scope of this general inspection. TBD

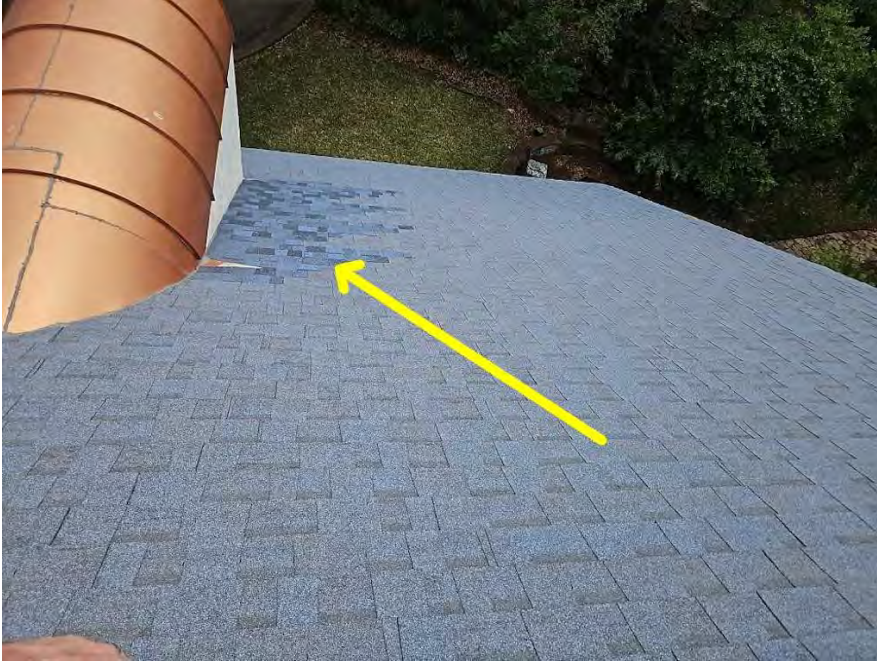
Description:
Previous repairs observed at the roof.

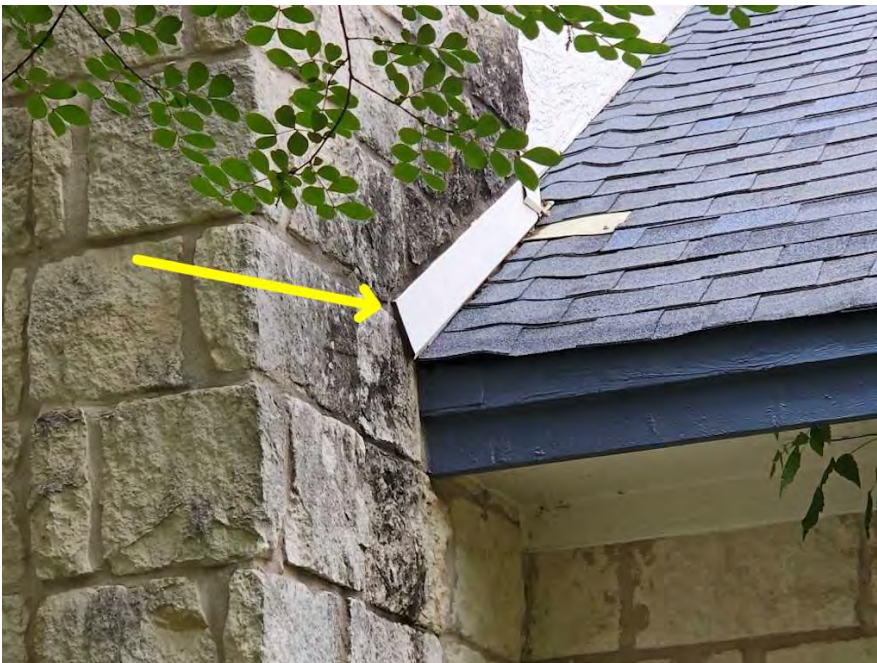
Description:
Missing kickout flashing at the front right. Stucco is in contact/too close to the roof surface and is stained.

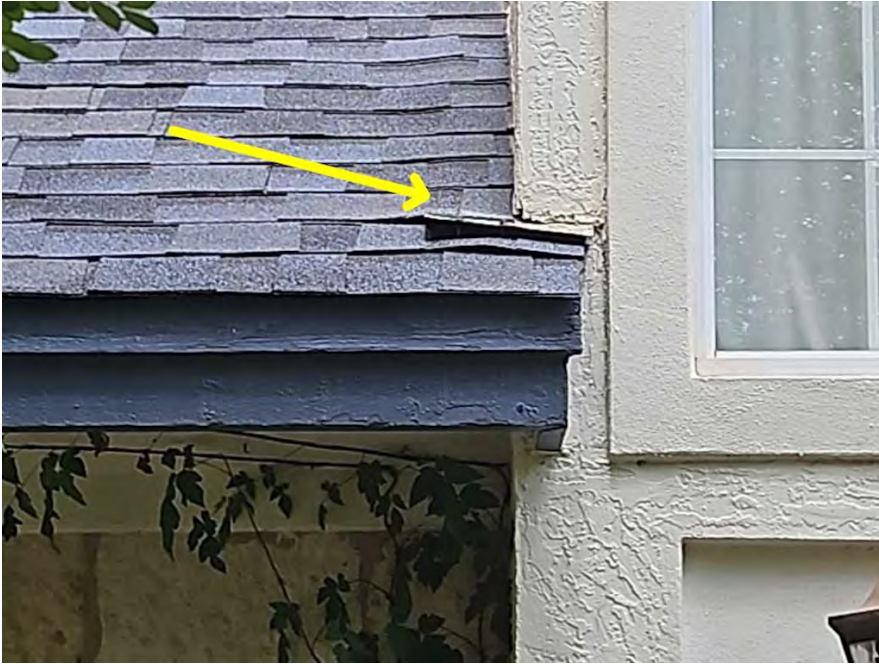
Description:
Raised flashing at the front left.

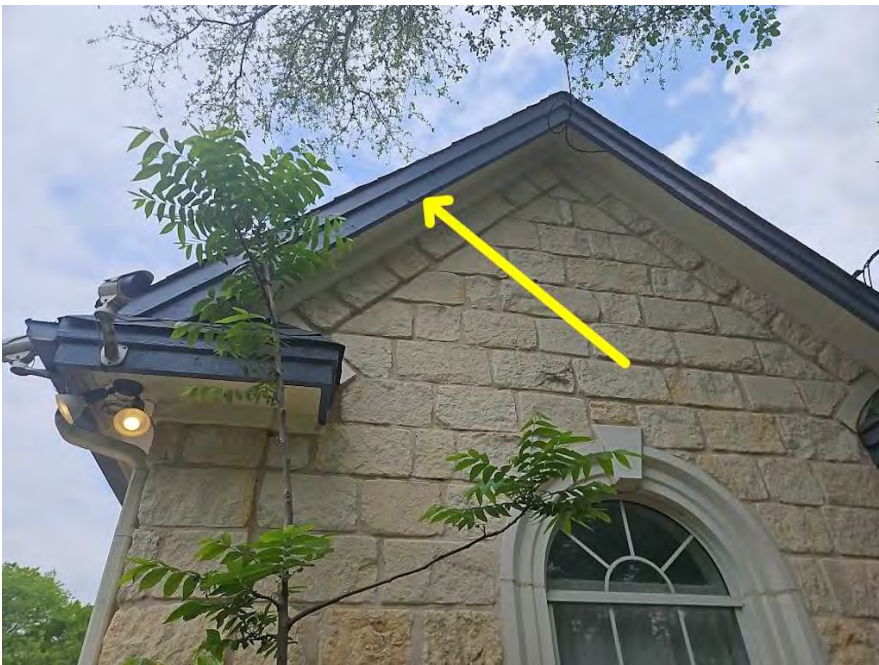
Description:
Missing drip edge flashing at the front/right.

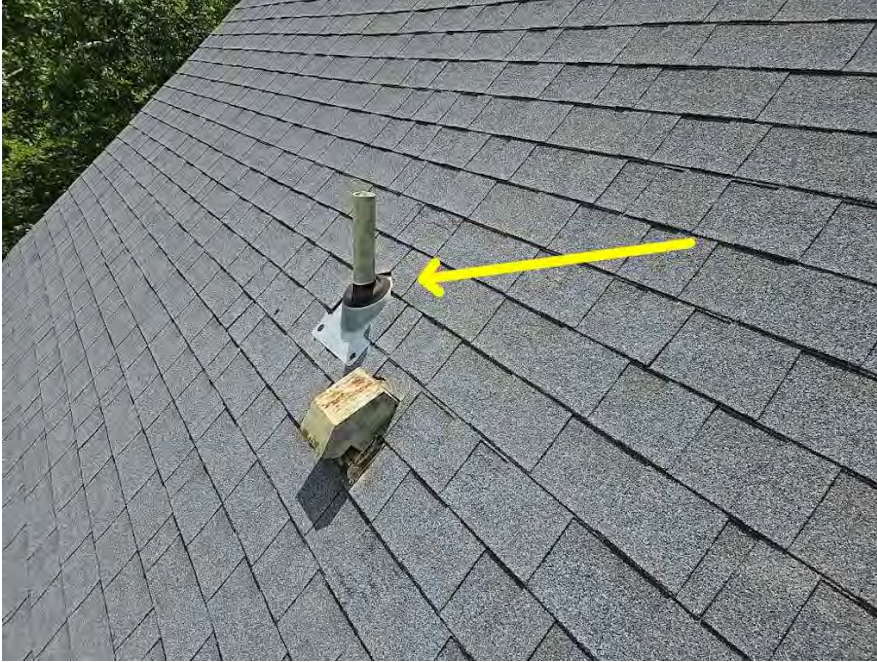
Description:
Cupped plumbing vent boot at the roof.

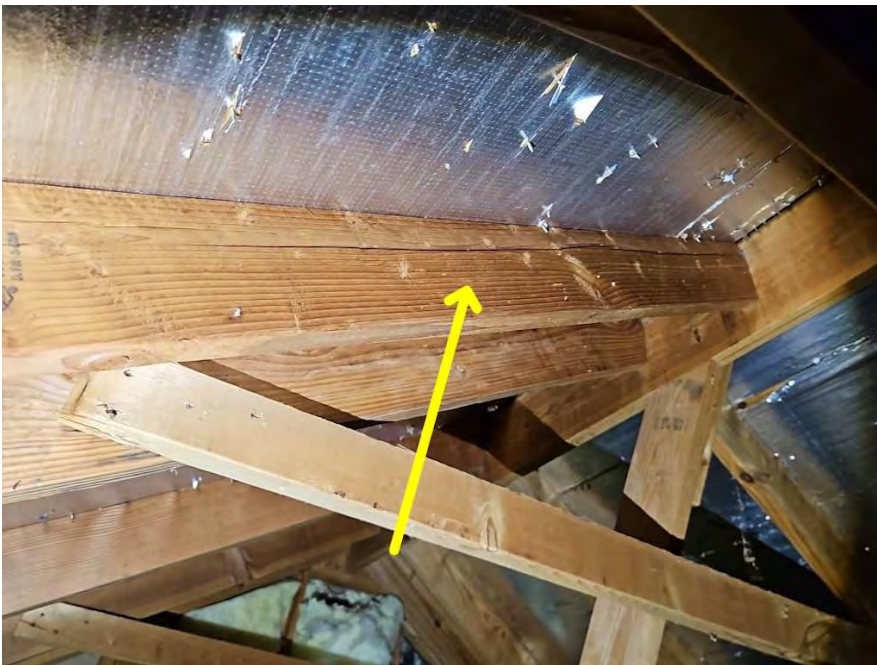
Description:
Separation/crack observed at the attic rafter.

1. Qualified contractor to correct as determined necessary, but not limited to, the conditions below:

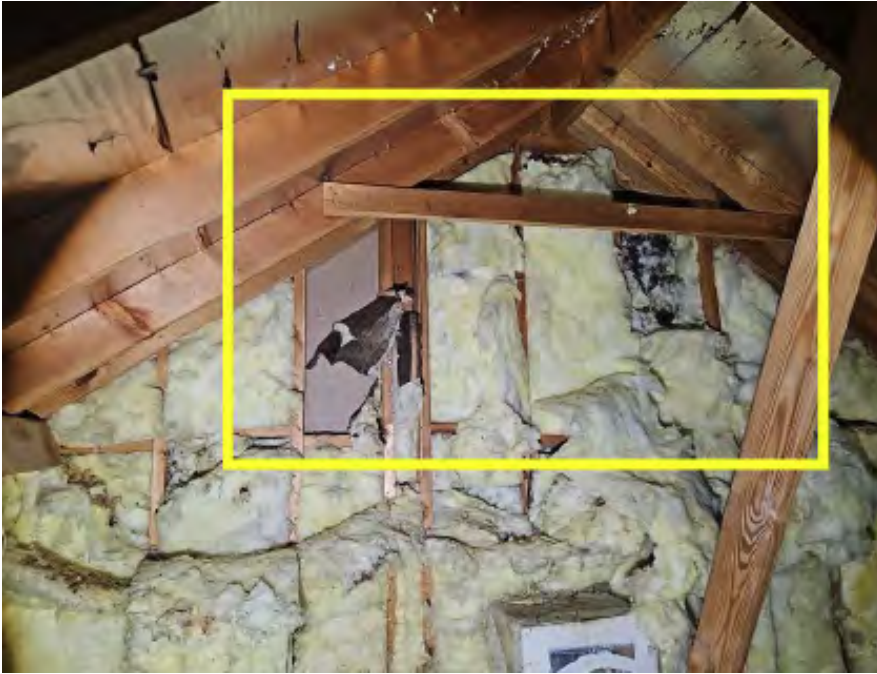
Description:
Missing insulation in the attic above the master closet.

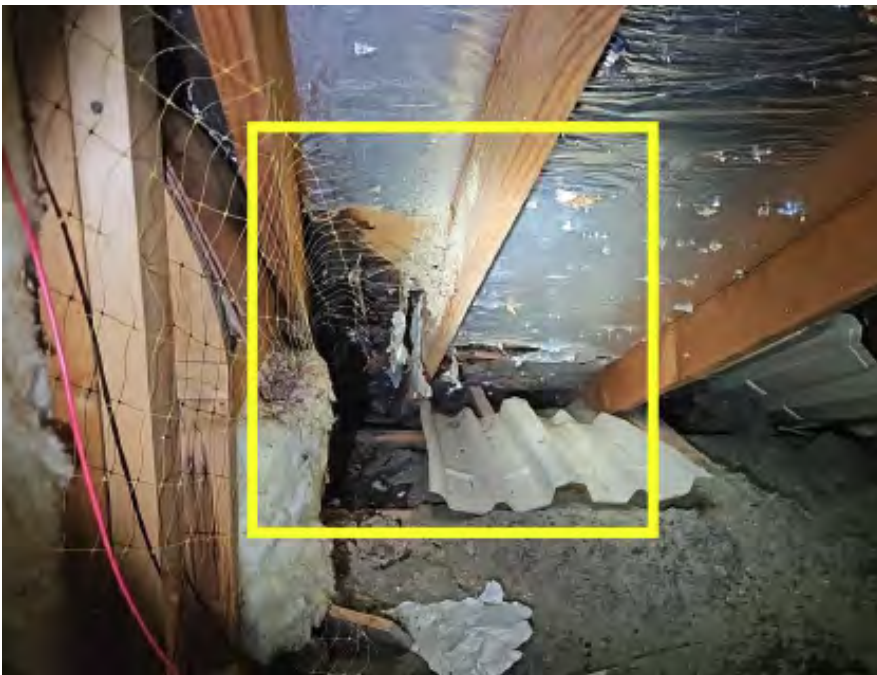
Description:
Damaged insulation and soffit vent in the attic above the master closet.

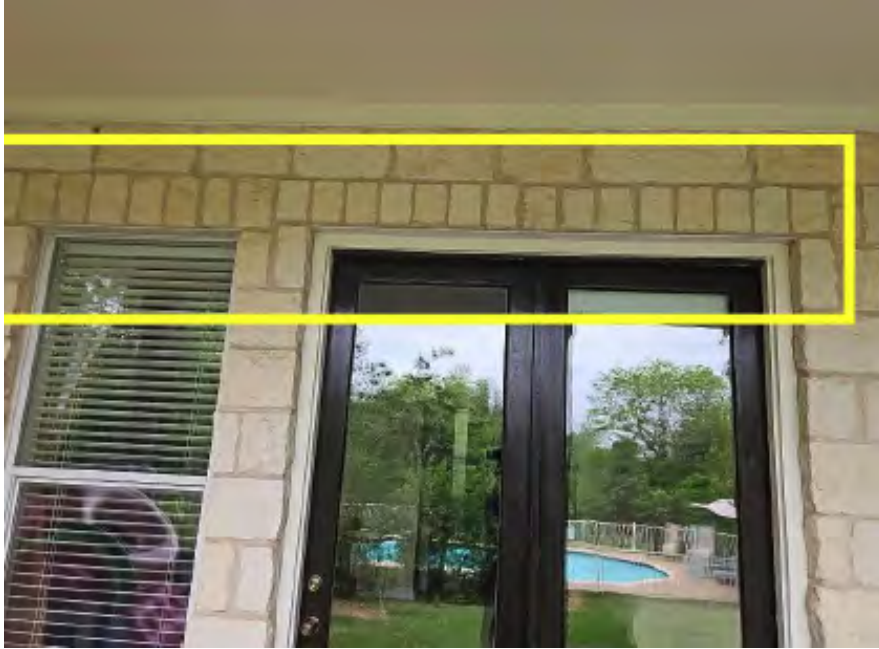
Example of: Missing weep holes above the windows and doors.

1. Qualified contractor to correct as determined necessary, but not limited to, the conditions below:

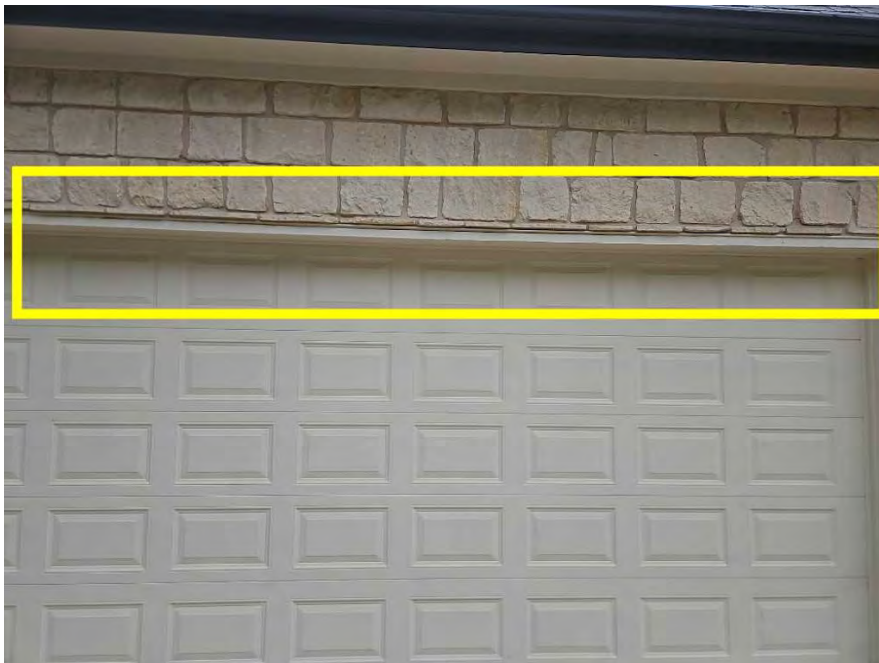
Example of: Missing weep holes above the windows and doors.

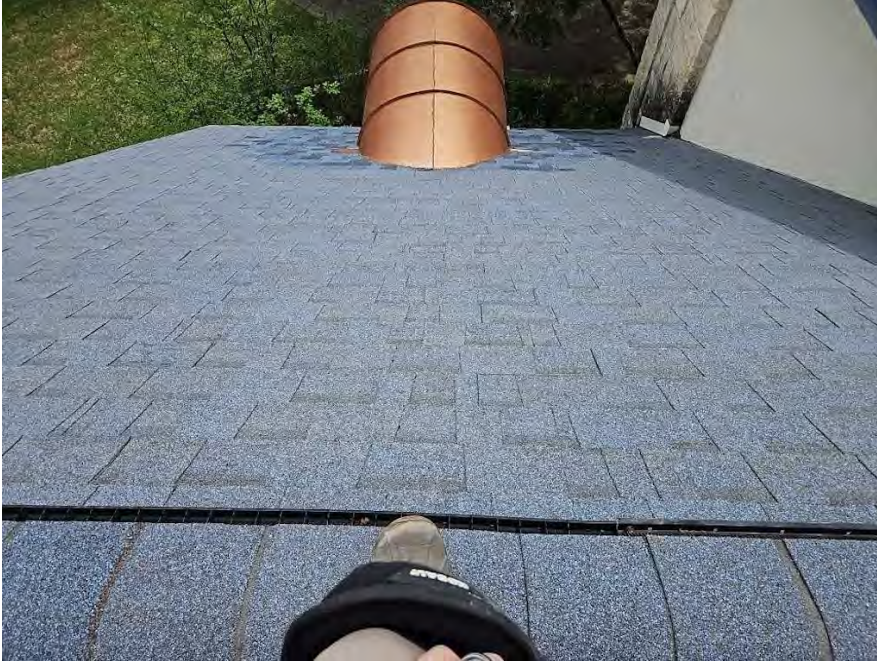
Stucco is in contact/too close to the roof surface and is stained.

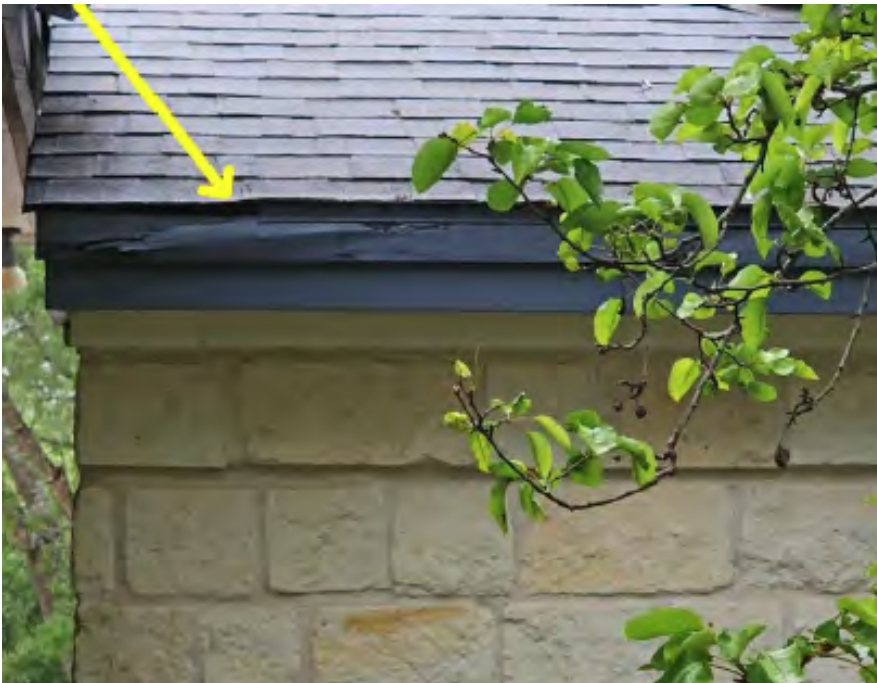
Rotted fascia at the rear left.

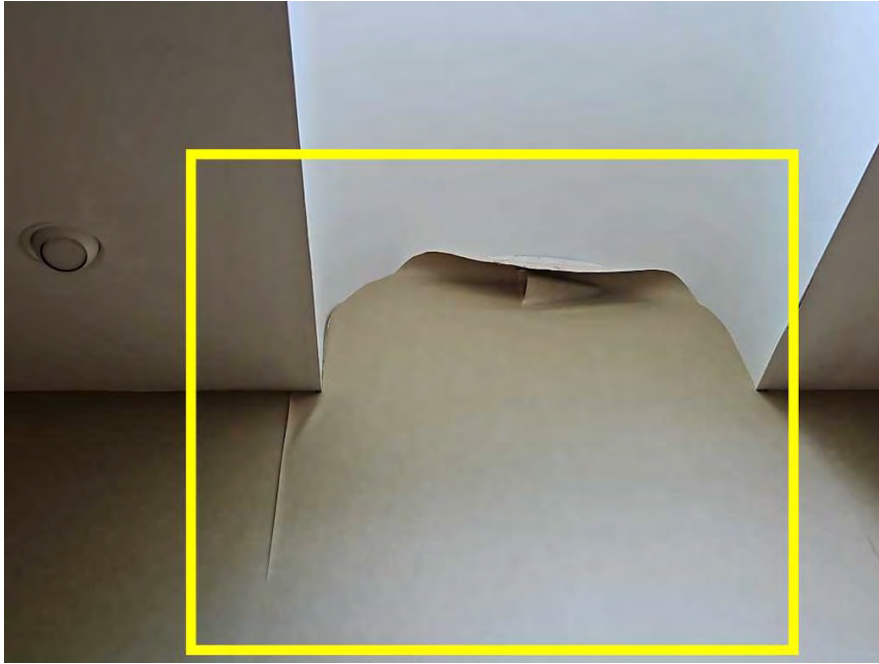
Description:
Evidence of previous moisture at the kitchen wall.

3. Qualified contractor to determine cause and correct as determined necessary, but not limited to, the evidence of previous moisture at the kitchen wall.

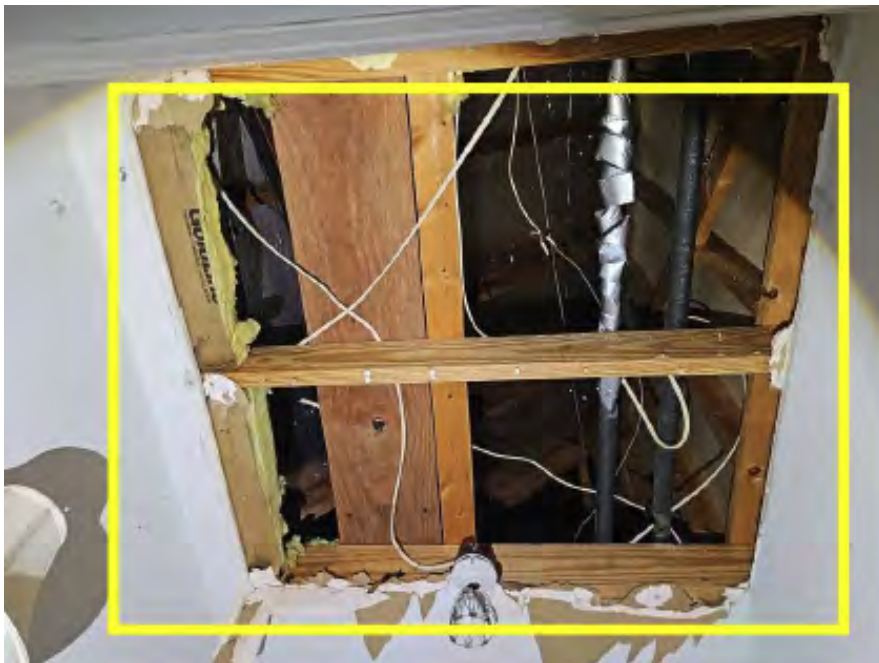
Description:
Damaged/missing ceiling at the garage utility closet.

1. Qualified contractor to correct as determined necessary, but not limited to, the conditions below:

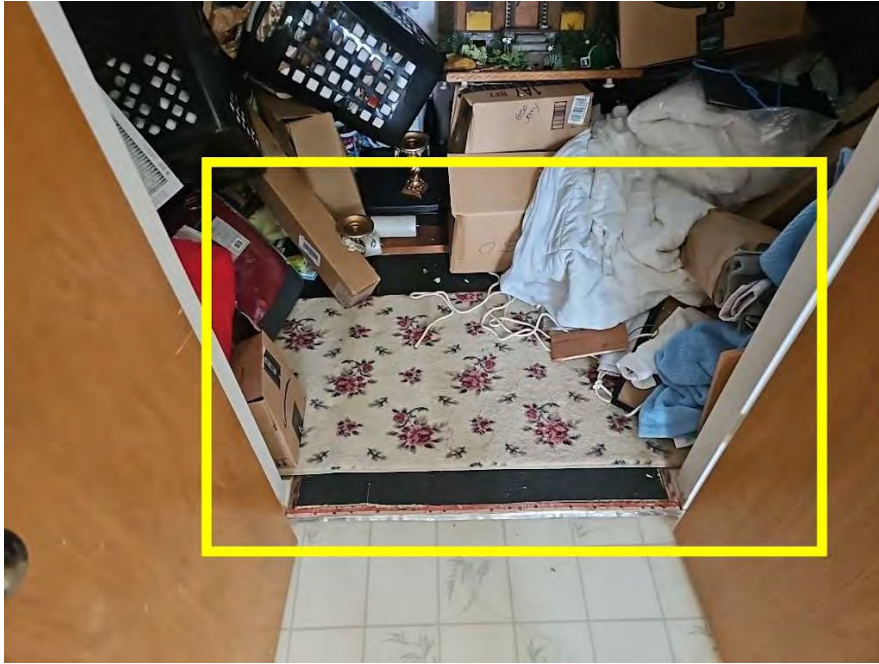
Description:
Missing floor covering at the master bathroom closet.

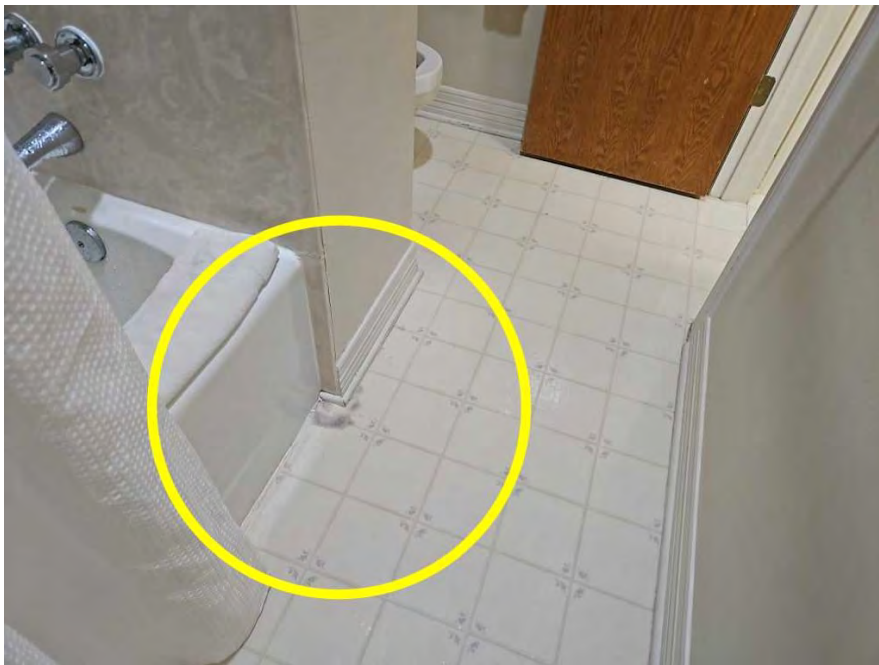
Description:
Evidence of previous moisture at the upstairs right side bathroom floor.

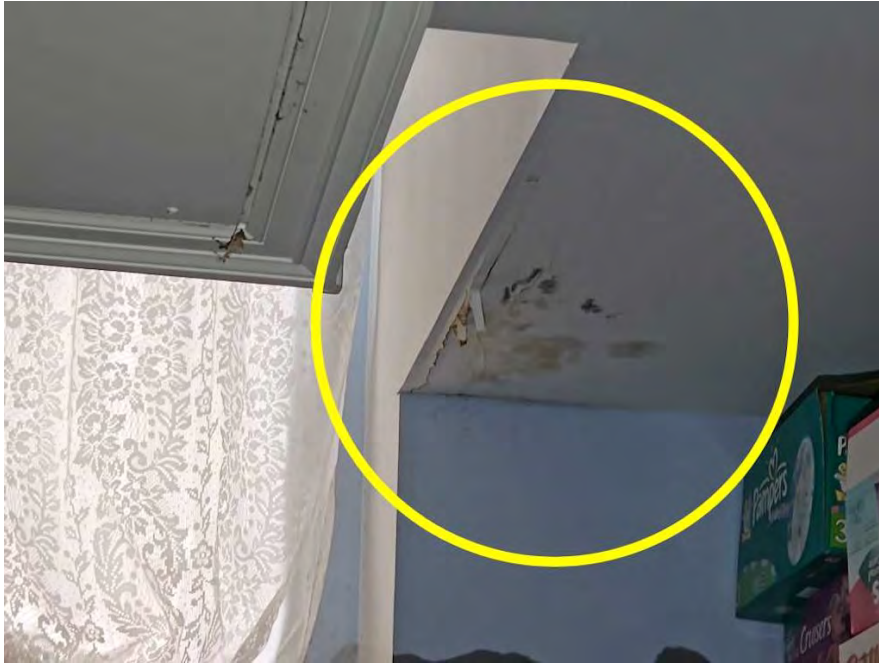
Description:
Evidence of previous moisture and suspected mold/organic growth at the master bedroom closet ceiling.

2. Suspected mold/organic growth at the master bedroom closet ceiling. Recommend further evaluation by a qualified contractor and/or mold specialist to determine source/cause, scope of repairs and clean-up, and make all corrections as determined necessary. TBD

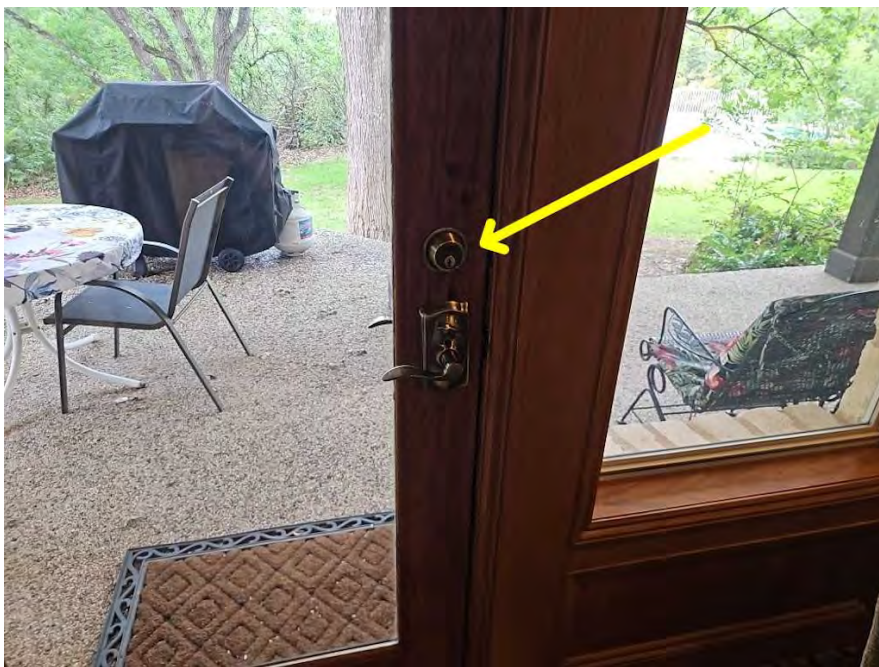
Description:
Interior keyed deadbolt locks at the living room door (safety).

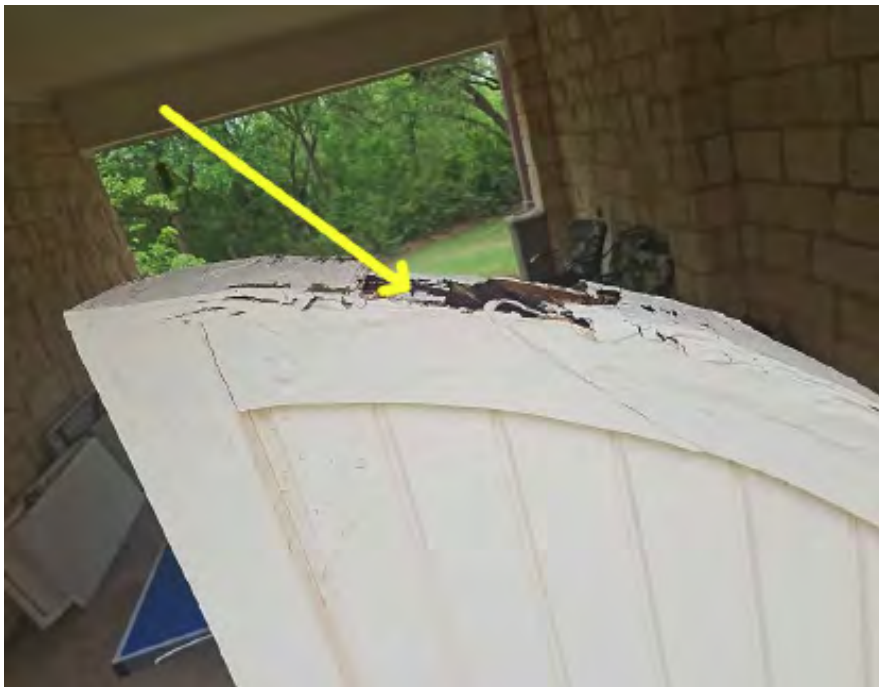
Rotted door at the side porch.

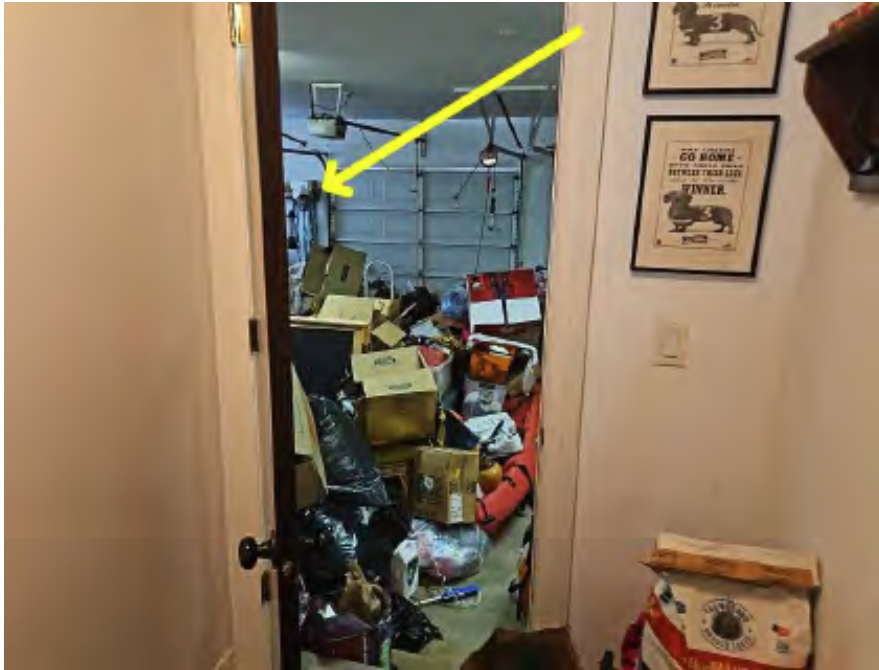
Description:
Garage door to house is not fire rated and is not self-closing.

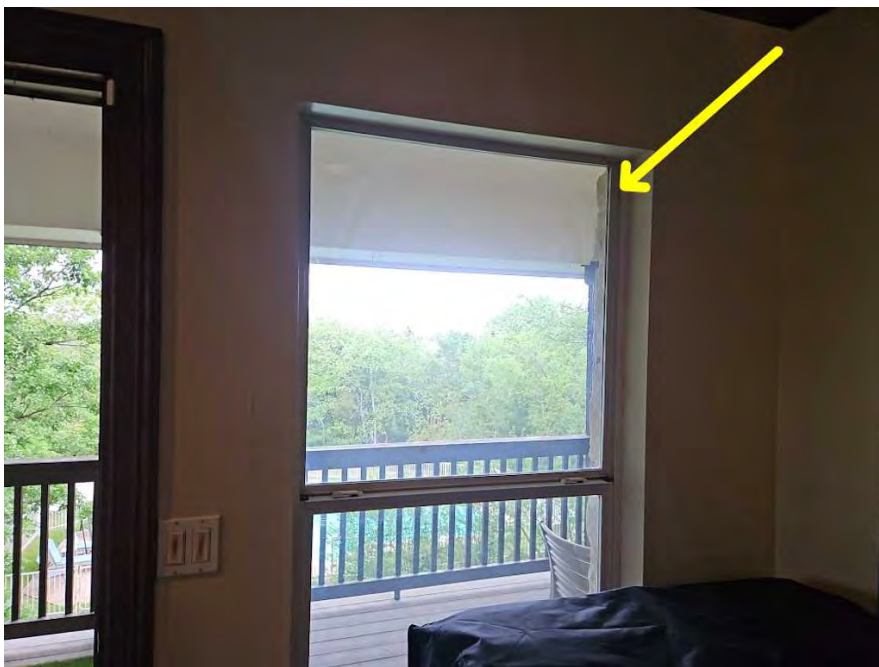
Description:
Failed thermal seal window at the family room.

1. Qualified window contractor to correct as determined necessary, but not limited to, the conditions below:

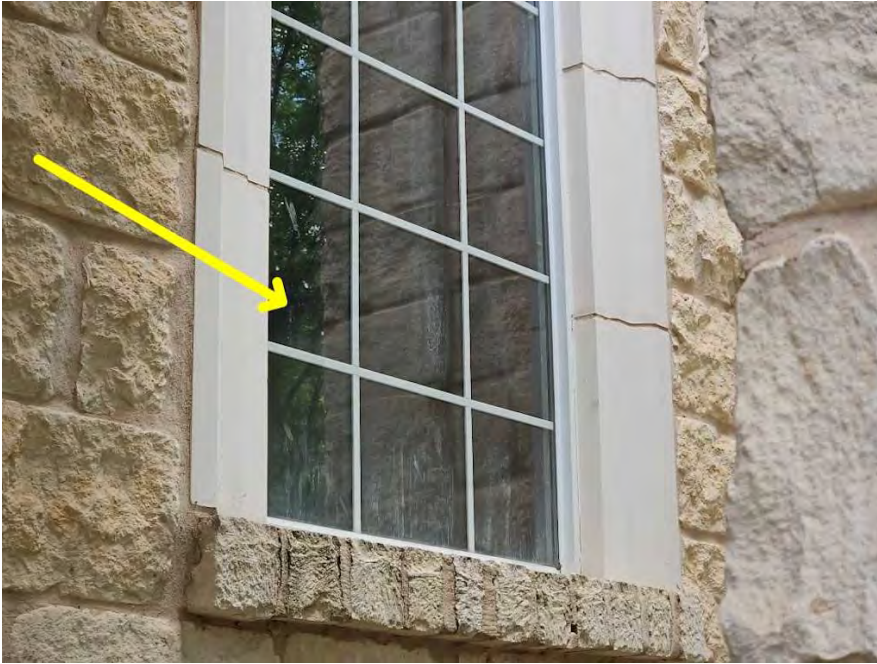
Description:
Failed thermal seal window at the front right.

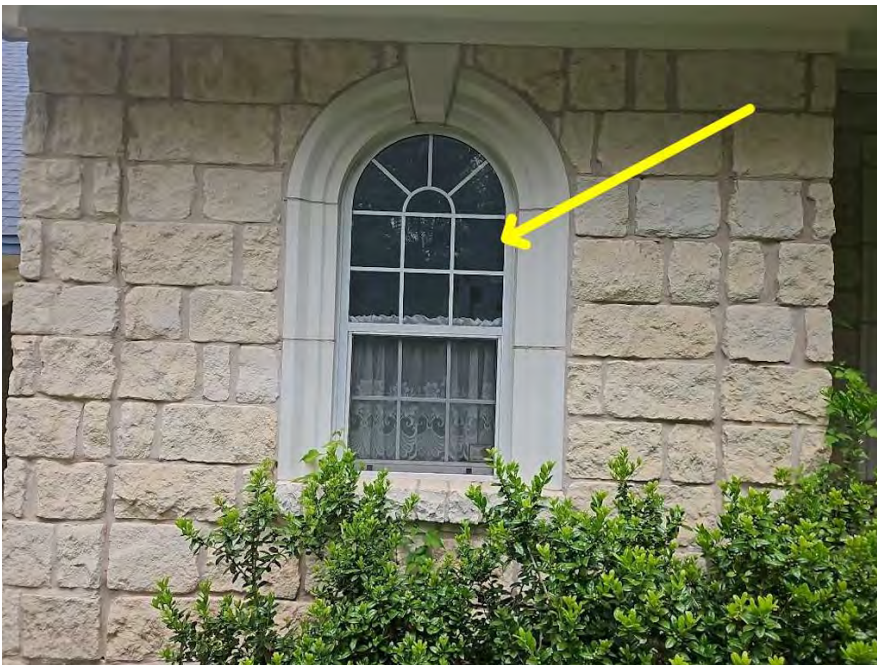
Description:
Failed thermal seal window at the front left.

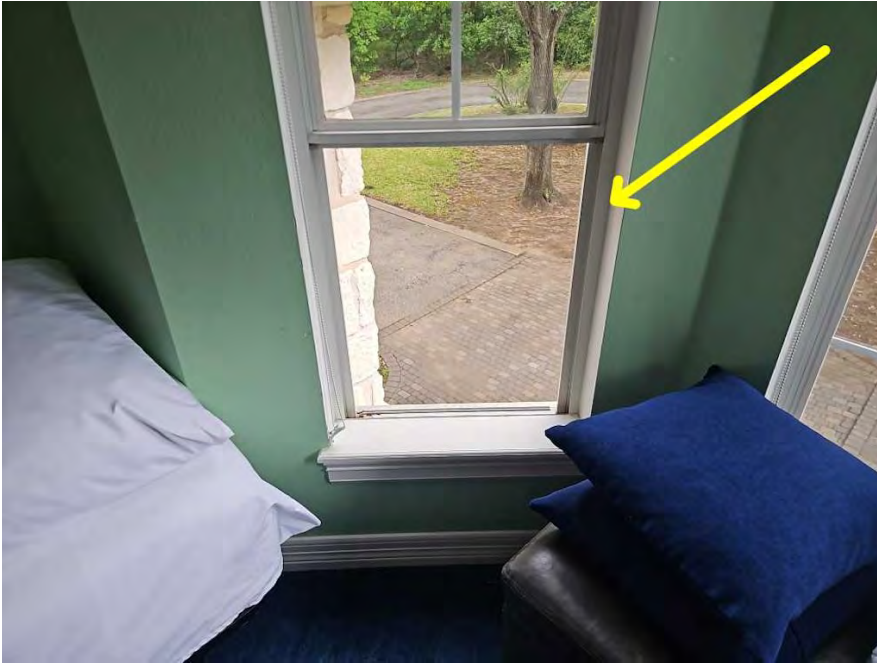
Description:
Missing window stop at the upstairs front left bedroom.

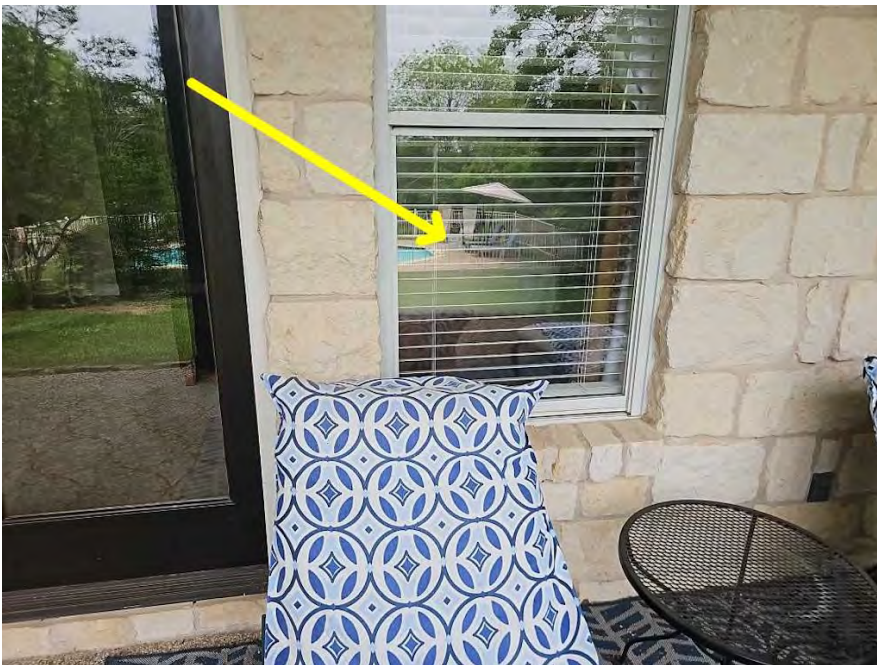
Description:
Missing screen at the rear porch window.

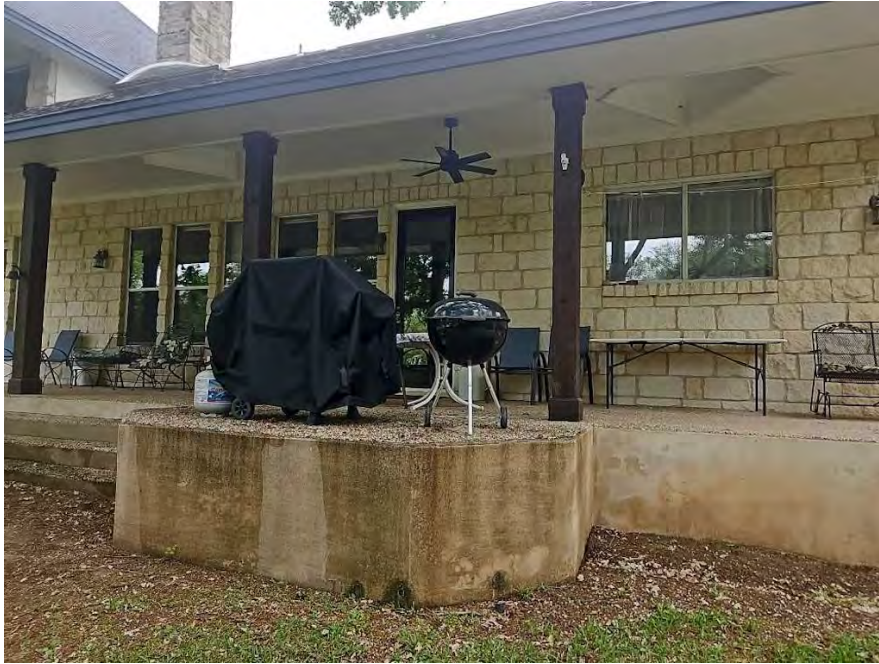
Description:
Missing handrail/guardrail system at the rear porch and/or steps.

1. Qualified contractor to correct as determined necessary, but not limited to, the missing handrail/guardrail system at the rear porch and/or steps.

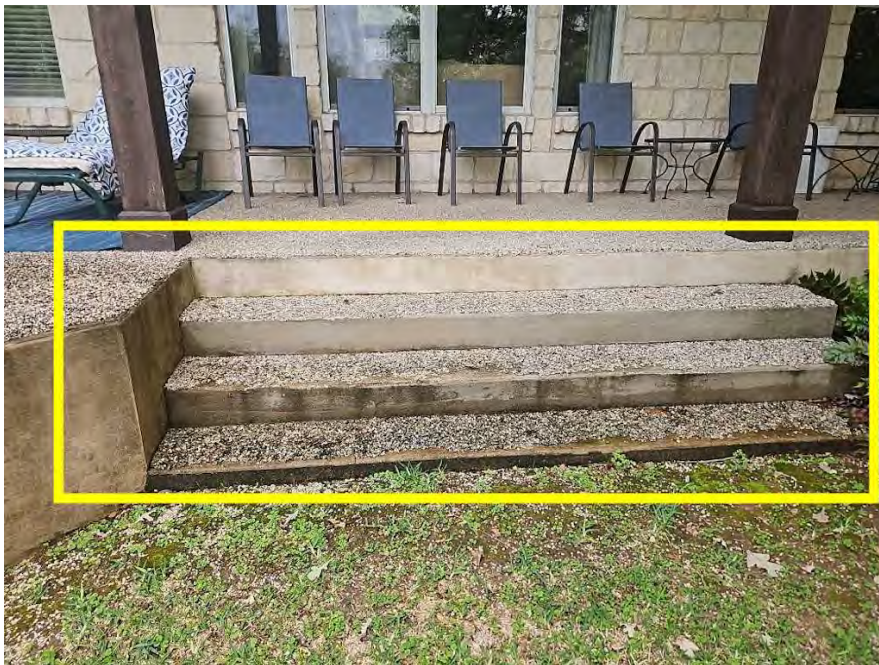
Description:
Missing handrail/guardrail system at the rear porch and/or steps.

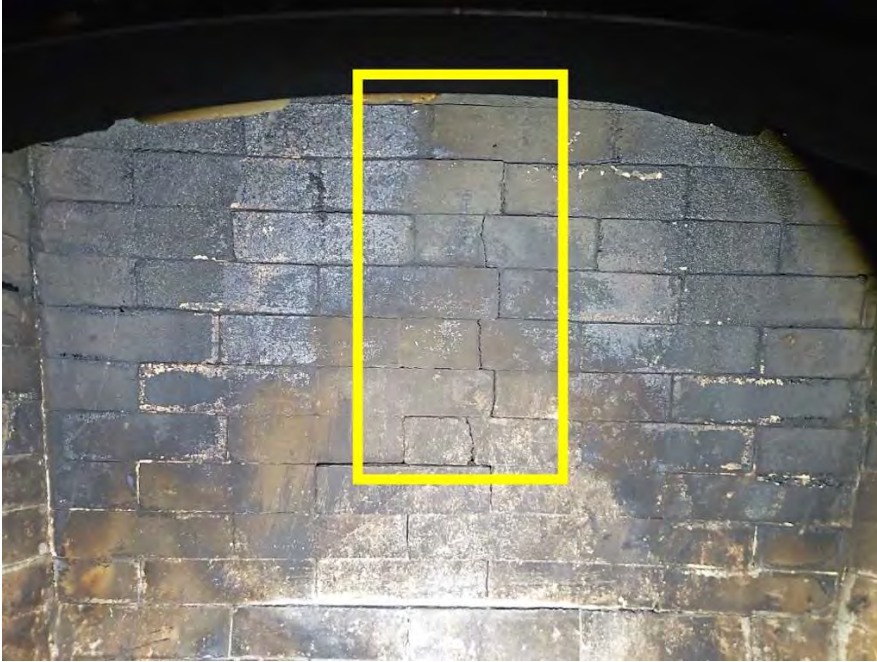
Description:
Cracks visible in the firebrick.

1. Qualified chimney/fireplace contractor to correct as determined necessary, the cracks visible in the firebrick and creosote buildup observed, and to verify in writing that the fireplace, flue, and chimney are safe to operate after repairs are completed. Scope and cost are to be determined by the qualified contractor. TBD

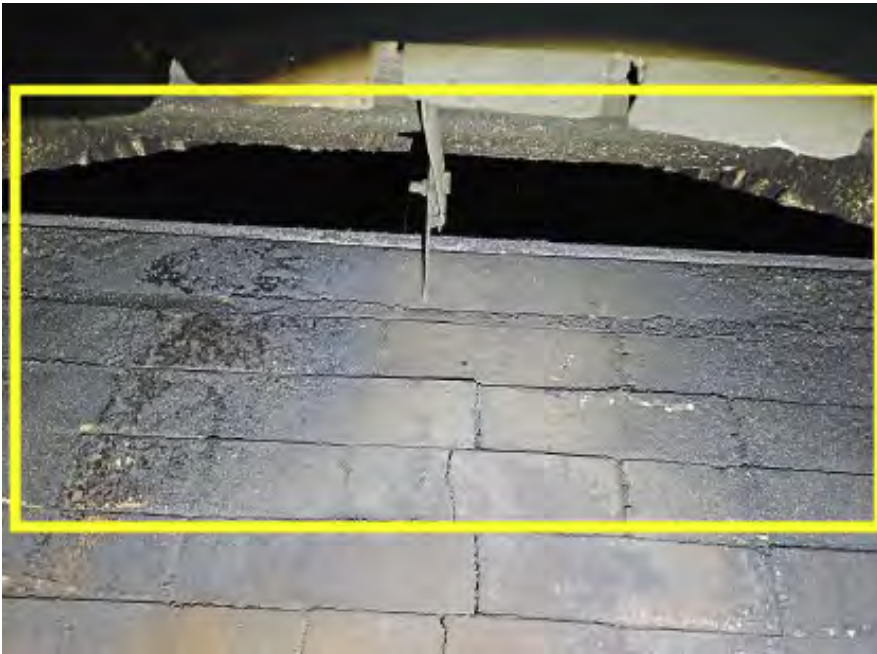
Description:
Cracks visible in the firebrick and creosote buildup observed.

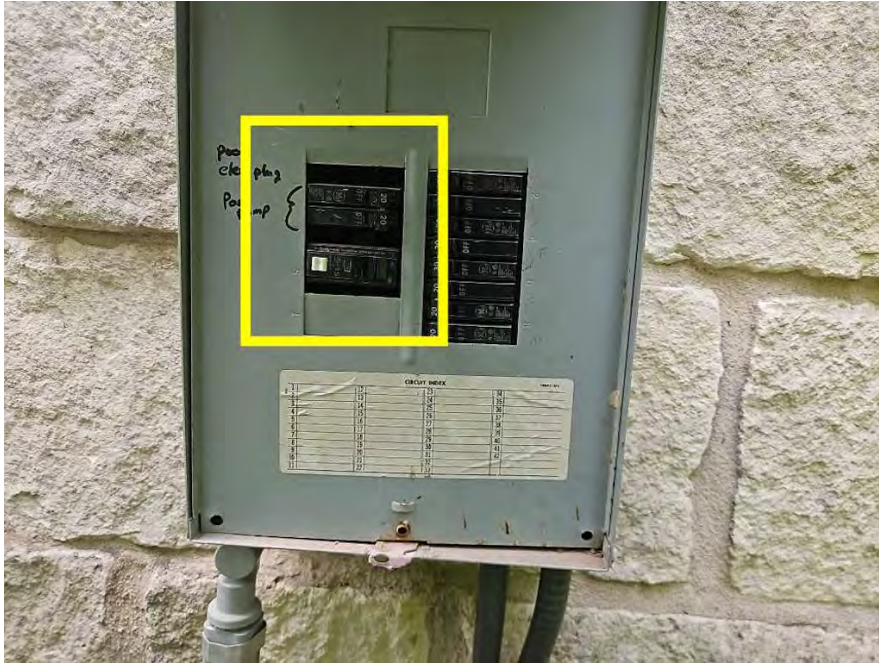
Description:
Open knockouts and missing fasteners at sub panel #1 cover. NOTE: Sub panel #1 is not labeled.

1. Qualified electrical contractor to correct as determined necessary, but not limited to, the open knockouts and missing fasteners at both sub panel covers.
