Customer Information		Report#: 21520-RE	Date: 4/21/2026
File #: 850 Jerrys Lane	Customer: Austin Trust Company	Location: Residential 850 Jerrys Lane Buda TX 78610	
Attention: Tawanda Bishop	Phone: 512-478-2121 x 125

Type of Service		
Inspection		Estimated Repair Cost
Trust Residential Property Assessment – Whole House (TREC)	<input type="checkbox"/> Clear <input checked="" type="checkbox"/> Not Clear	\$10,400.00

TRUST PROPERTY PRELIMINARY LIMITED VISUAL ENVIRONMENTAL SURVEY

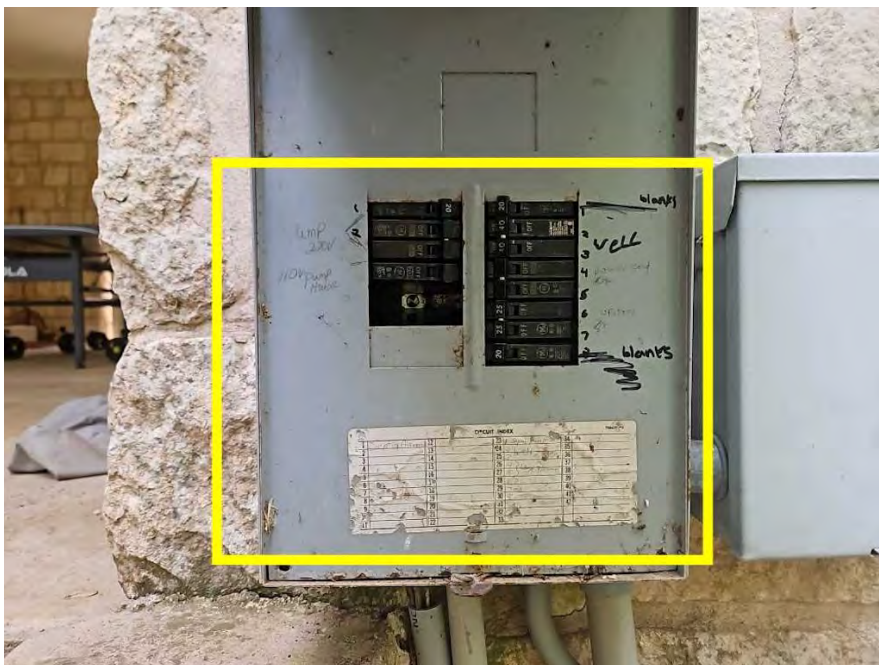
Description:
Open knockouts and missing fasteners at sub panel #2 cover. NOTE: Sub panel #2 is not labeled.

1. Qualified electrical contractor to correct as determined necessary, but not limited to, the open knockouts and missing fasteners at both sub panel covers.

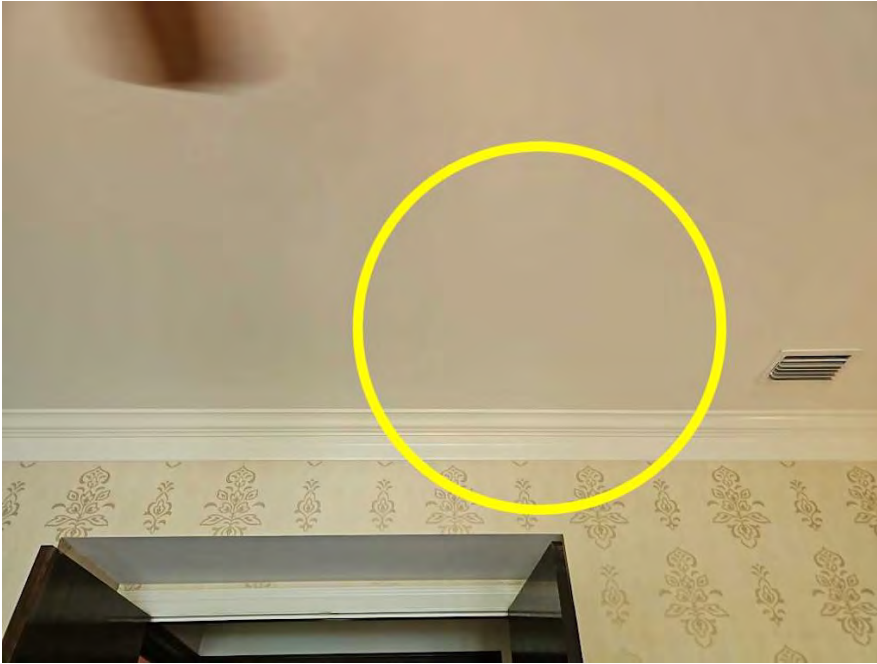
Missing smoke and/or carbon monoxide detectors in all bedrooms and outside of sleeping areas.

1. Qualified electrical contractor to correct as determined necessary, but not limited to, the conditions below:

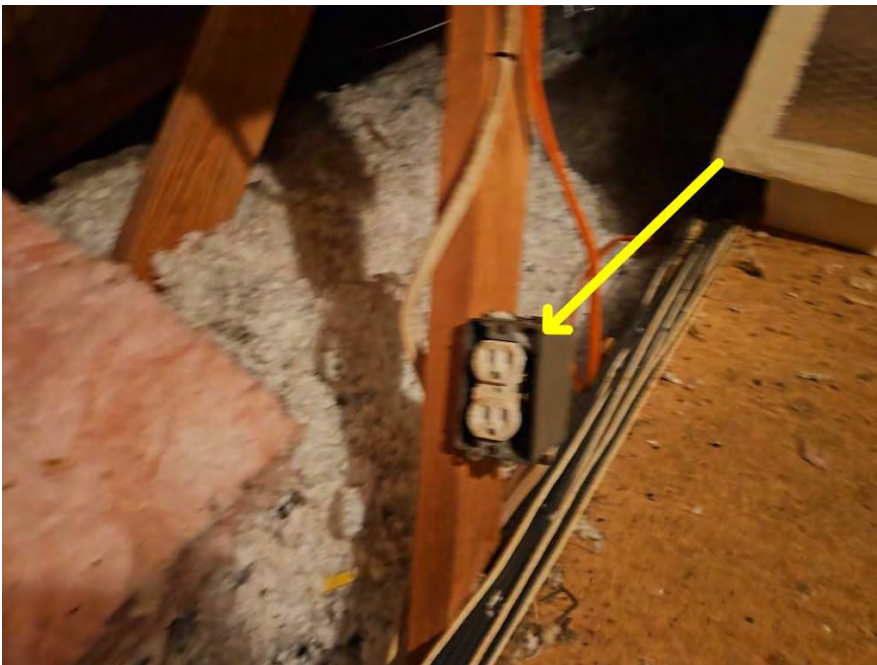
Missing cover at attic outlet.

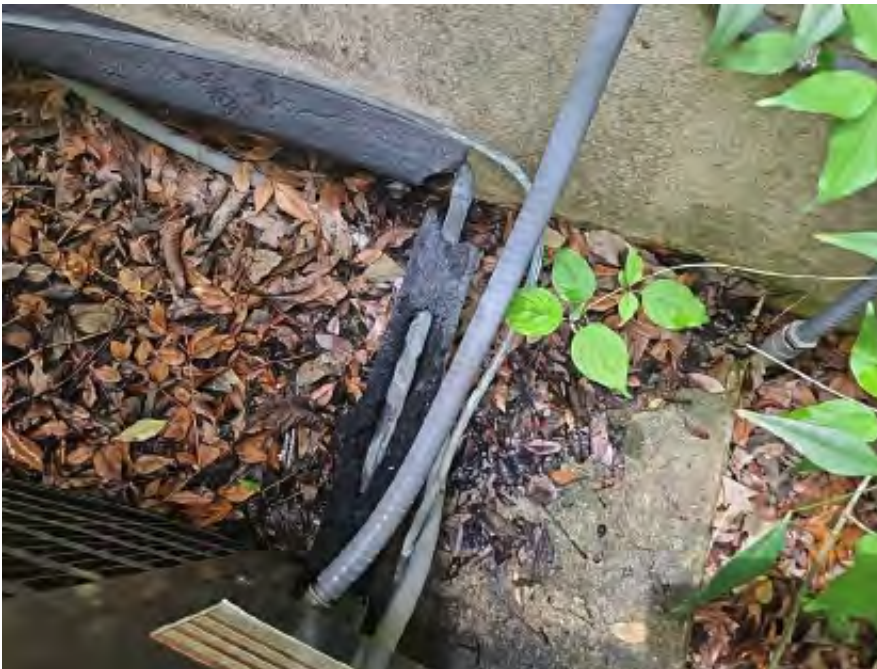
Description:
Example of: Deteriorated/damaged
refrigerant line insulation at all heat
pump units.

1. Qualified contractor to correct as determined necessary, but not limited to, the deteriorated/damaged refrigerant line insulation at all heat pump units.

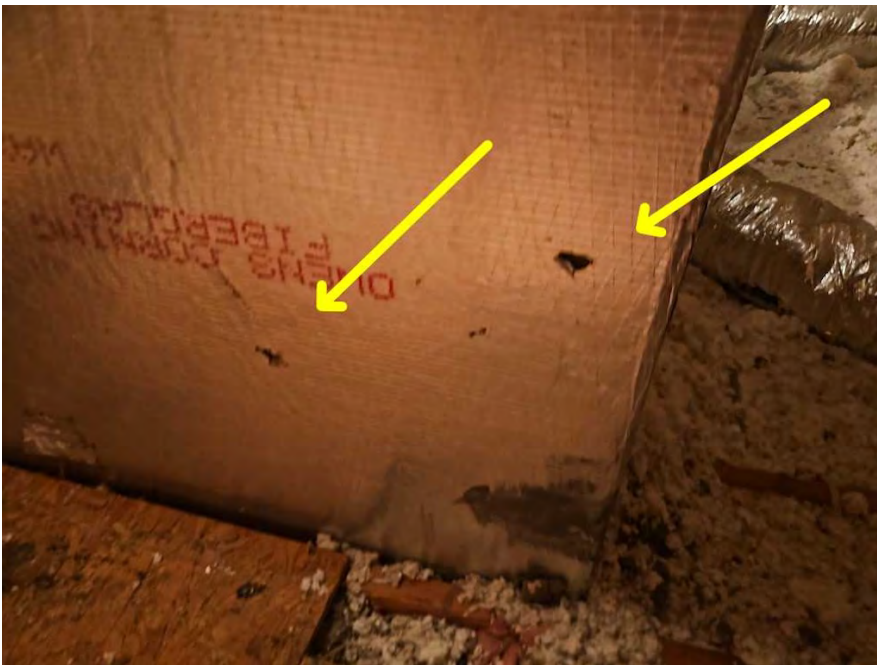
Description:
Damage observed to the return plenum in the attic.

1. Qualified contractor to correct as determined necessary, but not limited to, the conditions below:

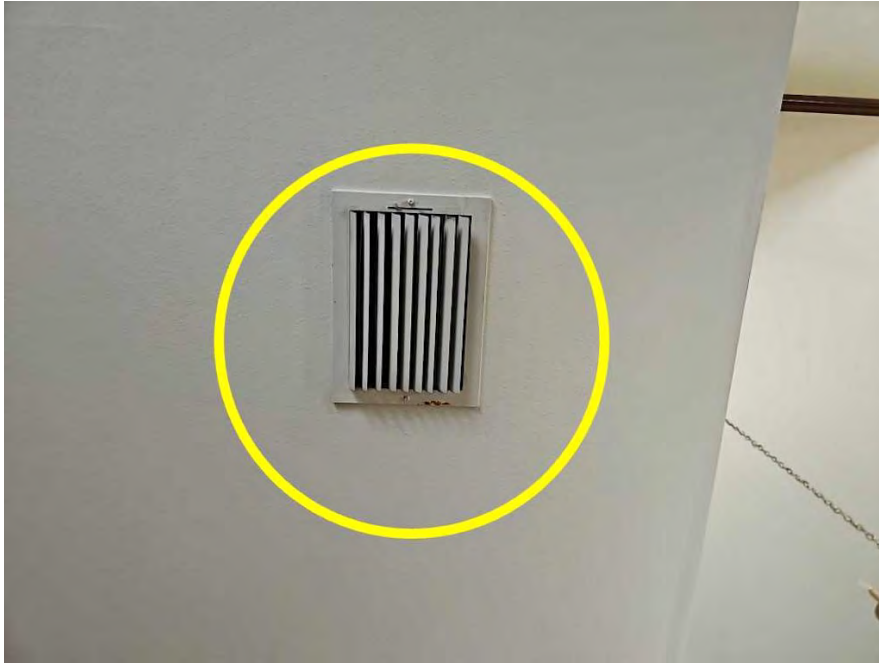
Description:
Rust and corrosion observed at the formal dining room HVAC register.

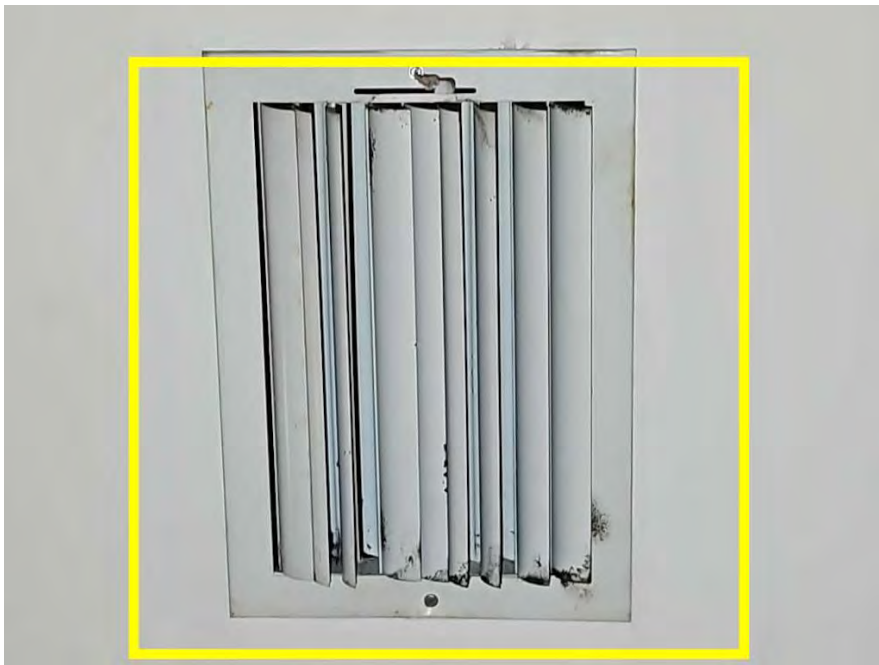
Description:
Suspected mold/organic growth on the living room HVAC register.

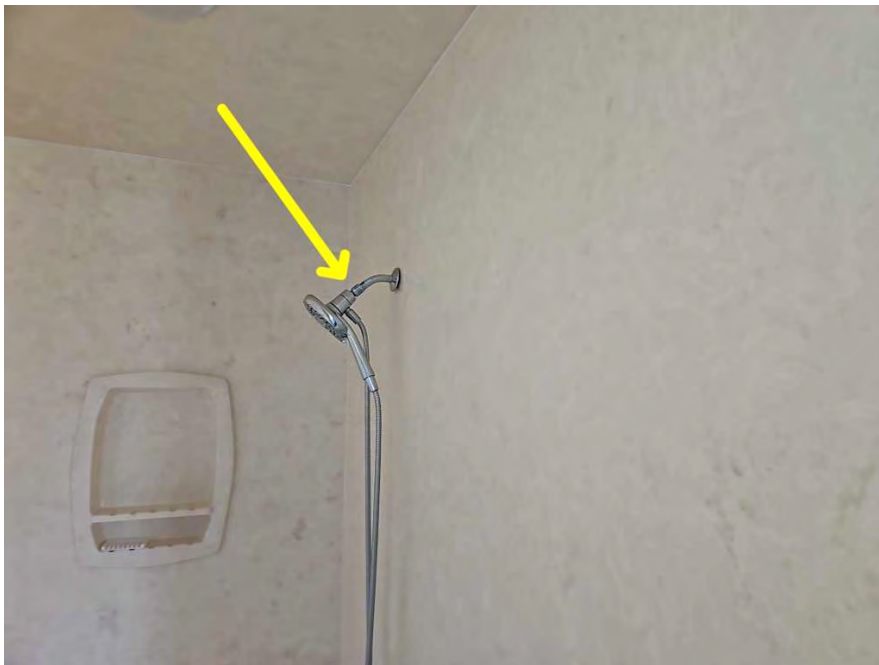
Description:
Loose master bathroom shower head.

1. Qualified plumbing contractor to correct as determined necessary, but not limited to, the conditions below:

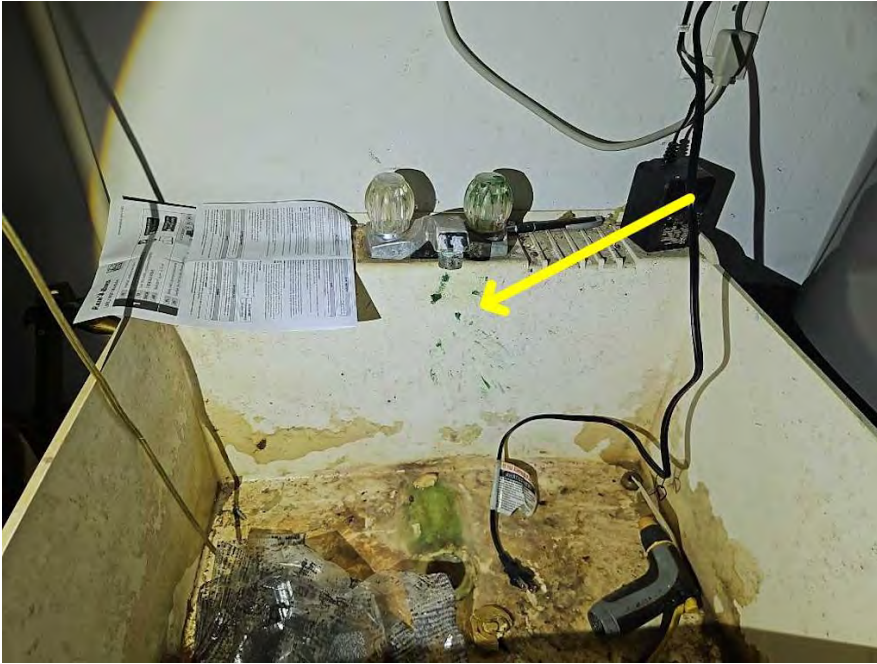
Leak at the garage utility closet sink.

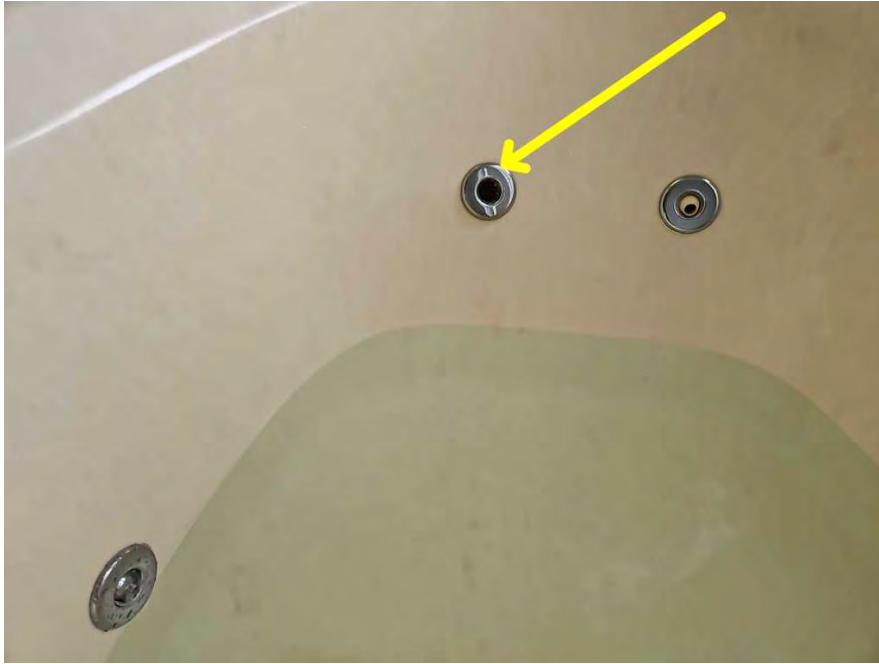
Description:
Missing jet head at the master bathtub.

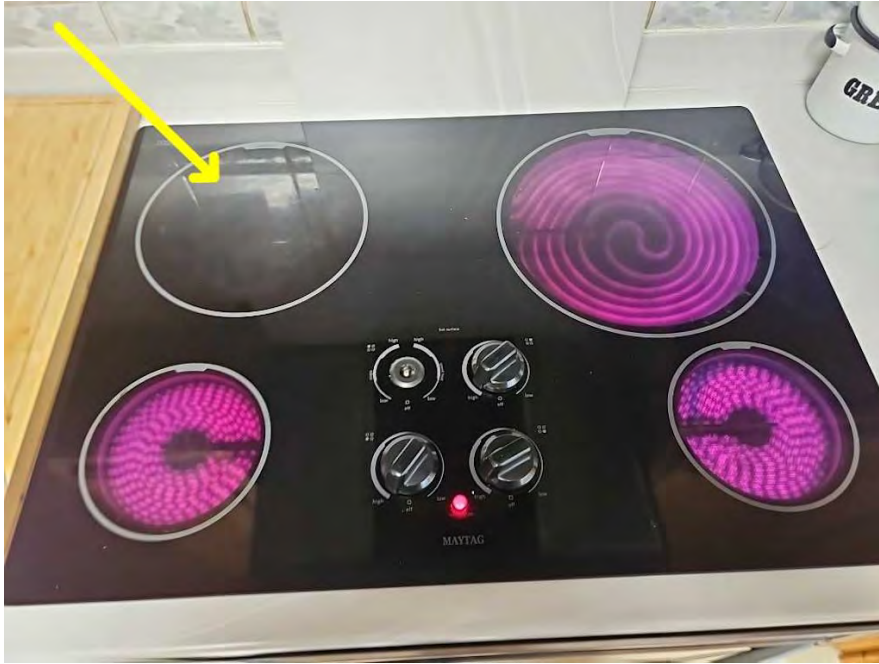
Description:
Rear left burner trips the breaker when operating and missing hardware at the control.

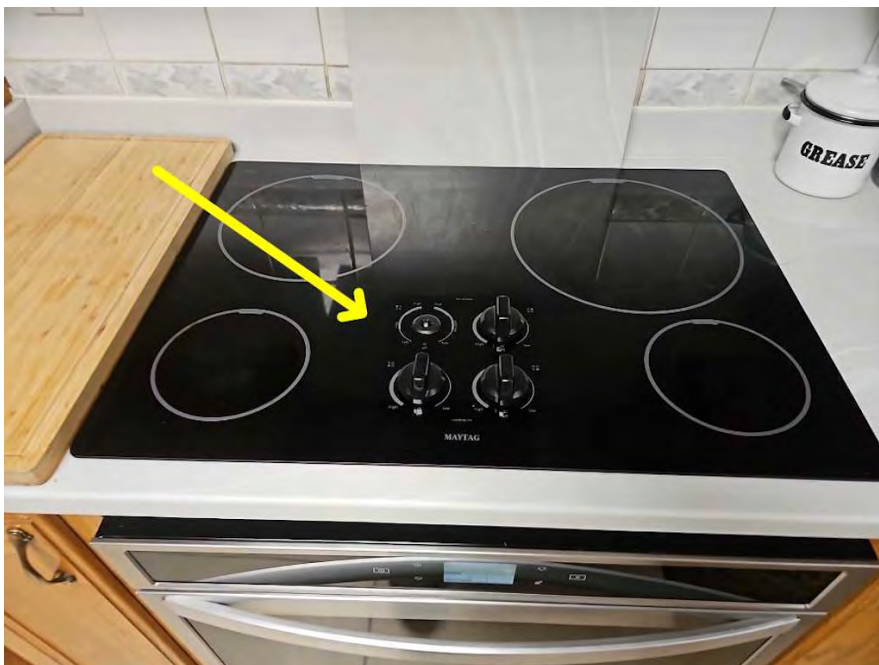
Description:
138 range - missing hardware.jpg
