# INSPECTION REPORT

SAMPLE DRONE INSPECTION  
RESIDENTIAL ROOF

09/15/2026

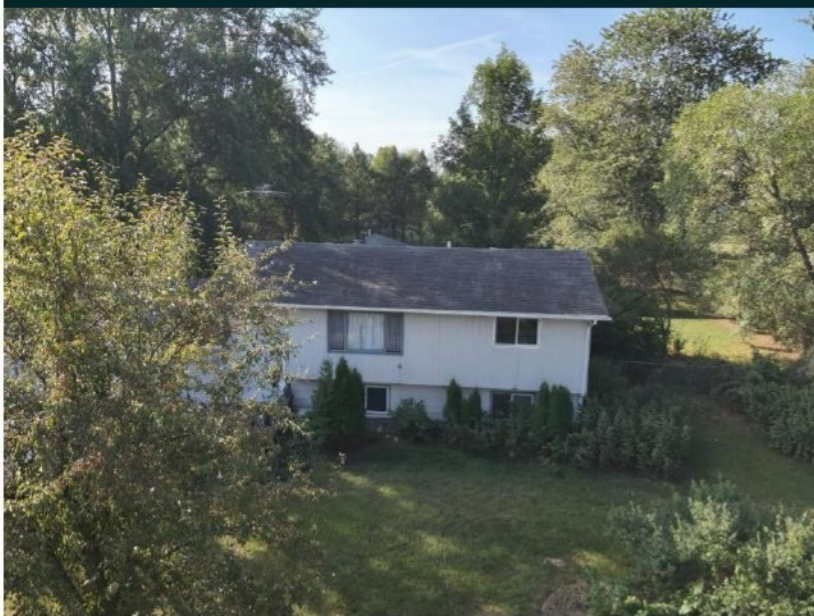
## PO001

Brian Nagorski  
09/14/2026 10:29 AM CDT  
Front of homeowners home.

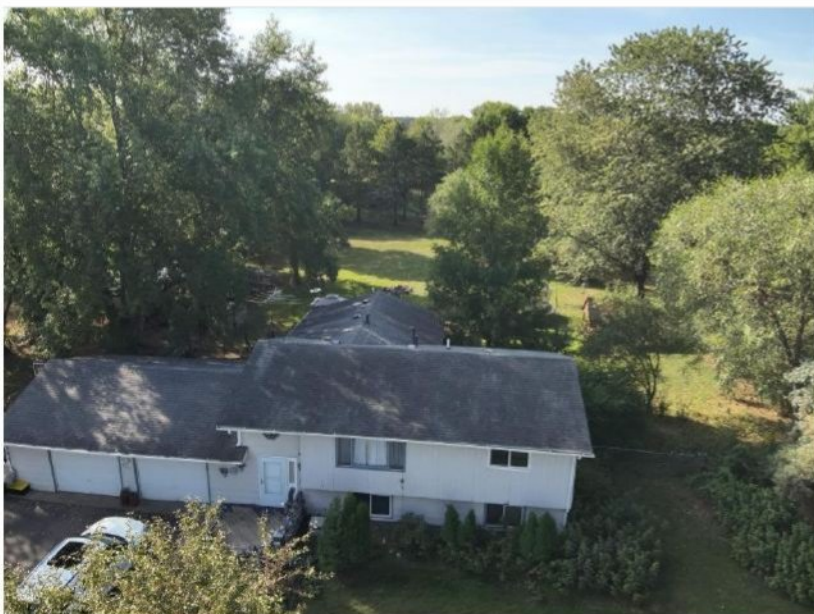
## PO002

Brian Nagorski  
09/14/2026 10:29 AM CDT  
Front overview of roof

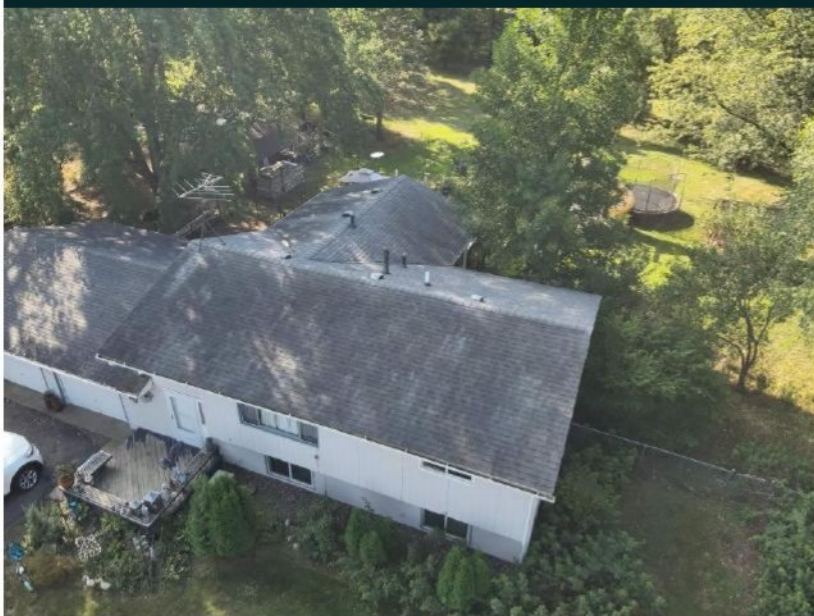
## PO003

Brian Nagorski  
09/14/2026 10:48 AM CDT  
Front right elevation overhead of the roof.

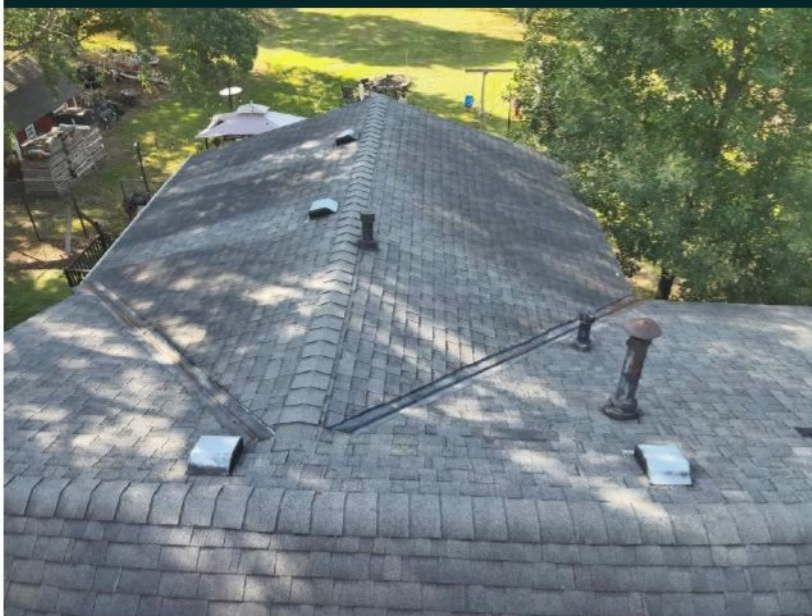
## PO010

Brian Nagorski  
09/14/2026 11:00 AM CDT  
Hail hits  
Soft metal damage  
rusted valleys  
wind damage on some lifting shingles

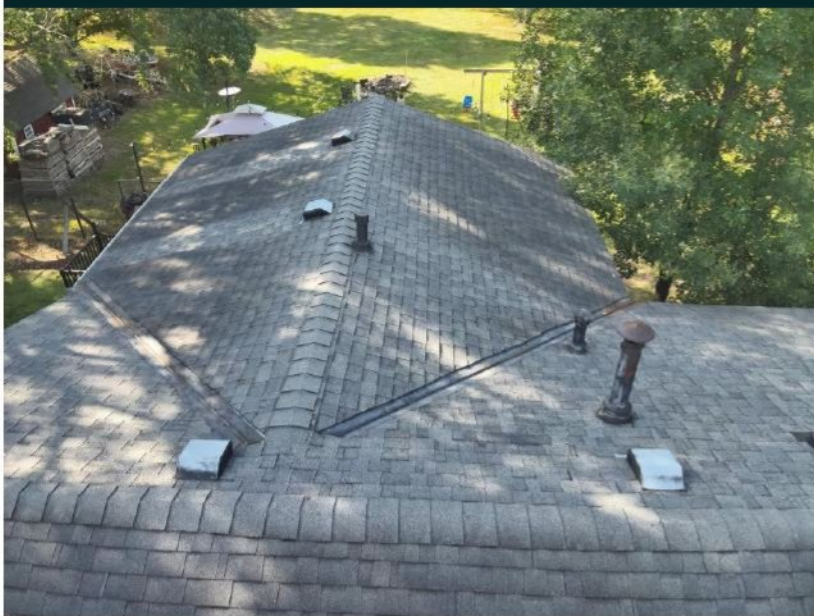
## PO011

Brian Nagorski  
09/14/2026 11:13 AM CDT  
Noticeable hail hits with drone footage

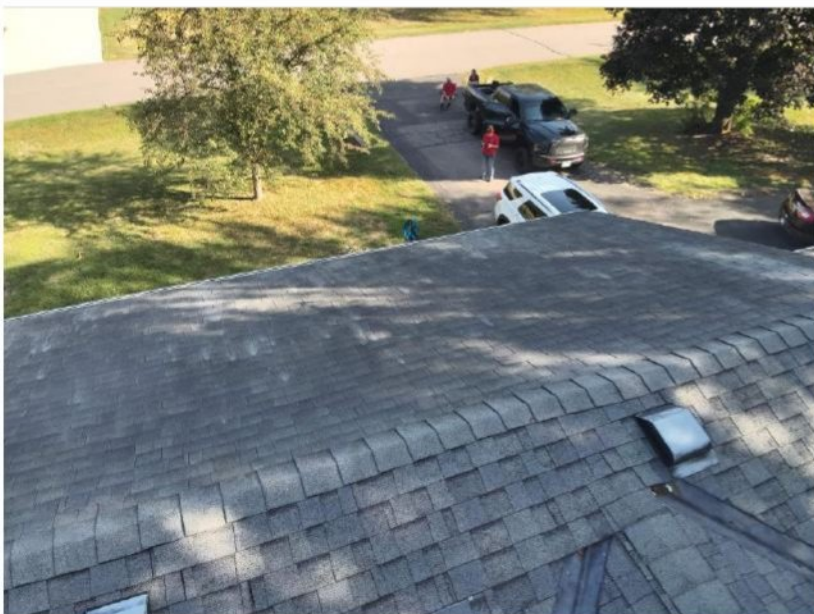
## PO017

Brian Nagorski  
09/14/2026 11:14 AM CDT  
Storm damage displays across this roof  
picture

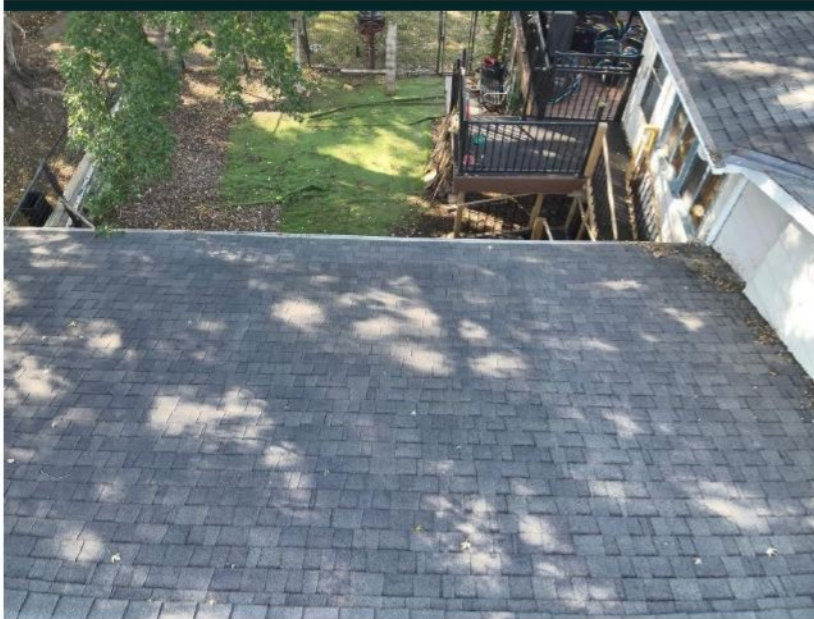
## PO022

Brian Nagorski  
09/14/2026 11:23 AM CDT  
Normal wear and tear

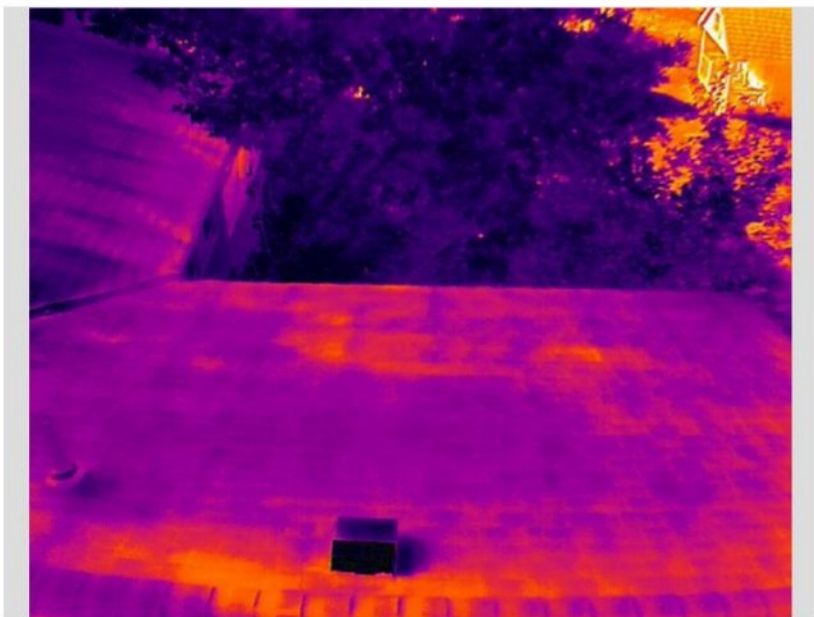
## PO012-T

Brian Nagorski  
09/15/2026 10:55 AM CDT  
Thermal image of the roof, detects darker, colder areas not necessarily moisture but something to keep an eye on.  
The darker the color palette the colder areas, lighter means warm/hot.

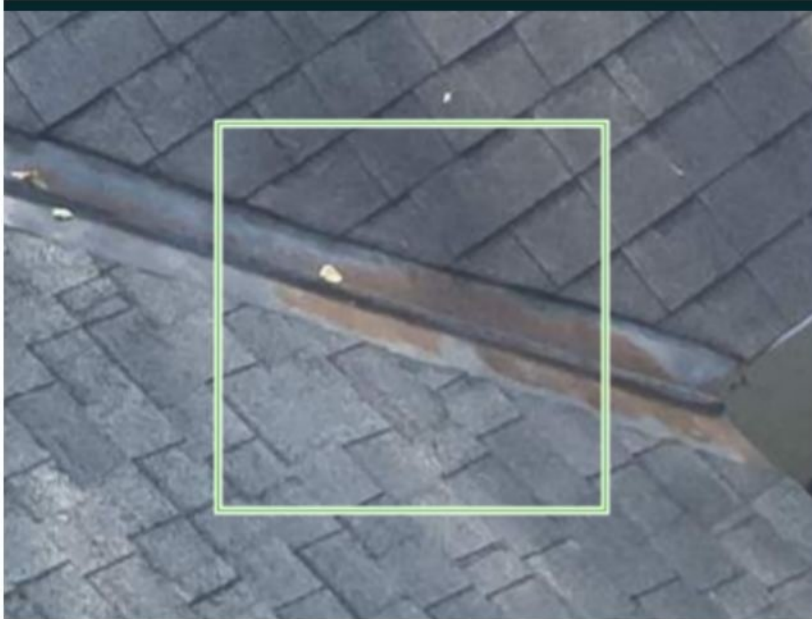
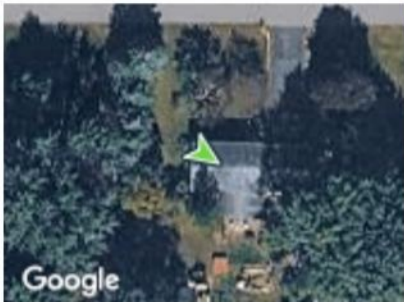
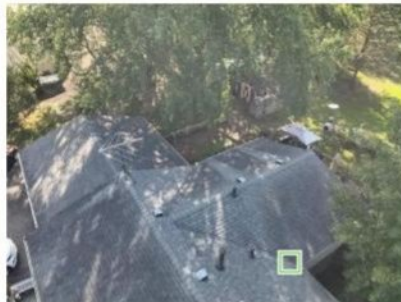
## PO006-1 GENERAL OBSERVATION

Brian Nagorski  
09/14/2026 10:14 AM CDT  
-Rusted valleys is a common way for water to intrude causing mold/mildew, ice and water problems down the road if not addressed.

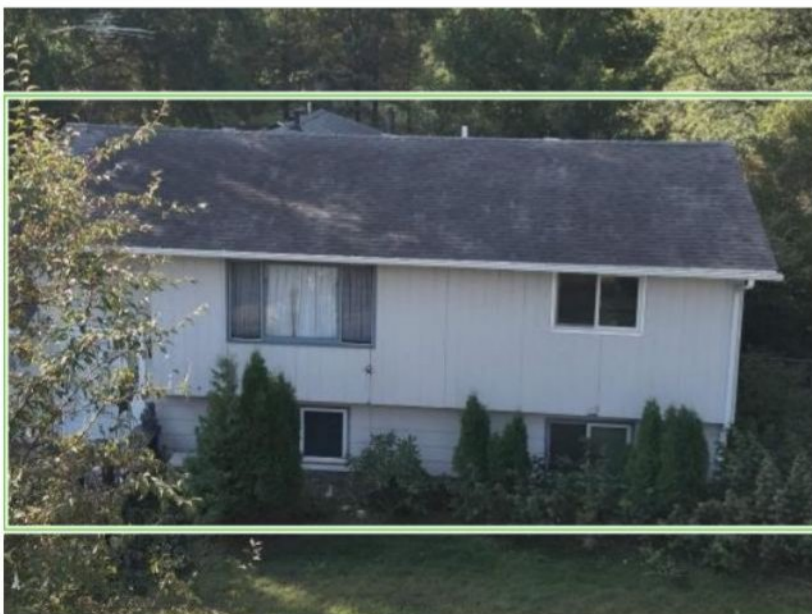
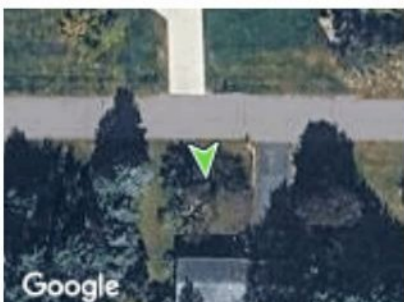
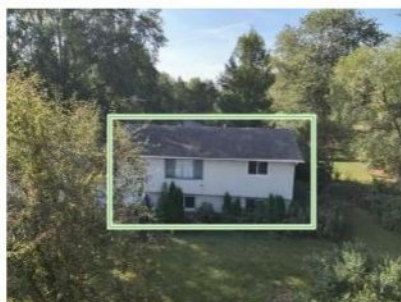
## PO001-1 GENERAL OBSERVATION

Brian Nagorski  
09/14/2026 10:17 AM CDT  
Above the bottom right window, some siding damage

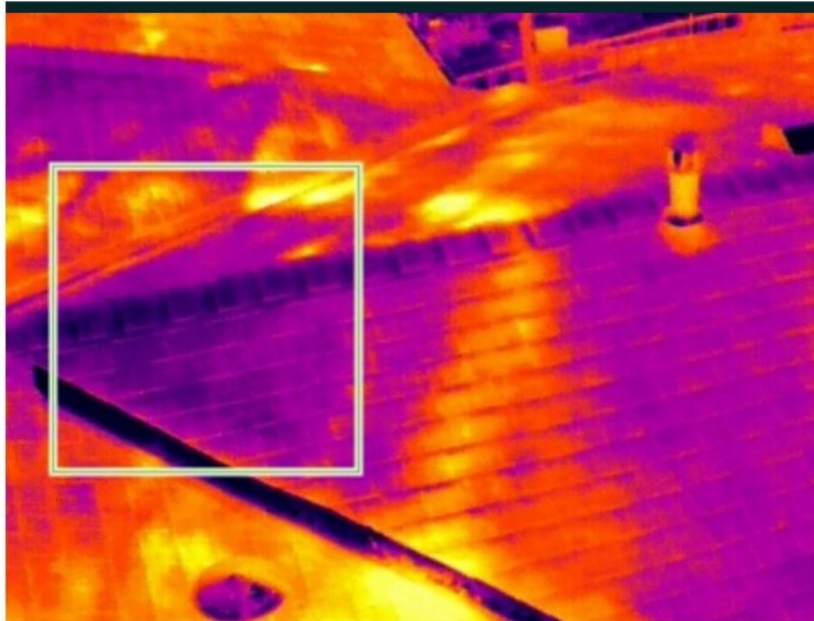
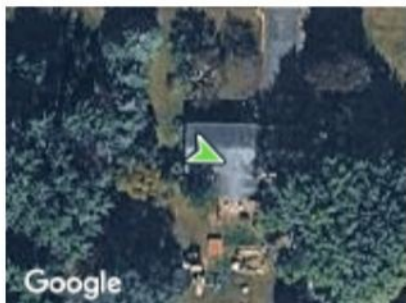
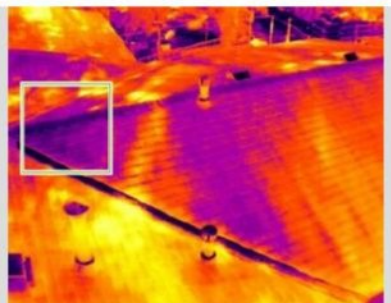
## PO013-T-1 GENERAL OBSERVATION

Brian Nagorski  
09/15/2026 10:56 AM CDT  
Cold temperature means air coming through.

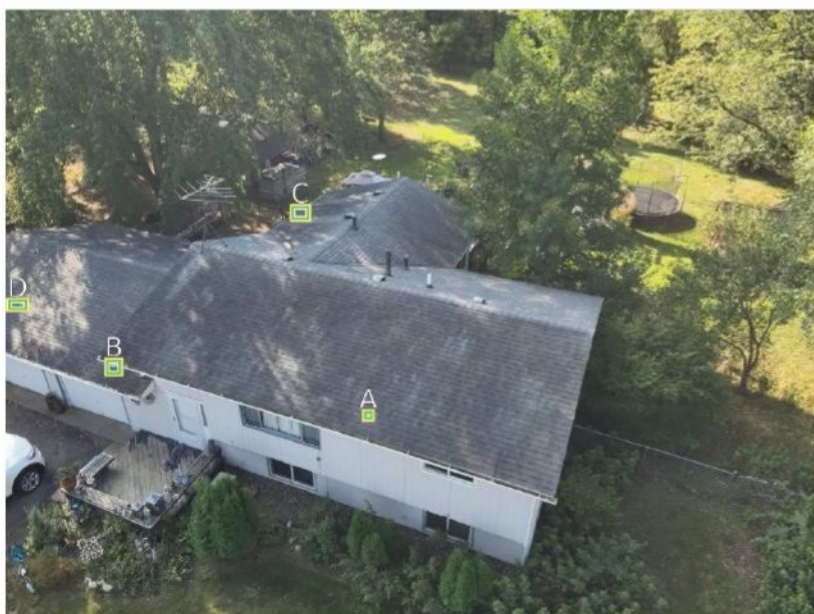
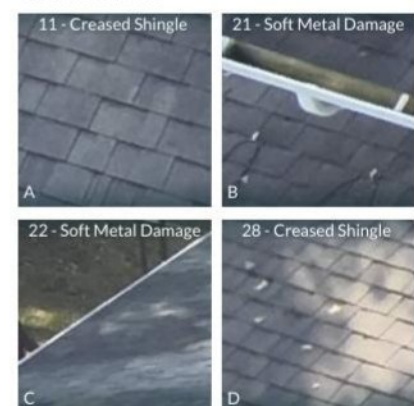
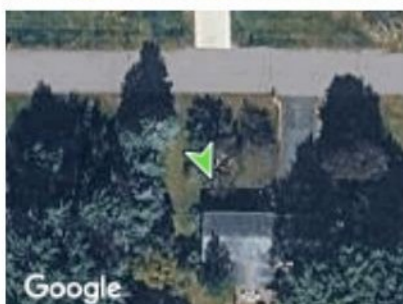
## PO003

| Creased Shingle | 2 |
| Soft Metal Damage | 2 |

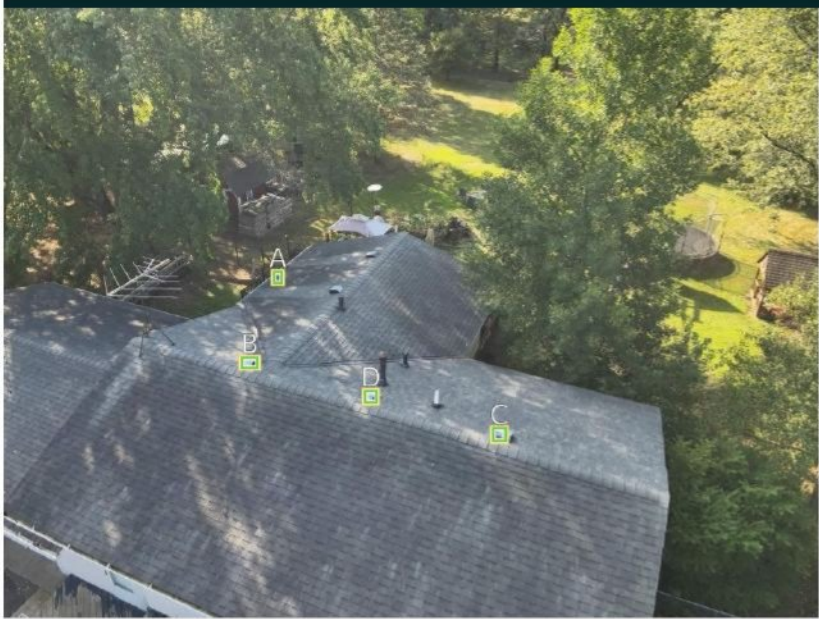
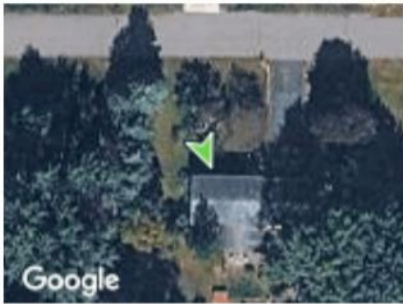
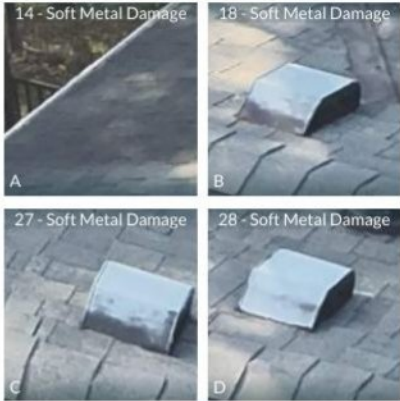
PO004

Soft Metal Damage4

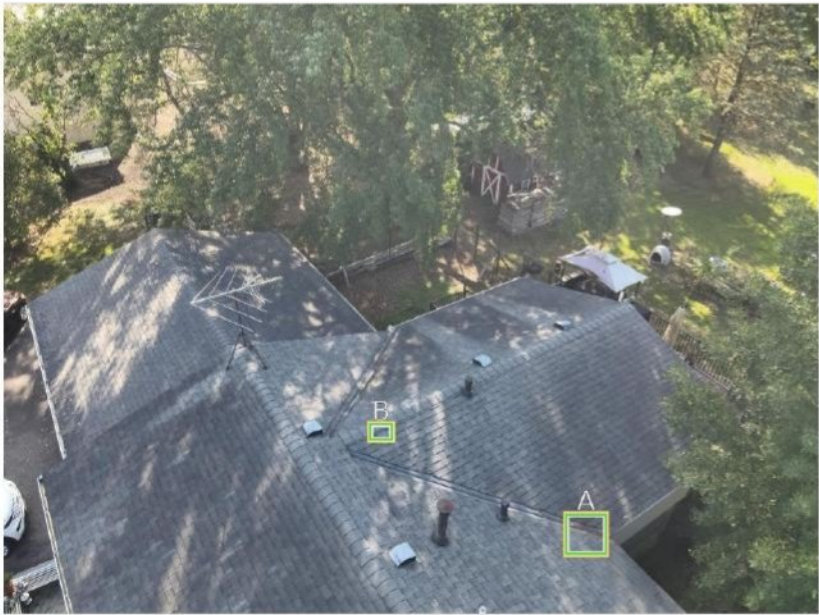
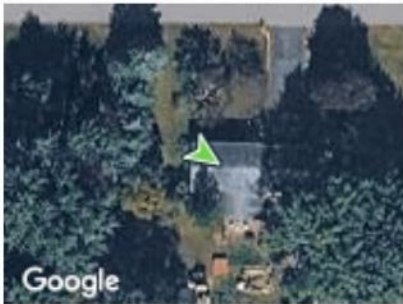
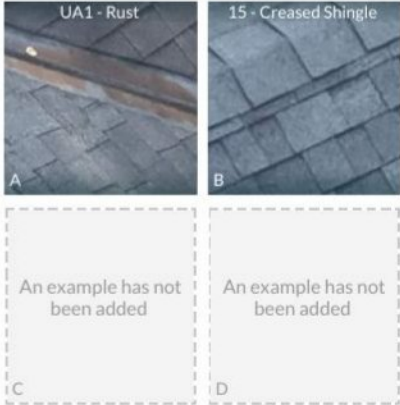
PO006

Creased Shingle1  
Rust1

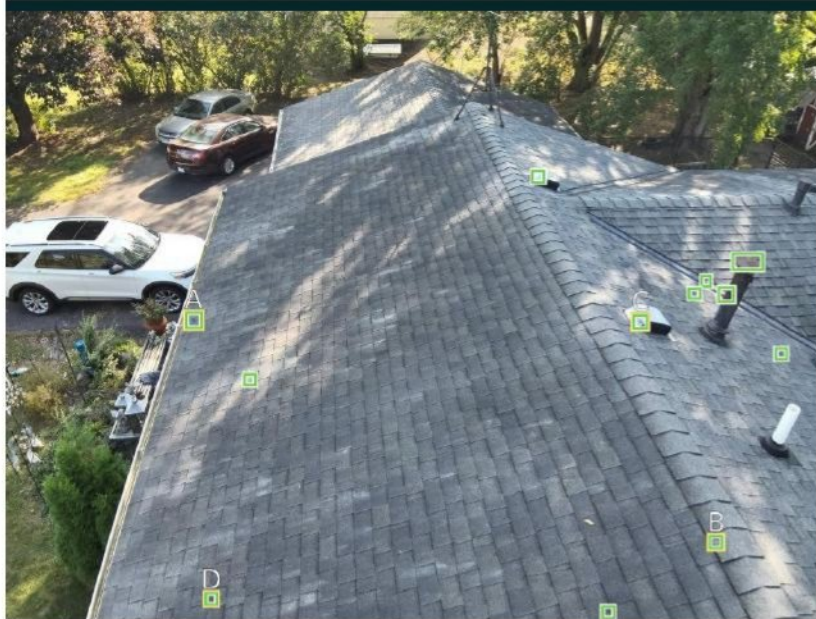
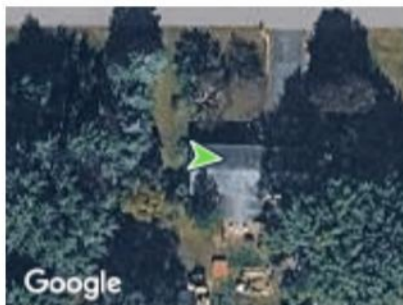
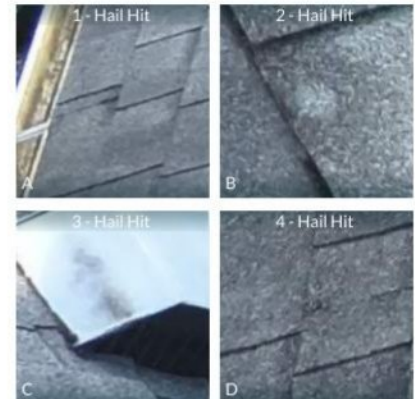
PO008

| Hail Hit | 8 |
| Rust | 3 |
| Soft Metal Damage | 1 |

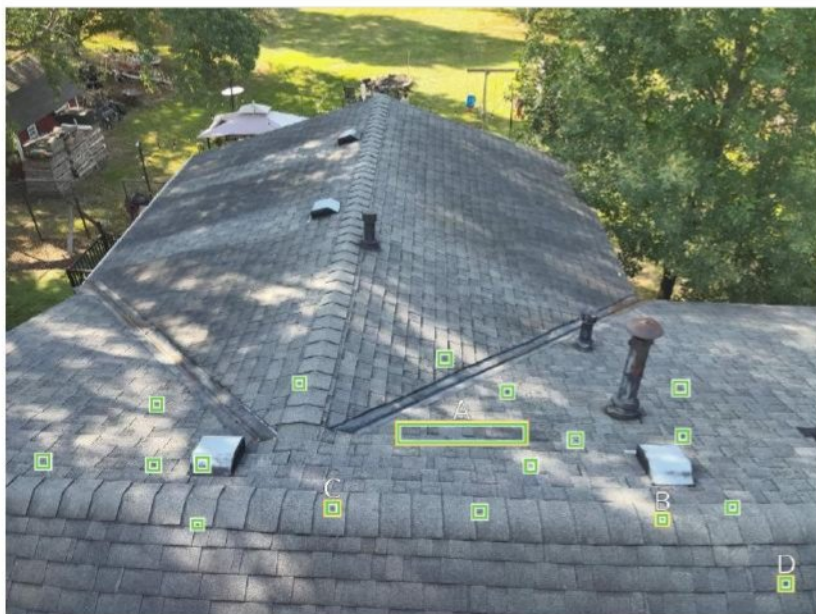
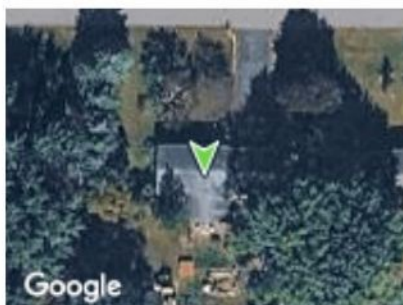
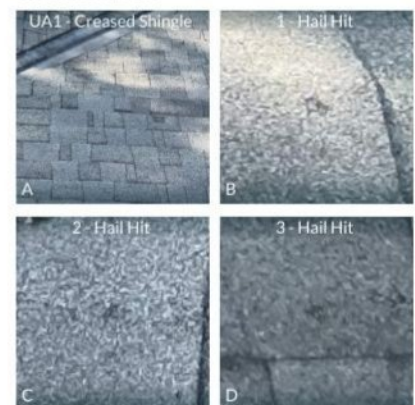
PO010

| Creased Shingle | 1 |
| Hail Hit | 16 |
| Soft Metal Damage | 1 |
