# ***MH INSPECTIONS LLC***

## **Property Inspection Report**

9 Northumberland Drive, Shoreham, NEW YORK 11786

Date of Inspection: 6/19/2026 Time: 10:00AM

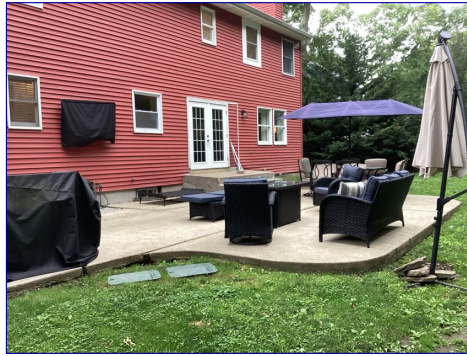
STOOP TO BACK DOOR CRACKED SIGNIFICANTLY- CONSULT QUALIFIED CONTRACTOR

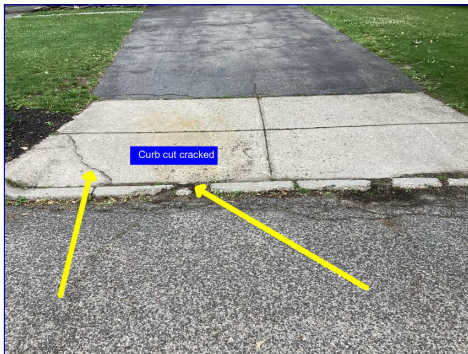
CRACKS AT DRIVEWAY CURB CUT

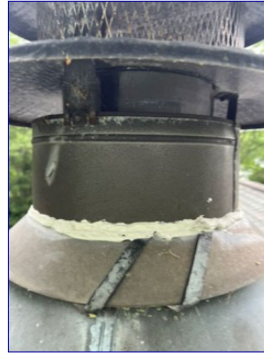
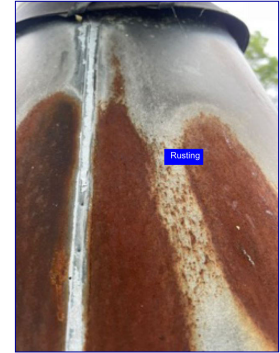
RUSTED RECOMMEND RUSTOLEUM TO PROLONG LIFE

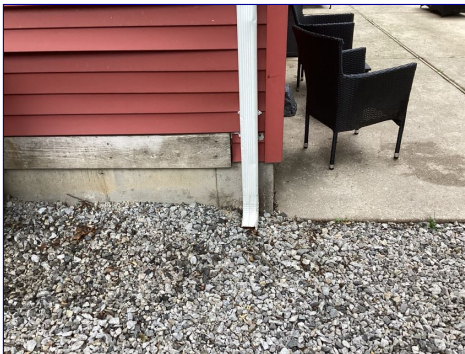
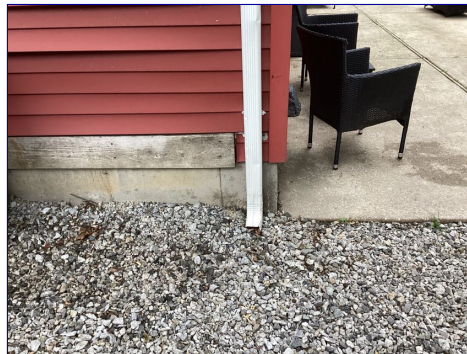
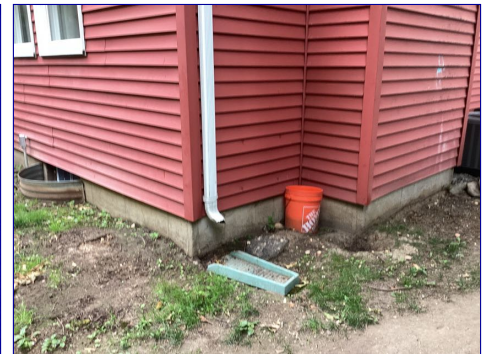
- The gutters are dirty. Recommend cleaning the gutters to ensure proper water flow to the downspouts.
- The gutter downspouts don't direct water far enough away from the house. Recommend adding downspout extensions (5-6' extensions recommended) to discharge away from the home.

DRAINAGE SHOULD BE EXTENDED AWAY FROM FOUNDATION TO PREVENT DAMAGE AND WATER INTRUSION INTO BASEMENT SEE SPLASH BLOCK AT OTHER GUTTER LOCATION

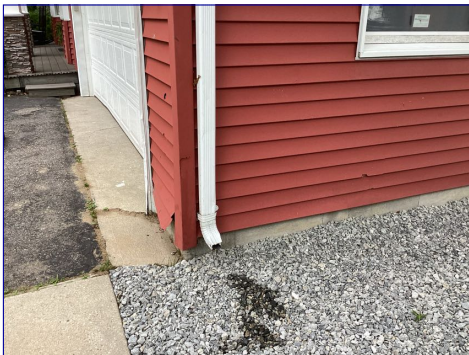
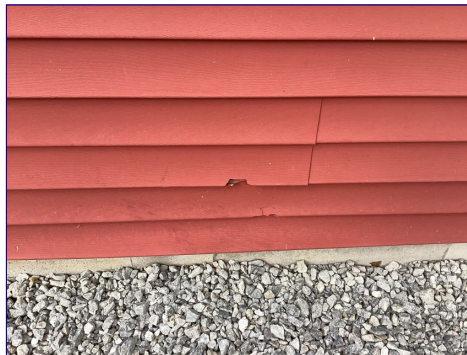
- The siding had some damage, recommend a licensed contractor repair/replace damaged sections.

damaged siding in several exterior locations

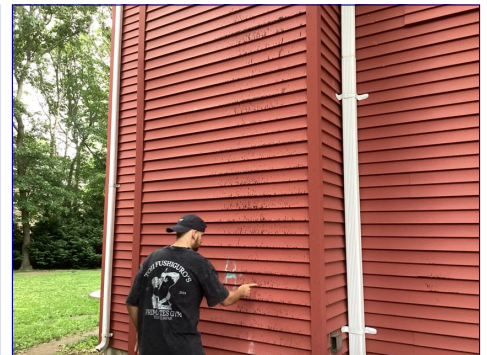
tar on siding

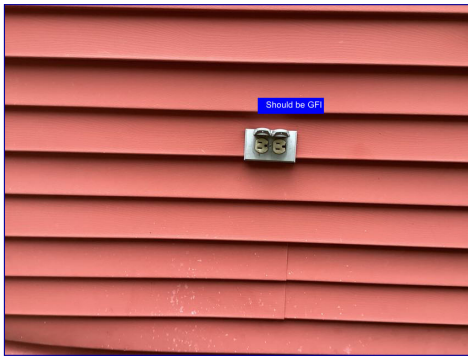
- GFCI receptacles are not installed at outdoor locations, which is a safety concern. Recommend a licensed electrician install GFCI receptacles.

should be GFI for exterior outlets subject to rain

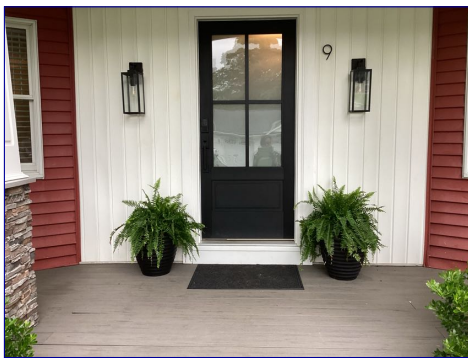
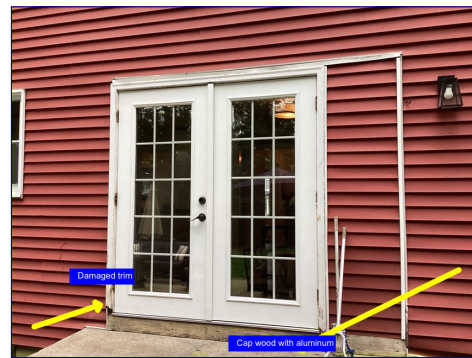
damaged trim, recommended capping wood below door to prevent damage and rotting

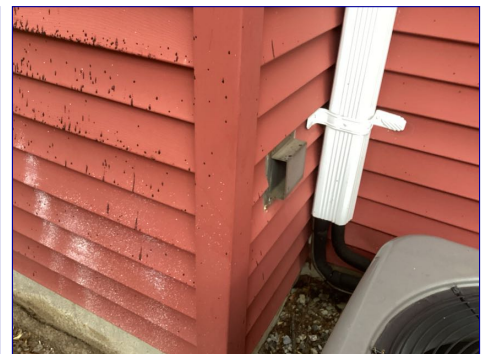
tar on siding

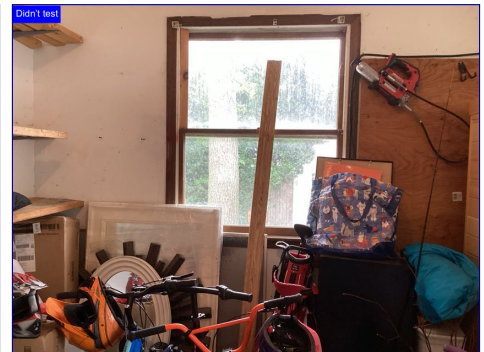
DID NOT OPEN WINDOW COULDN'T  
GET TO WITHOUT MOVING TOOLS

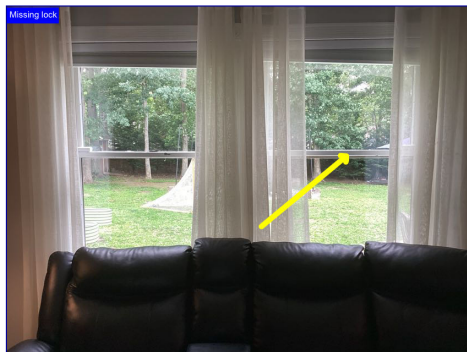
MISSING LOCK

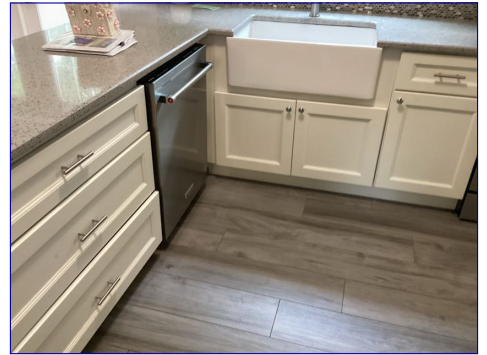
DRAW DOESN'T CLOSE FULLY

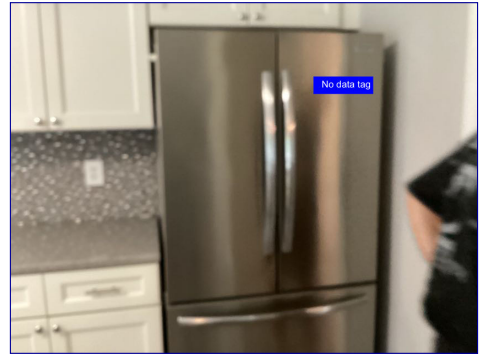
MISSING DATA PLATE WITH AGE INFO LOOKS FAIRLY NEW LIKELY SIMILAR AGE TO OTHER KITCHEN APPLIANCES

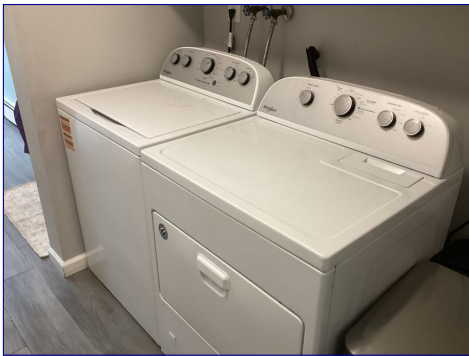
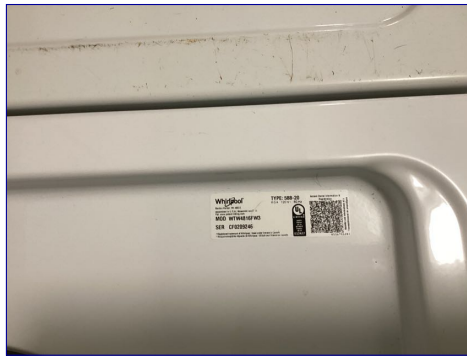
WASHER AGE 1996 BUDGET FOR POSSIBLE REPLACEMENT

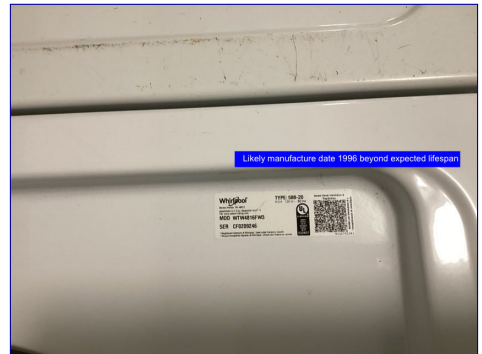
washer made in 1996 budget for future replacement

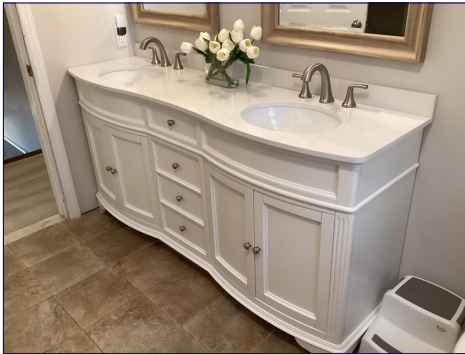
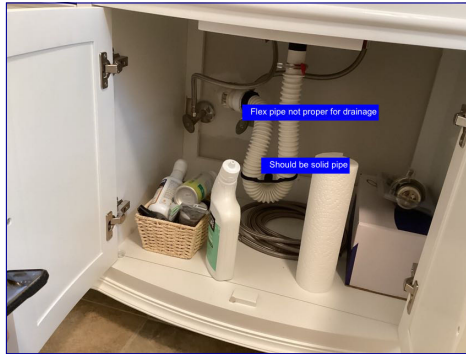
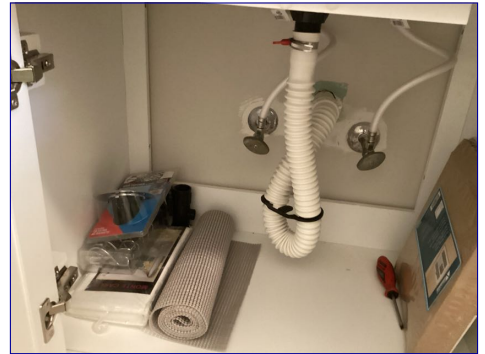
FLEXPIPE SHOULD BE REPLACED

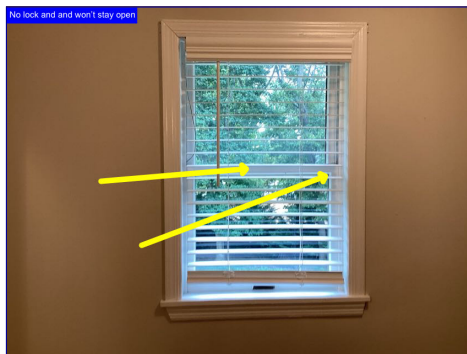
NO LOCK BROKEN PULLY STRING

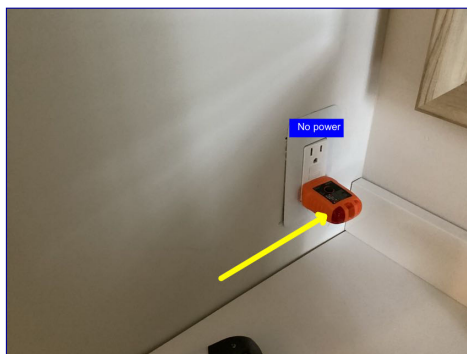
NO POWER TO THIS OUTLET

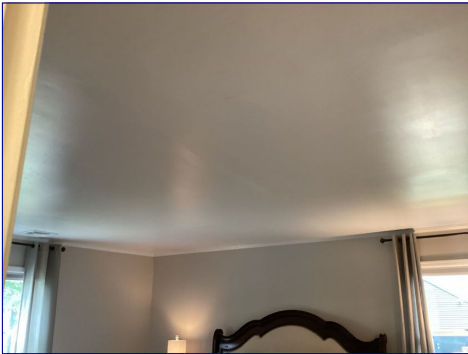
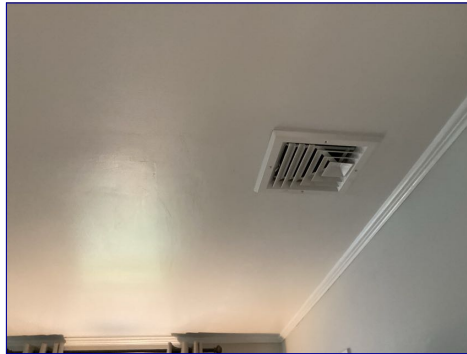
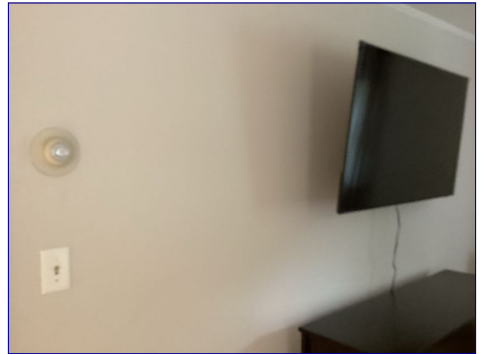
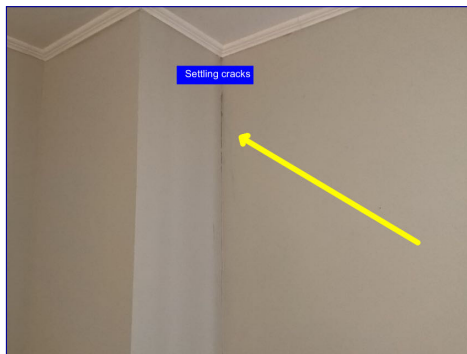
SETTLEMENT CRACKS

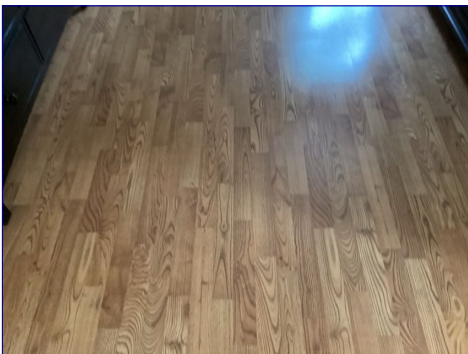
Soft spot in front of bed

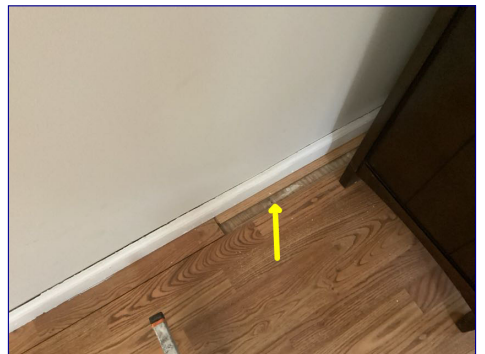
LAMINATE SEPERATING

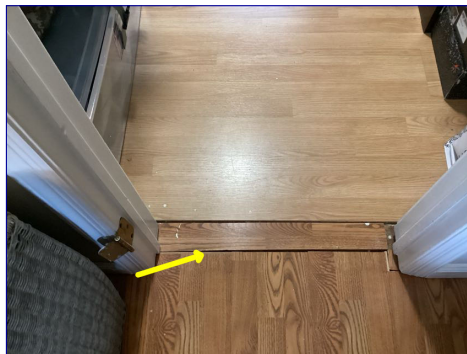
MISSING SADDLE

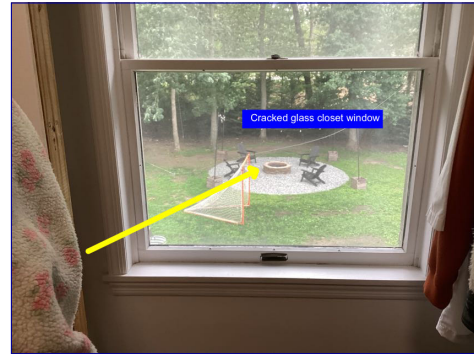
CRACKED GLASS IN MASTER CLOSET

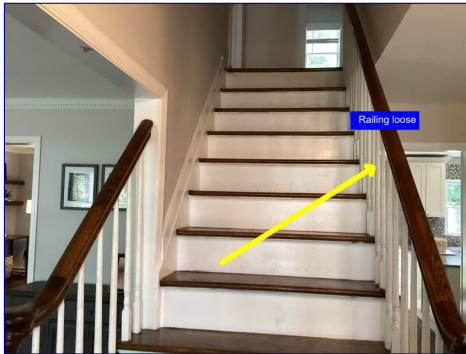
RAILING LOOSE

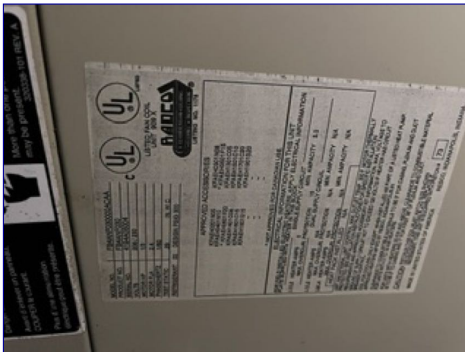
AC DATA TAG MADE IN 1994  
BUDGET FOR FUTURE  
REPLACEMENT

Observations:  
• The average life expectancy for an air conditioning system is 8-15years. Recommend budgeting for repairs and/or replacement.  
• The ac unit in the attic was made in 1994 these units life span are 15-20 years

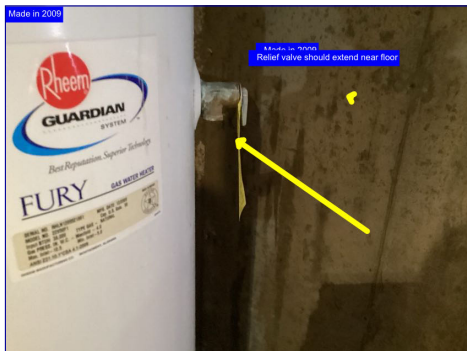
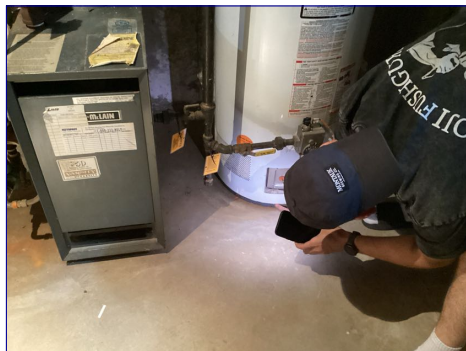
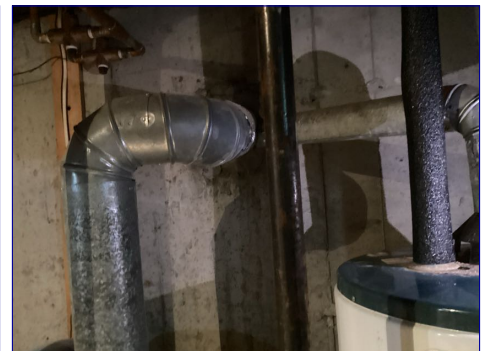
MISSING PIPE SHOULD REACH  
NEAR GROUND SAFETY CONCERN

- Extension proper: No
- Extension proper: Missing

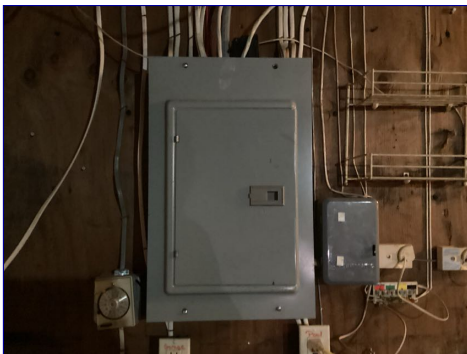
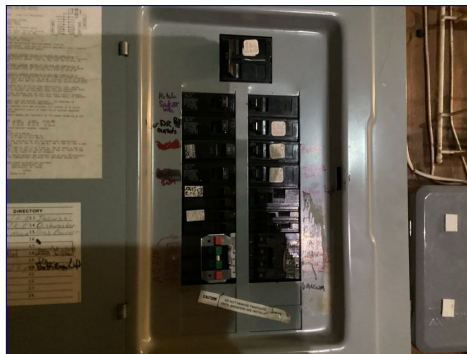
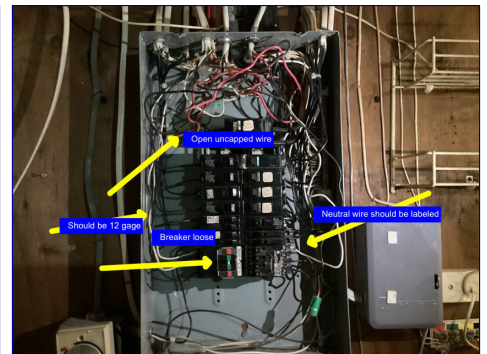
LOOSE BREAKERS, WRONG GAGE WIRE TO ONE BREAKER NEUTRAL WIRE USED AS HOT SHOULD BE LABELED OPEN UN CAPPED WIRES
