Report V1.0

# Engineer's Foundation Evaluation

123 Main St, Your City, AR, 12345

On 3/26/2024 a foundation evaluation was performed at the property located at address 123 Main St, Your City, AR, 12345, which consists of a 3079 square-foot single family attached structure built in 2008 (18 years old) with a slab on grade foundation.

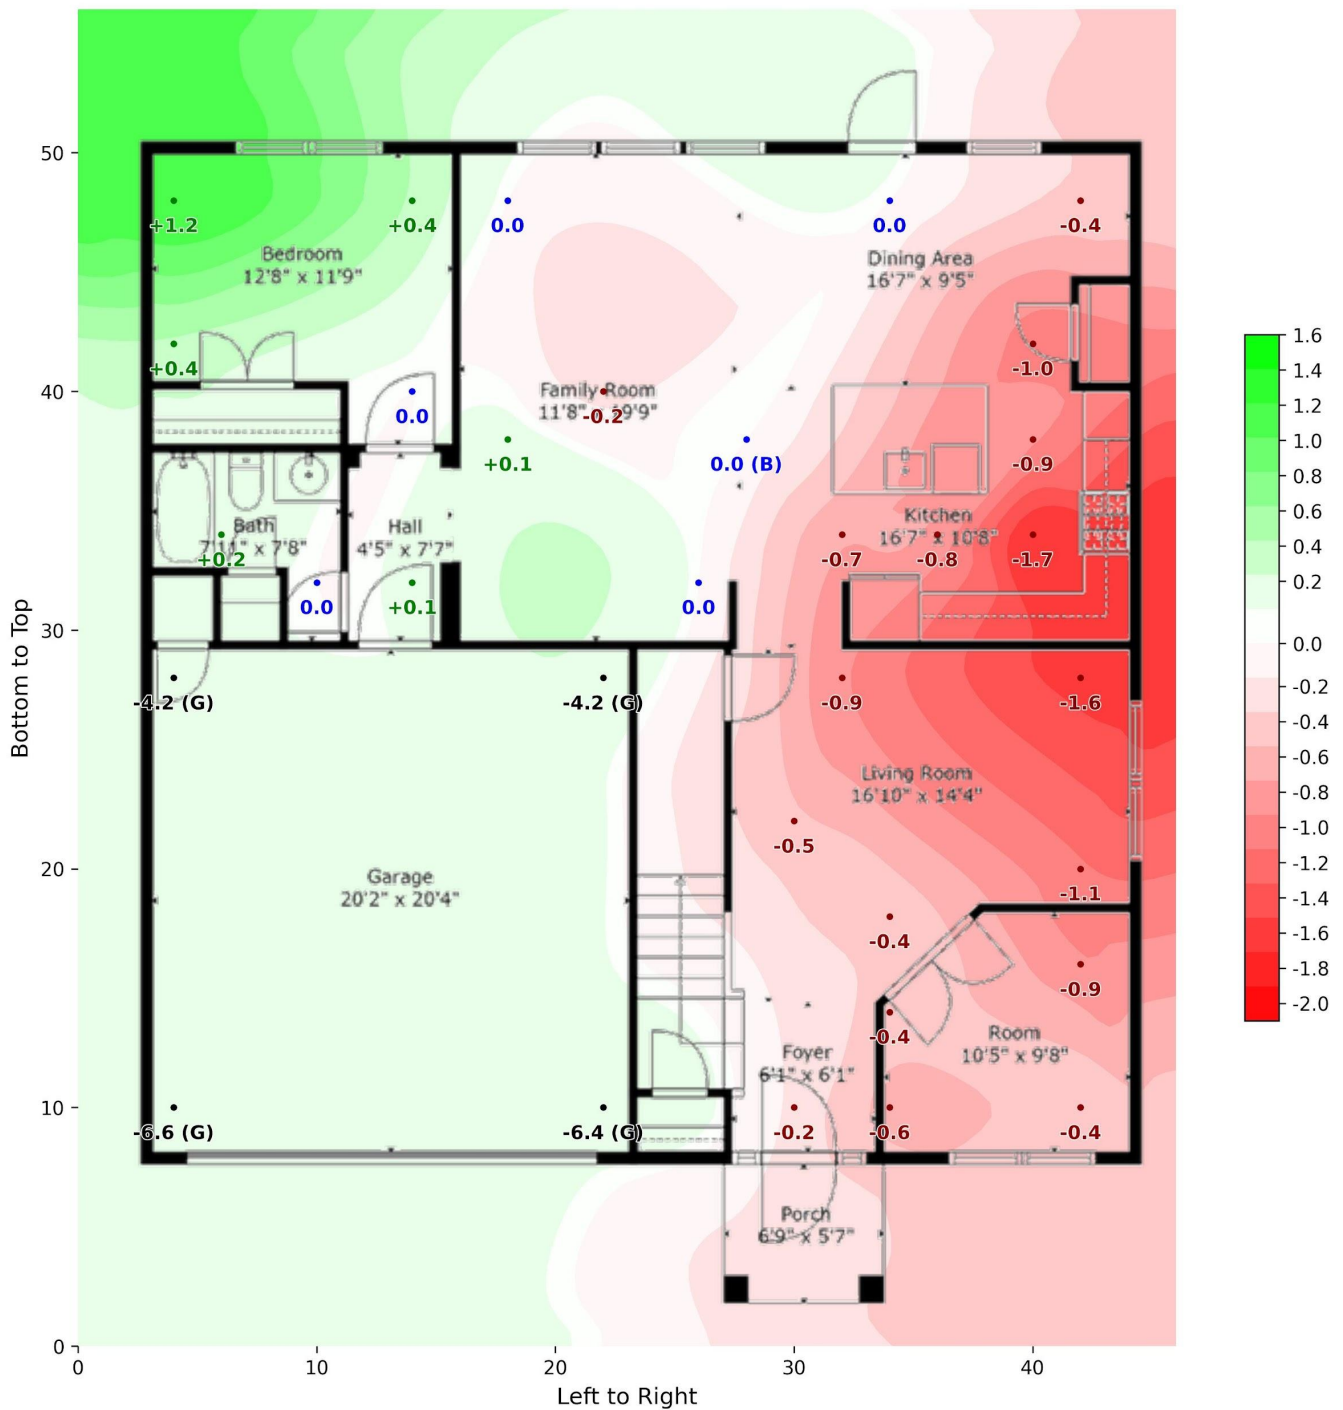
**Elevation Plot Graphic (Figure A)**

The elevation plot resulted in the graphic as depicted above in Figure A. The red-points and areas are elevation measurements that were lower than the base station elevation (0.0). The green-points and areas are elevation measurements that were higher than the base station elevation (0.0). The blue-points (and white areas) are equal to the base station elevation (0.0). The base station is depicted with a (B) symbol. The elevation plot takes into account differences in flooring thicknesses. The maximum elevation point was determined to be 1.2 inches and the minimum was -1.7 inches, resulting in an elevation difference of 2.9 inches of difference across the structure.

The elevation plot graphic above will show points labeled with a (G) symbol representing Garage. These elevation points were measured and plotted so they can be compared year-to-year, however, they are excluded from the foundation analysis. This is because garages can be non-monolithic and/or they are poured to purposefully slope toward the exterior garage door making any conclusions derived difficult to interpret.

Elevation differences across the structure are the first indicator that a foundation problem may or may-not exist. As documented above, the maximum elevation point of this structure was determined to be 1.2 inches and the minimum was -1.7 inches, resulting in an elevation difference of 2.9 inches of difference across the structure. The elevation plot takes into account differences in flooring thicknesses. The elevation deflection across an entire structure should, best-case-scenario, remain within 0.5 to 1-inch depending on the age of the structure. Measured differences approaching 2-inches are an initial sign of possible foundation fatigue. The maximum allowable elevation difference is subjective, depending on other factors such as the visual condition, size, and age of the structure (18 year(s) old) along with how the foundation performs when calculating deflection and tilt.

Based on observed elevations of the foundation from the elevation plot, the elevation differences do not fall within industry standards and tolerable limits. These findings indicate that the foundation does not have consistent and uniform elevation measurements. Note: elevation measurements alone is not the only indicator of foundation problems; see the deflection and tilt calculations (and the report's overall conclusion) for a complete understanding of foundation stabilization. If elevations fall outside of industry standard/tolerable limits, it is a first indicator that the foundation will fail in deflection and/or tilt.

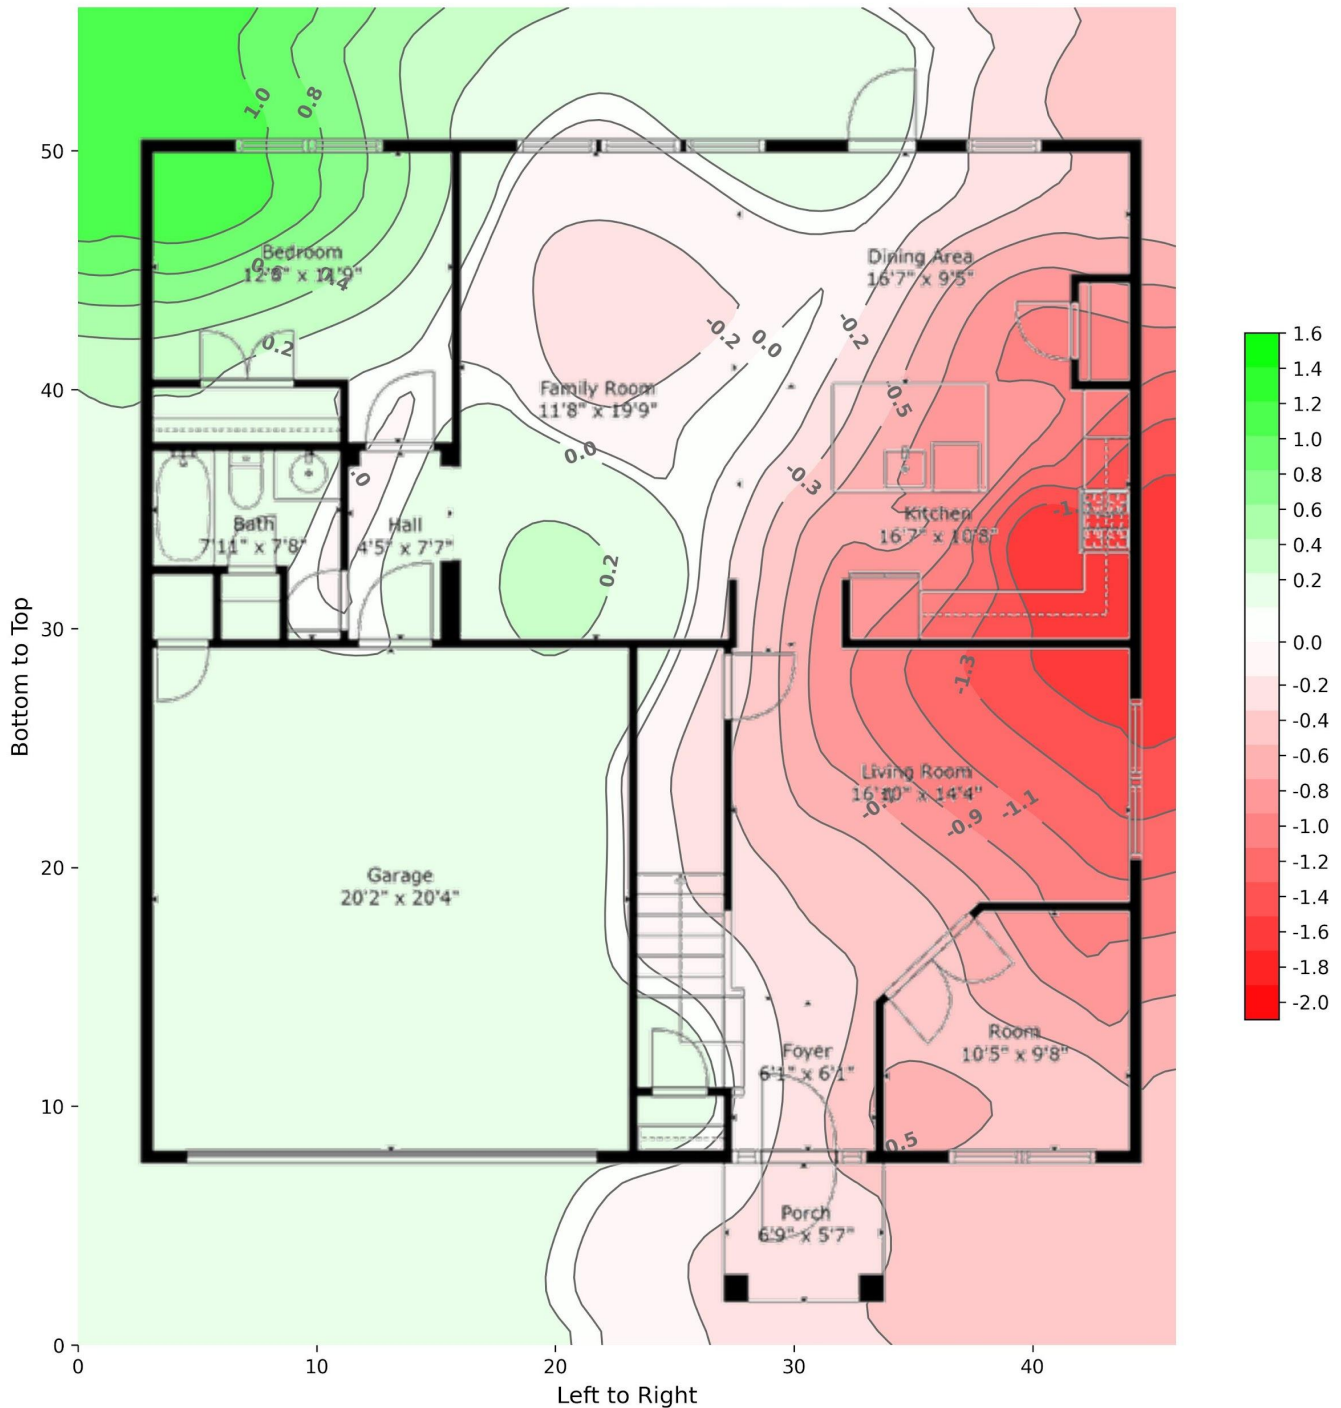
**Mesh Contour Graphic (Figure B)**

The mesh contours graphic depicted above in Figure B is similar to the elevation plot. The red, green, and white areas depict areas that are lower, higher, and equal to the base station elevation (0.0). The lines or contours (similar to map topography) are labeled at specific intervals.

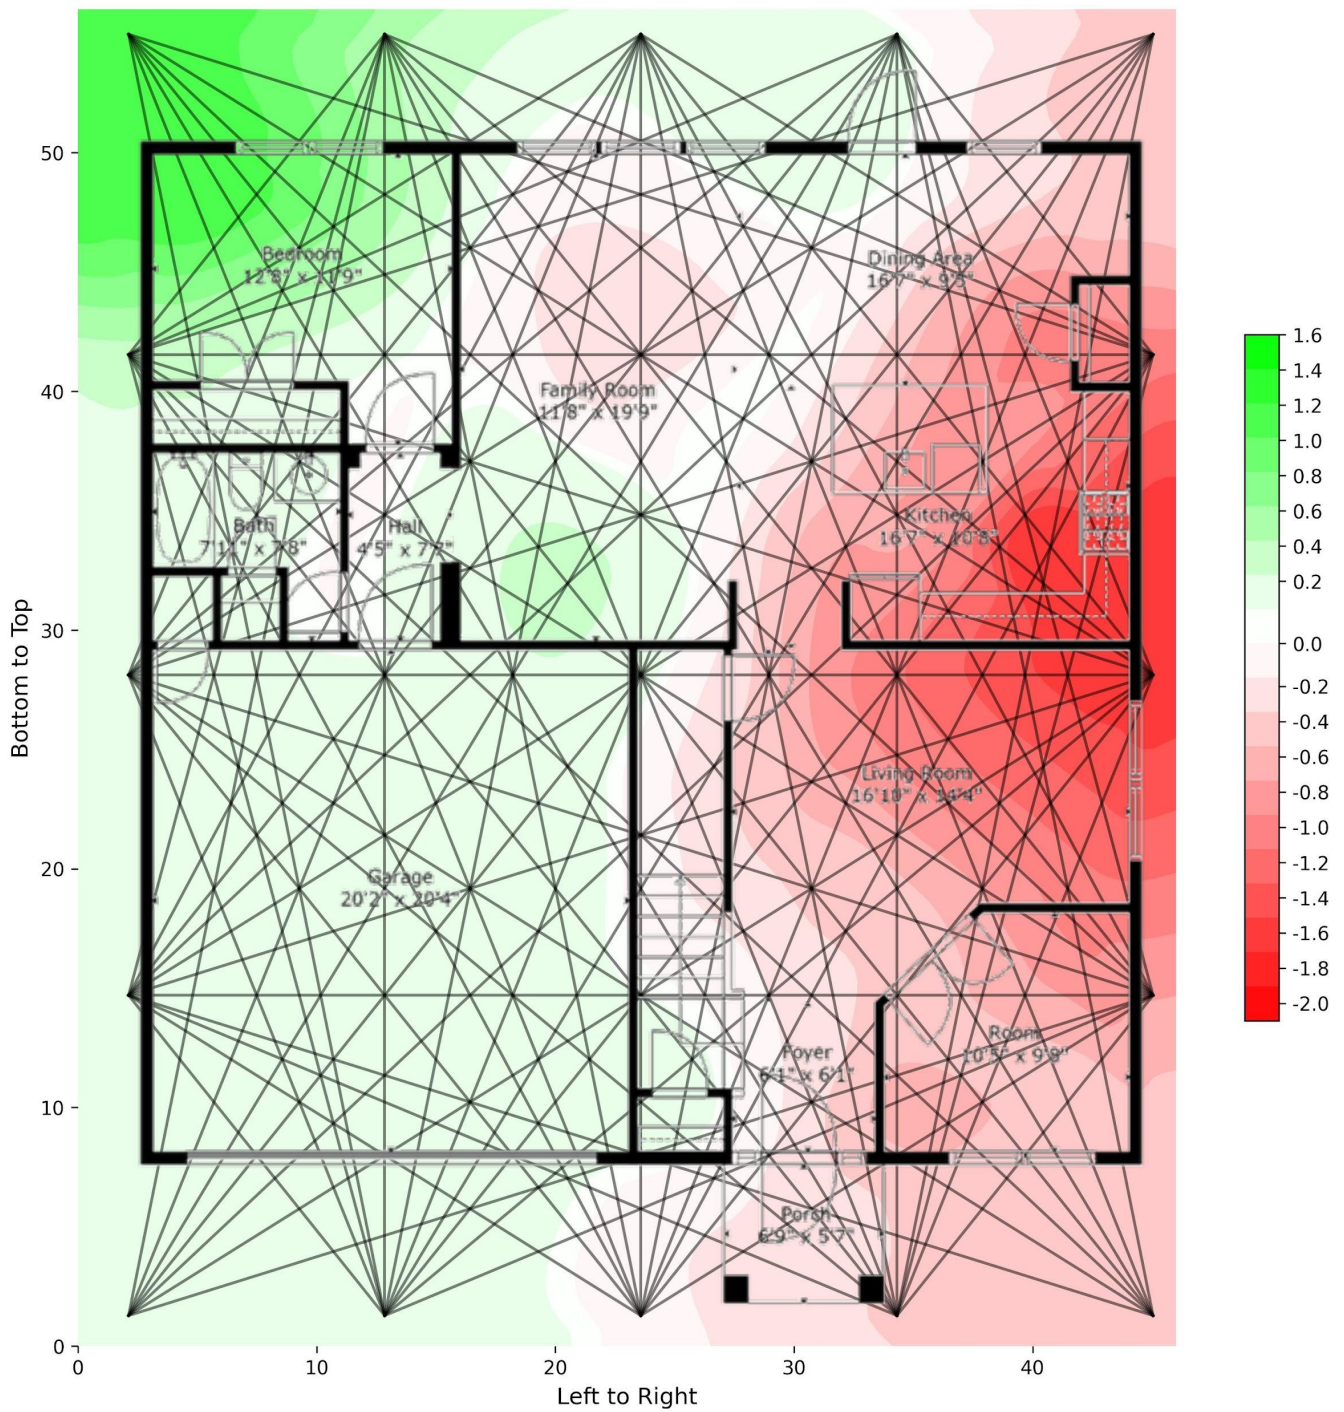
**All Profiles Graphic (Figure C)**

Below is a graphic that shows the locations of deflection and tilt profiles that were calculated. The total profiles calculated was 79 with a total usable profiles (above the effective length threshold) of 75.

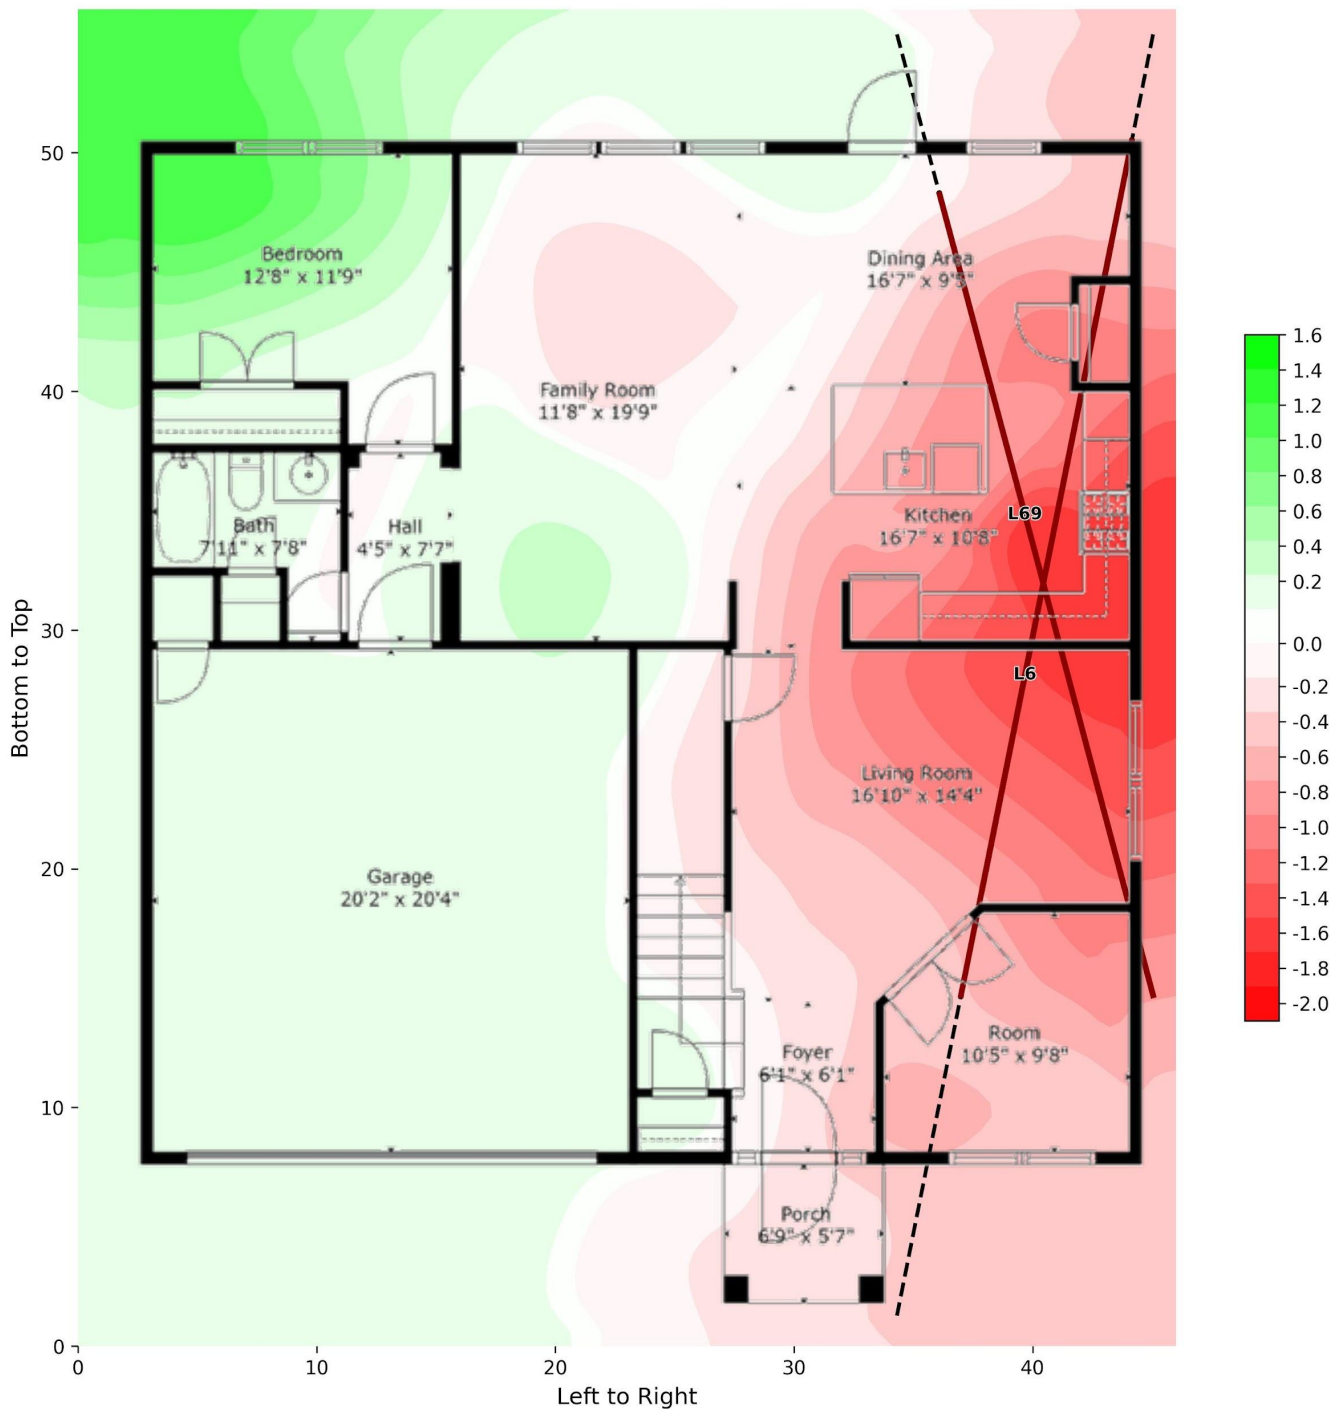
**Deflection Failures Graphic (Figure D)**

The above Figure D shows deflection failures along the foundation. Deflection failures can be considered localized failures in (sometimes) isolated portions of the foundation. The profile lines that were calculated are represented by a dashed black line and the areas that the deflection failures occur are represented by a dark red line segment. Of the 75 deflection profiles calculated, 2 profile failures were identified.

Deflection failures can be considered localized failures of the foundation in (sometimes) isolated portions of the foundation. Of the 75 deflection profiles calculated, 2 failures were identified.

Deflection failures are above standard acceptable limits; they exceed industry-standard thresholds and the structure should be considered actively moving/settling in areas where deflection failures are occurring. See the report's overall conclusion for a complete understanding of the overall foundation stabilization issue.

**To stabilize and lift the foundation, install and/or adjust perimeter and interior piles/piers as shown in the attached Exhibit A - Proposed Repair Plan. The underpinning may be concrete cylinders, steel pipe, helical screws, or drilled concrete piers – refer to Exhibits D, E, F, and G. Underpinning will not improve the performance of the foundation in non-underpinned areas. Note, any foundation movement, even corrective, can cause additional cosmetic distress. The contractor shall determine the amount of elevation correction needed based on the reaction of the structure during the adjustment in order to minimize stress and additional cosmetic damages.**

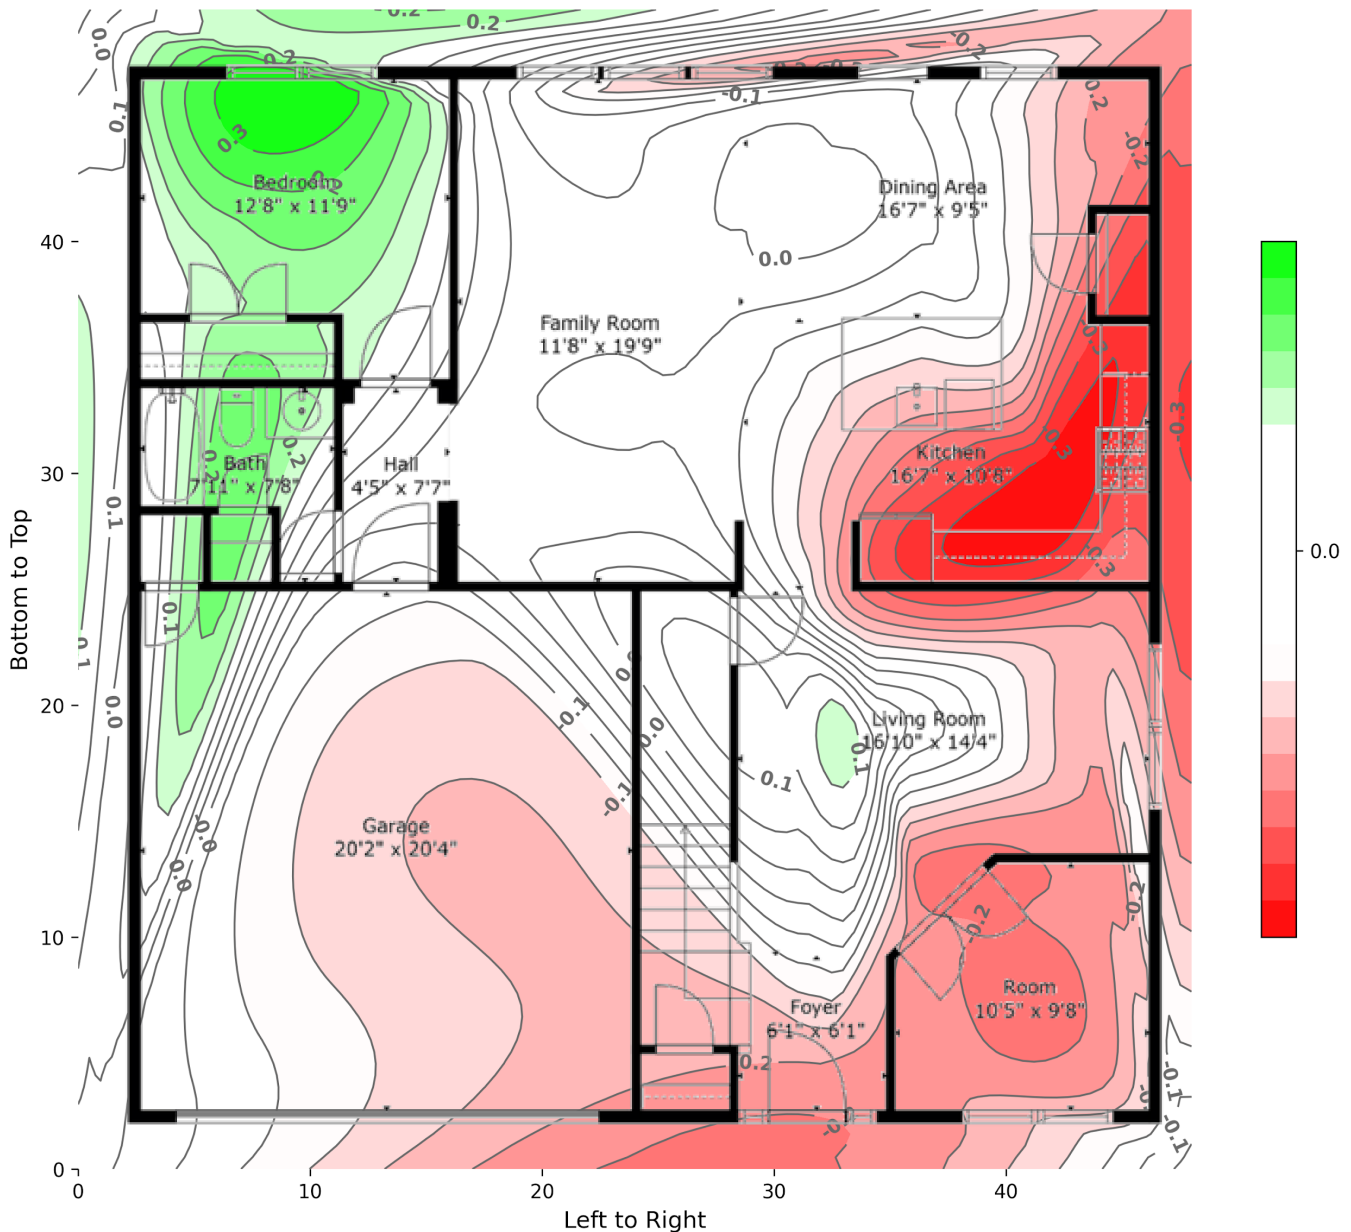
**Elevation Plot Difference Graphic (Figure F)**

A previous elevation plot completed in 2022 was available to use as a baseline of movement progression. Elevation differences are shown that show us the clear progression of movement from one date to another. As part of this evaluation, a contour mesh showing the elevation differences between the current contour mesh and the baseline was processed and is shown below.

The mesh contour graphic above in Figure F shows areas in red that are lower than the baseline elevation plot and areas of green that are higher than the baseline elevation plot (from the provided drawing completed in 2022). The darker the color (both red and green) the larger/smaller the elevation differences.
