**RVA HomeSpec LLC**  
home inspections

## Inspection Report

1004 Charles St  
South Hill VA 23970

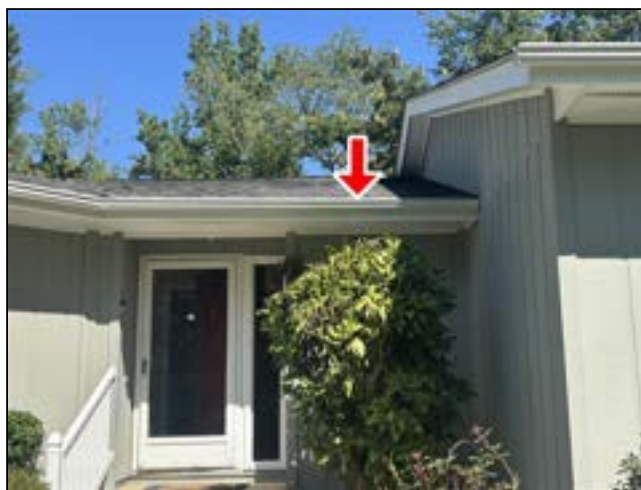
1.3 Item 1 (Picture)

- (1) The gutters sag or slope away from downspouts in areas. Have a qualified contractor correct as needed to ensure water drains away from the home as intended
- (2) The addition of downspout extensions is recommended to divert water away from the home and foundation.

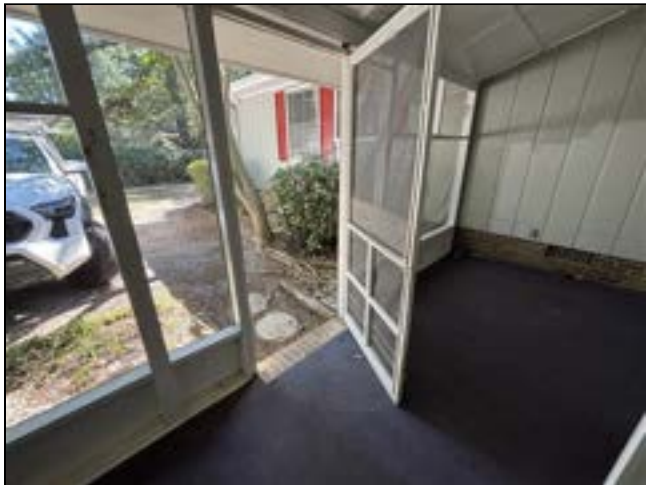
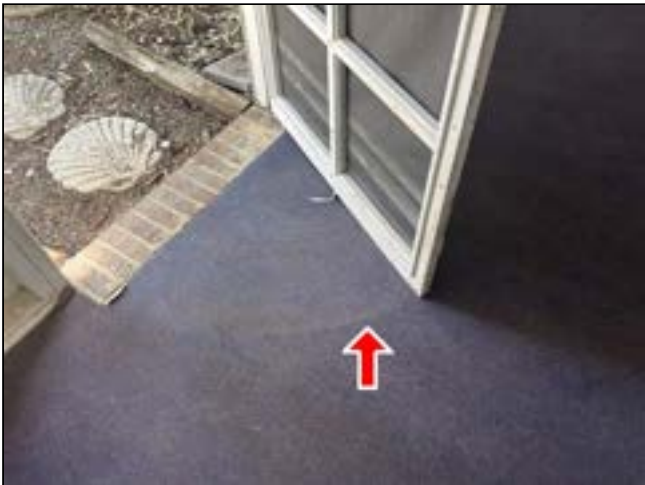
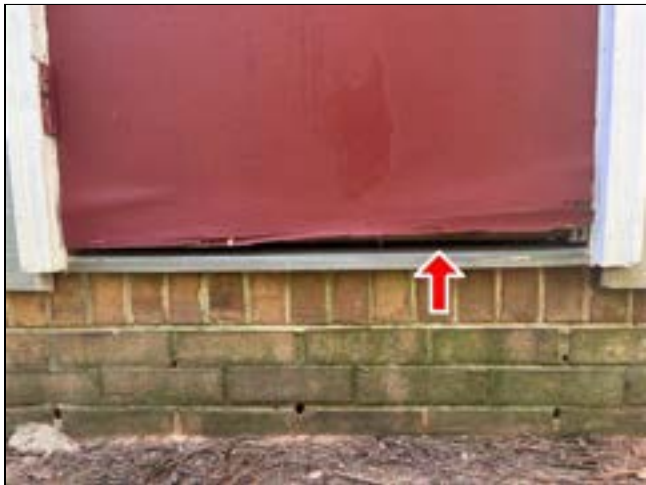
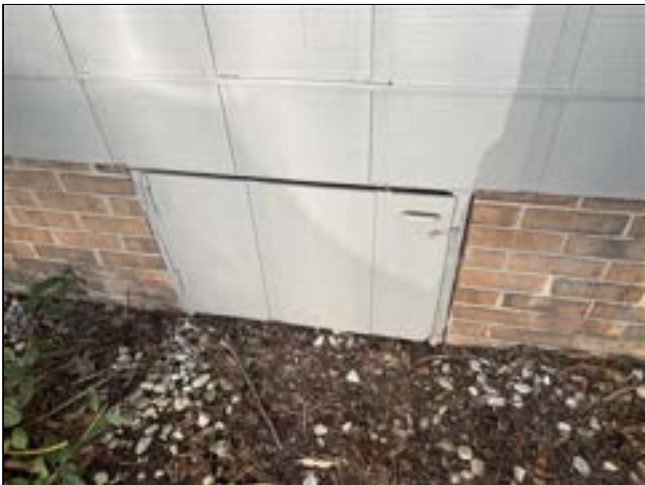
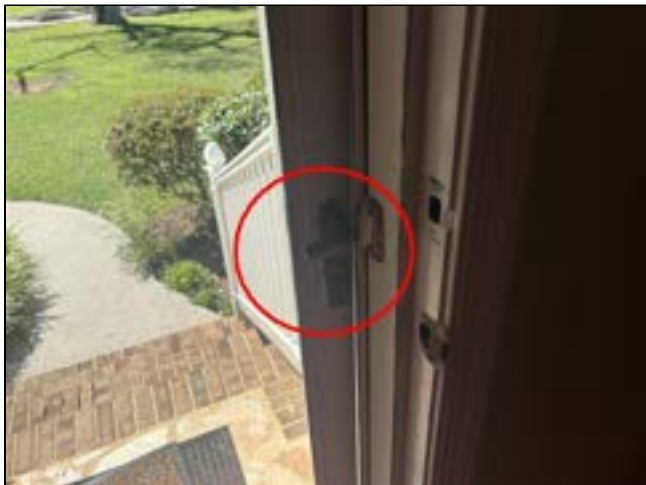
2.1 Item 1 (Picture)

- (1) I recommend adjusting the screen door so it doesn't drag on the floor
- (2) Have a qualified contractor repair or replace the damaged door at the attached storage shed
- (3) The crawlspace door does not fit well, leaving gaps around its perimeter. This can allow pest intrusion. Have a qualified contractor correct as needed.
- (4) The storm door strike needs adjustment. It does not keep the door latched closed. Have a qualified person adjust or repair as needed.
- (5) I was unable to access the attached storage room at the left rear corner. It's possible that hidden defects exist. Recommend evaluating further when access can be obtained.

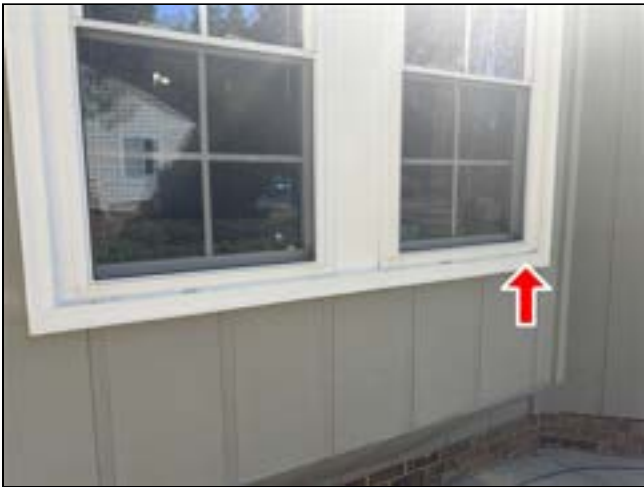
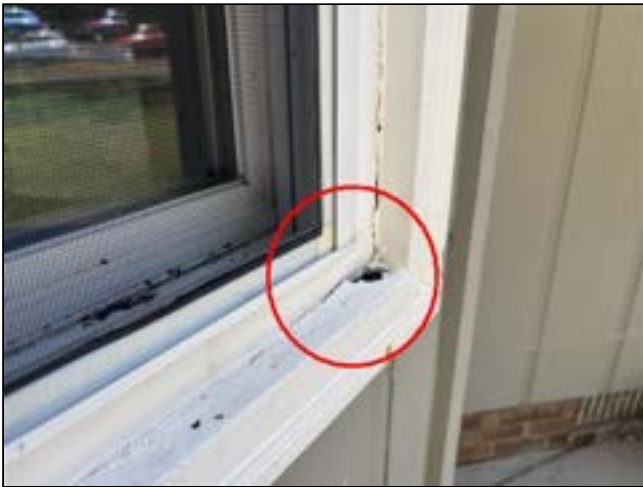
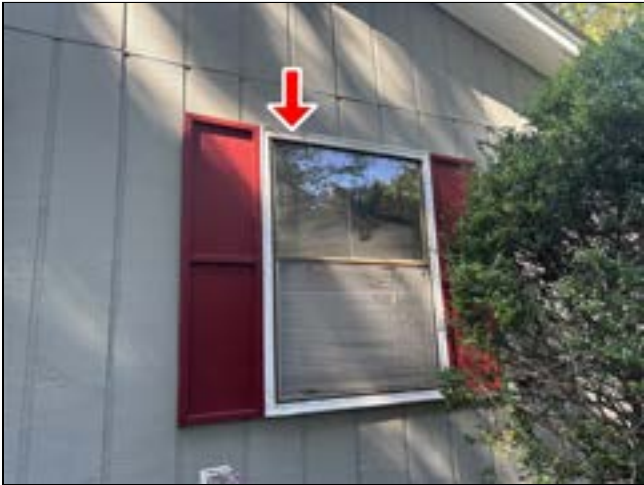
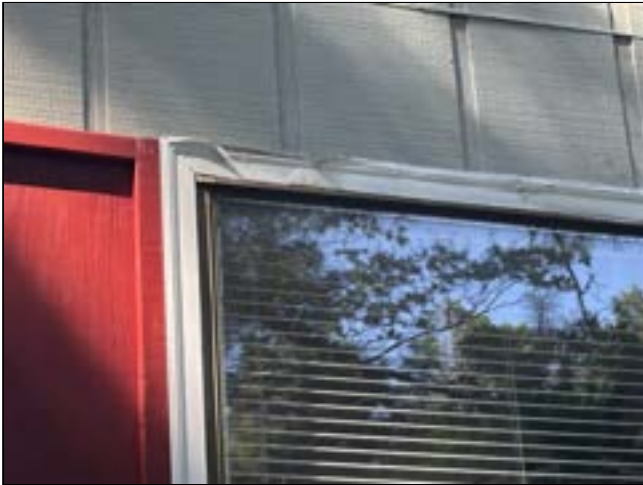
2.2 Item 1 (Picture)

- (1) Some windows have deterioration at the sill and trim. Have a qualified contractor repair and paint as needed to prevent water intrusion and/or further damage.
- (2) Some screens are installed and some are not, and there is minor damage in areas. These are not required so I recommend repair or replace as desired

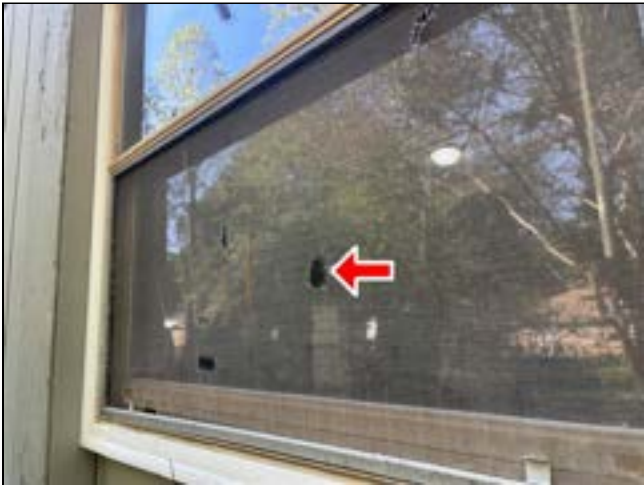
2.2 Item 5 (Picture) Some screens are installed and some are not, and there is minor damage in areas. These are not required so I recommend repair or replace as desired

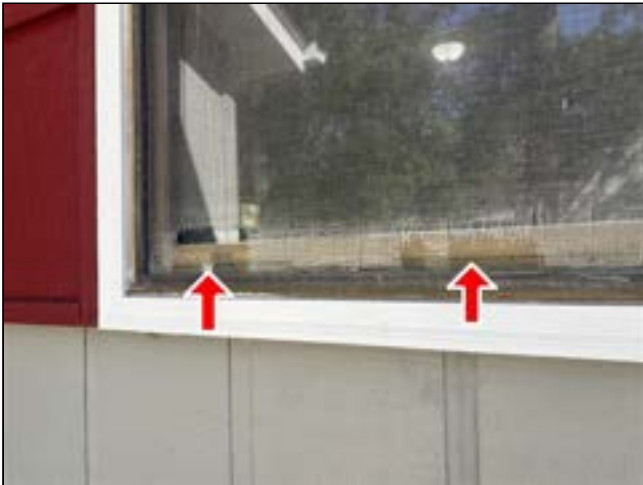
2.2 Item 6 (Picture) Some screens are installed and some are not, and there is minor damage in areas. These are not required so I recommend repair or replace as desired

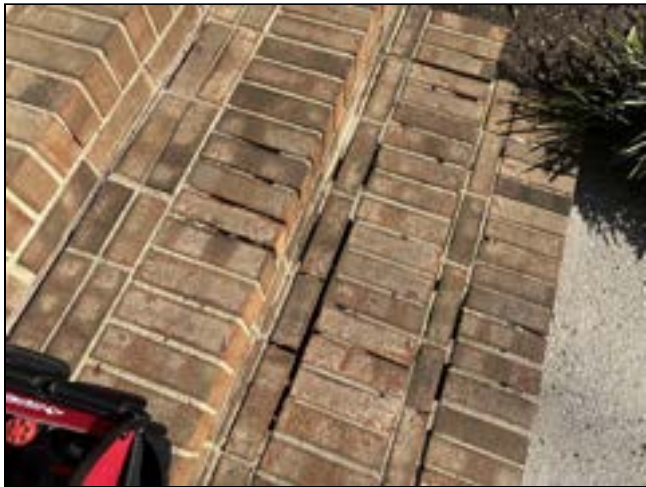
2.3 Item 1 (Picture)

- (1) Some of the bricks at the front porch have deteriorated mortar joints. I recommend having a brick mason re-point the joints to restore structural integrity and prevent further deterioration.
- (2) Be advised that uneven risers are a potential trip hazard. Correction is recommended for safety.

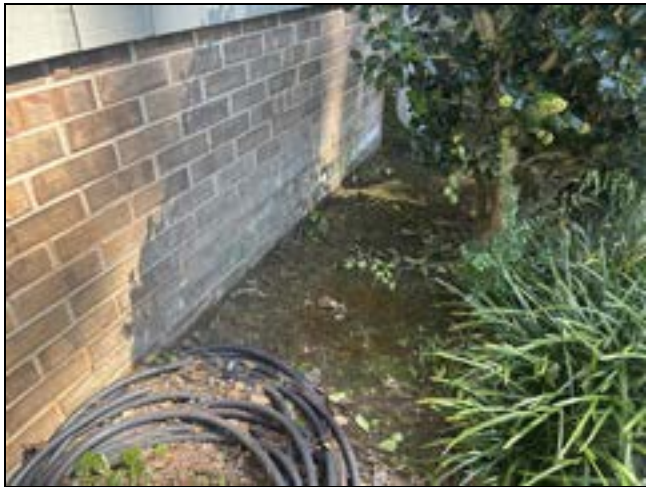
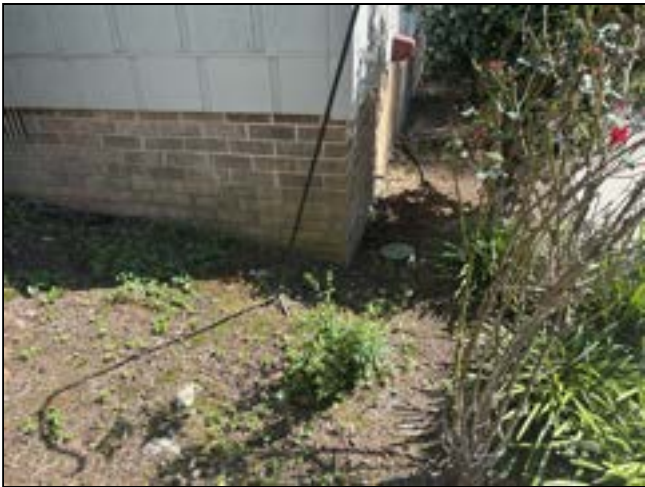
2.4 Item 1 (Picture)

- (1) There is some negative grade or "low spots" at areas around the perimeter of the foundation. The ground appears to slope toward the house. This can allow water to collect against the foundation, potentially leading to excessive water intrusion and foundation problems. Have a qualified contractor evaluate and correct as needed to help divert water away from the building.
- (2) It is recommended that the tree limbs in contact with or hanging near the roof be trimmed to help prevent damage, debris, pests from gaining access, etc.
- (3) Be aware of potential trip hazards at the walkway(s). Correction is recommended for safety

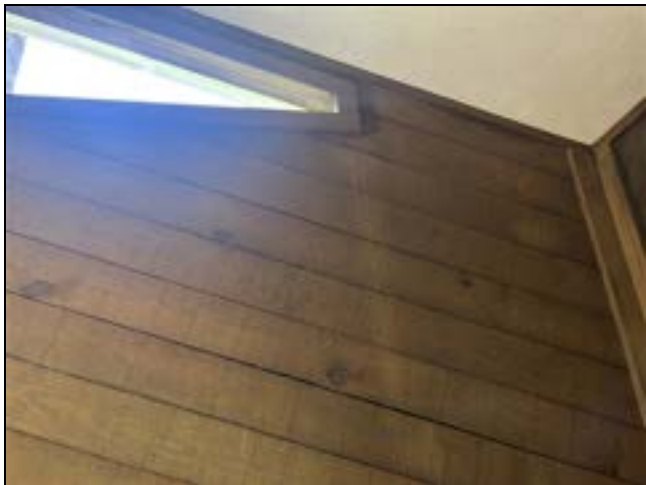
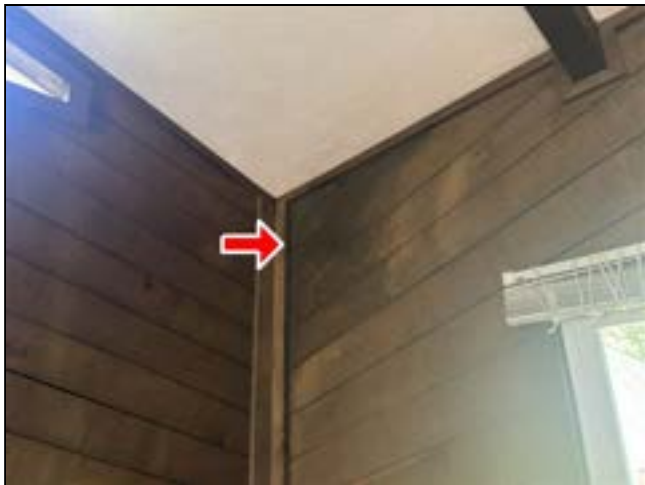
4.1 Item 1 (Picture)

- (1) Signs of water intrusion were observed at the den walls (staining and streaking). This could be from power washing or there may be other causes. Have a qualified contractor evaluate and repair all as needed
- (2) Some typical cosmetic flaws were present in areas. These are not related to functional defects so I recommend repair as desired (minor cracking from truss uplift are unsightly but are not concerning unless there are related structural deficiencies, but no significant movement was apparent)

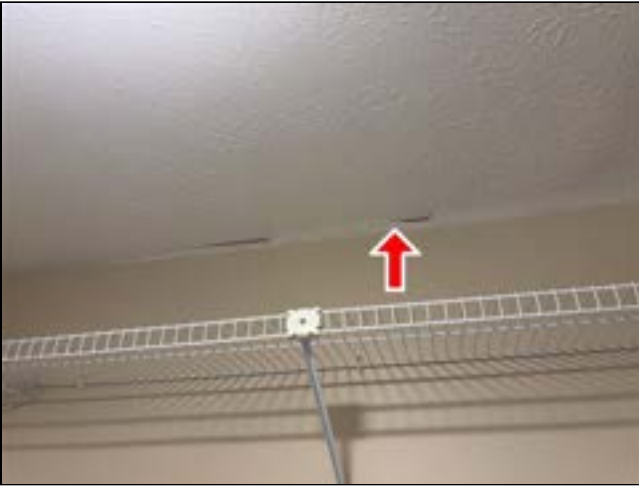
4.1 Item 3 (Picture) Some typical cosmetic flaws were present in areas. These are not related to functional defects so I recommend repair as desired (minor cracking from truss uplift are unsightly but are not concerning unless there are related structural deficiencies, but no significant movement was apparent)

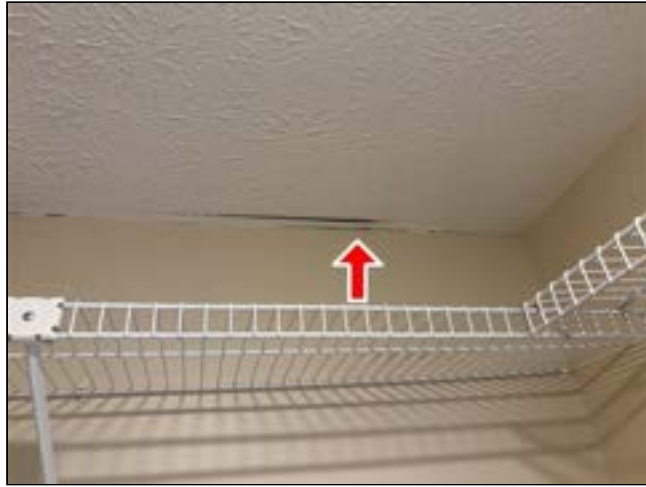
4.1 Item 4 (Picture) Some typical cosmetic flaws were present in areas. These are not related to functional defects so I recommend repair as desired (minor cracking from truss uplift are unsightly but are not concerning unless there are related structural deficiencies, but no significant movement was apparent)

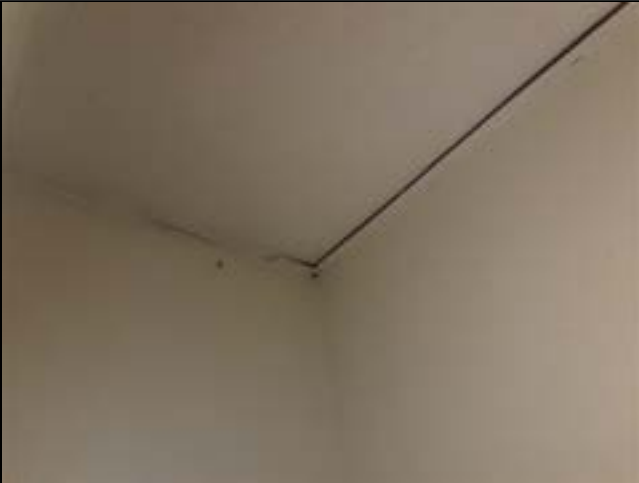
4.1 Item 5 (Picture) Some typical cosmetic flaws were present in areas. These are not related to functional defects so I recommend repair as desired (minor cracking from truss uplift are unsightly but are not concerning unless there are related structural deficiencies, but no significant movement was apparent)

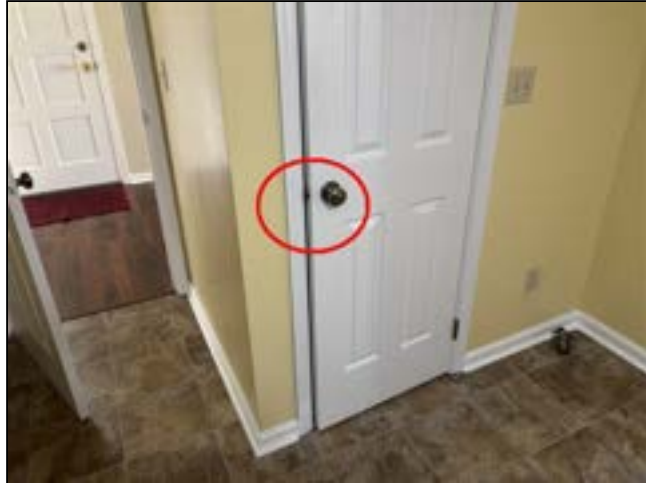
4.5 Item 1 (Picture)

The pantry door needs adjustment. The strike does not keep the door latched closed. Have a qualified person adjust or repair as needed.

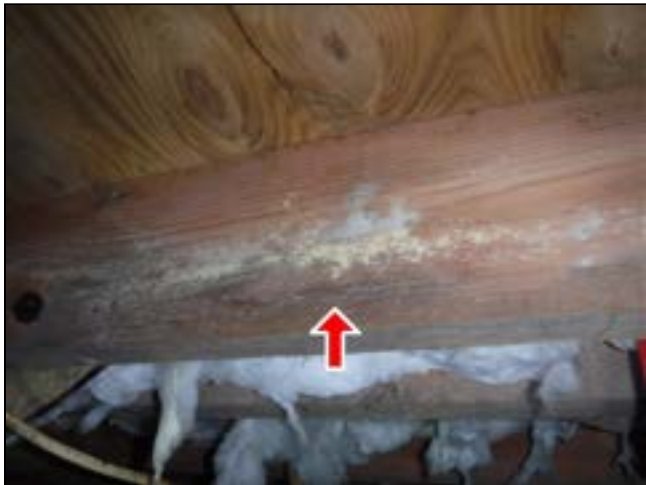
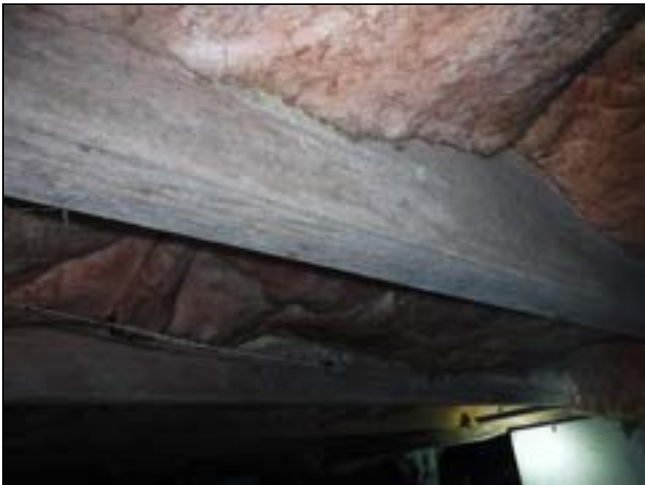
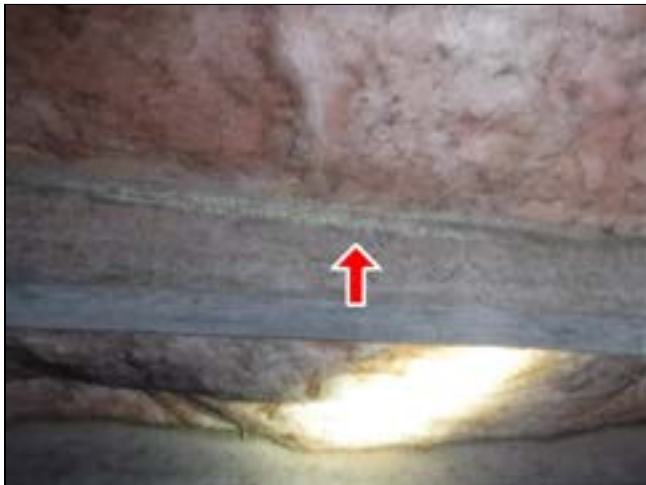
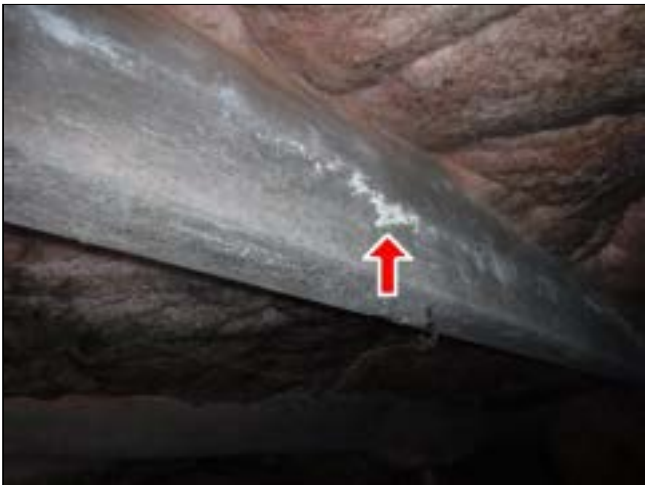
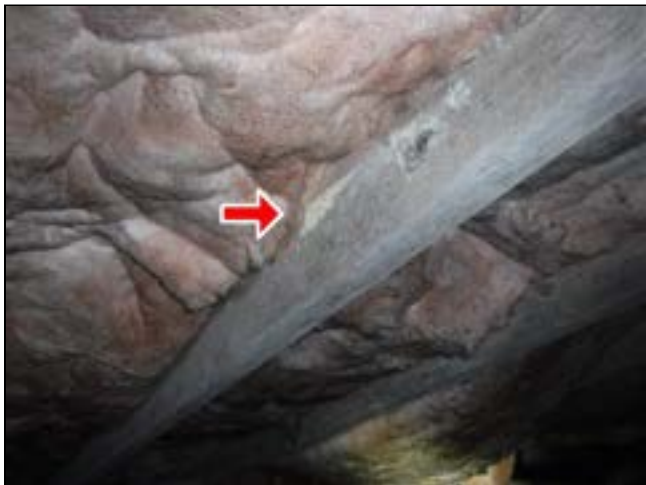
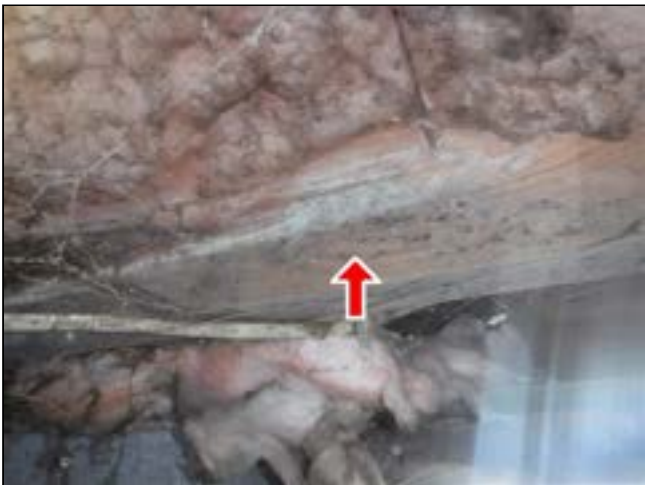
5.0 Item 1 (Picture)

(1) Not all areas were visible or accessible but no signs of significant deficiencies were apparent, it's possible that hidden defects exist that could not be observed during a non-invasive visual inspection.

(2) There are areas at the roof sheathing/rafters that show signs of previous water intrusion/moisture stains (likely from before the roof covering was replaced). I did not observe signs of an active leak and no significant structural damage was observed. I recommend monitoring periodically during heavy rainfall to ensure no leaks or further damage occurs.

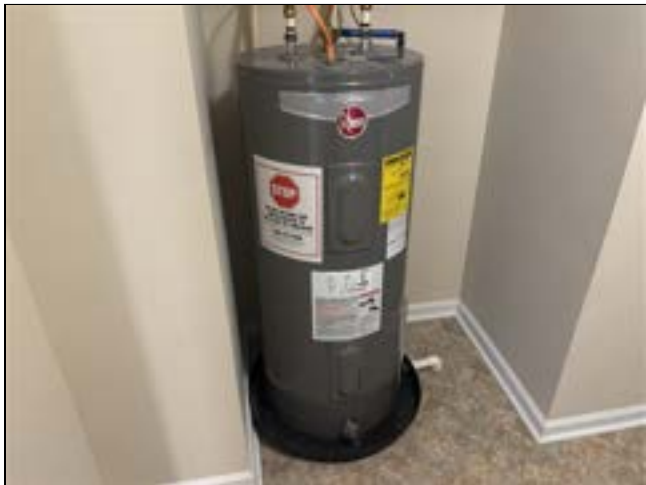
6.2 Item 4 (Picture) Water heater reference

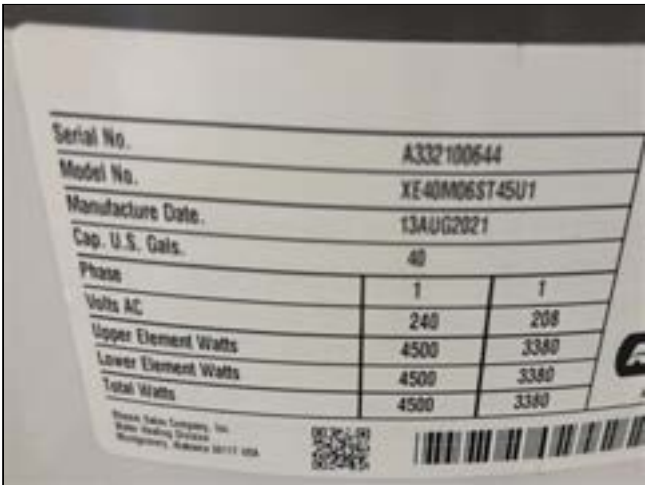
6.2 Item 5 (Picture) Water heater reference

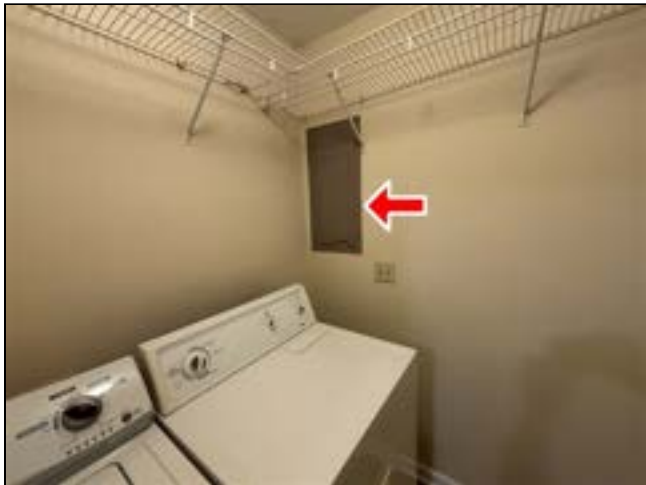
7.1 Item 3 (Picture) The main panel could not be safely accessed due to the laundry machines (we do not move large items or appliances). Be advised a 36" clearance is needed in order to safely remove a panel cover. I recommend having a qualified electrician evaluate further when safe access can be obtained

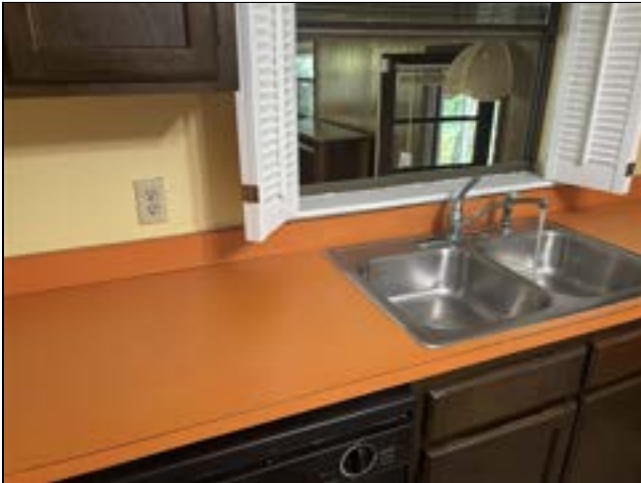
7.4 Item 1 (Picture) All kitchen receptacles serving countertops should be GFCI protected and are not (regardless of proximity to sink). While this was not required when the house was built, it is a potential safety hazard. I recommend having a qualified electrician correct as a safety upgrade.

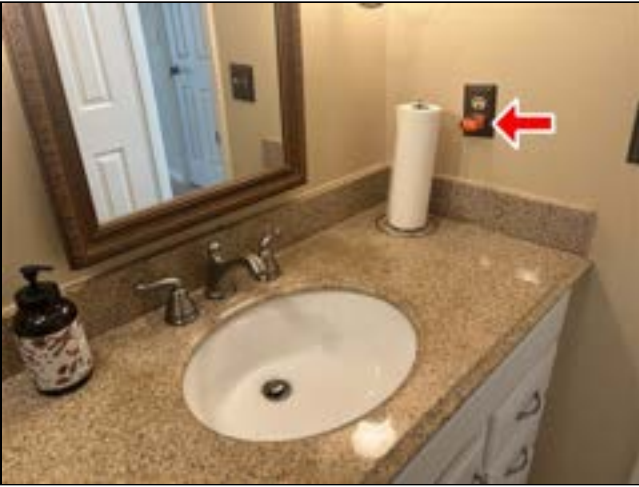
7.4 Item 3 (Picture) All bath receptacles should be GFCI protected and are not. While this may not have been required when the house was built, it is a potential safety hazard. I recommend having a qualified electrician correct as a safety upgrade.

(3) All bath receptacles should be GFCI protected and are not. While this may not have been required when the house was built, it is a potential safety hazard. I recommend having a qualified electrician correct as a safety upgrade.

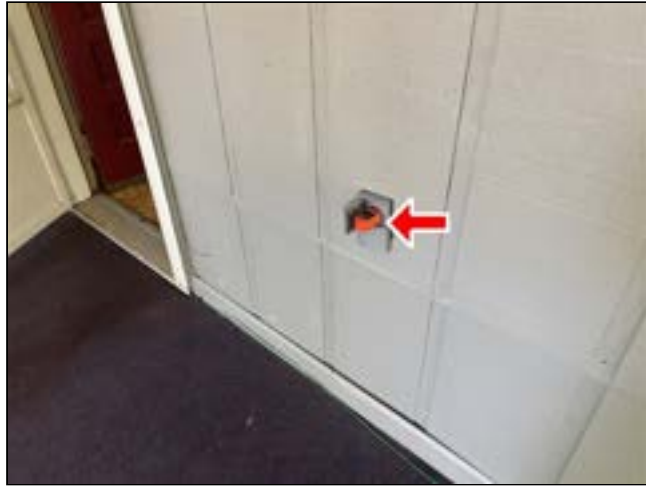
7.4 Item 4 (Picture) All exterior receptacles should be GFCI protected and are not. While this was not required when the house was built, it is a potential safety hazard. I recommend having a qualified electrician correct as a safety upgrade.

(4) All exterior receptacles should be GFCI protected and are not. While this was not required when the house was built, it is a potential safety hazard. I recommend having a qualified electrician correct as a safety upgrade.

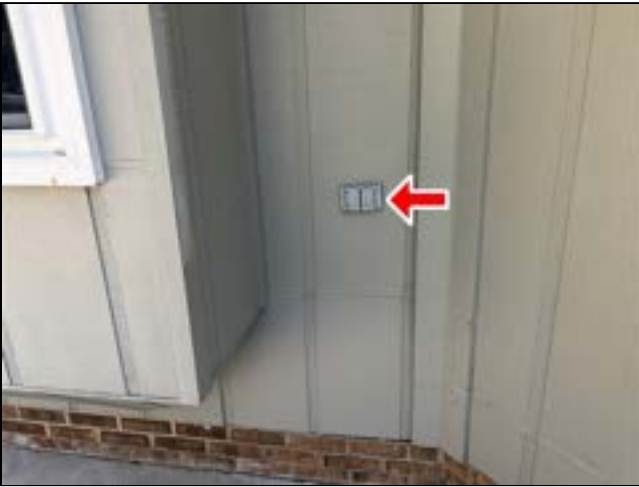
7.4 Item 5 (Picture) All exterior receptacles should be GFCI protected and are not. While this was not required when the house was built, it is a potential safety hazard. I recommend having a qualified electrician correct as a safety upgrade.

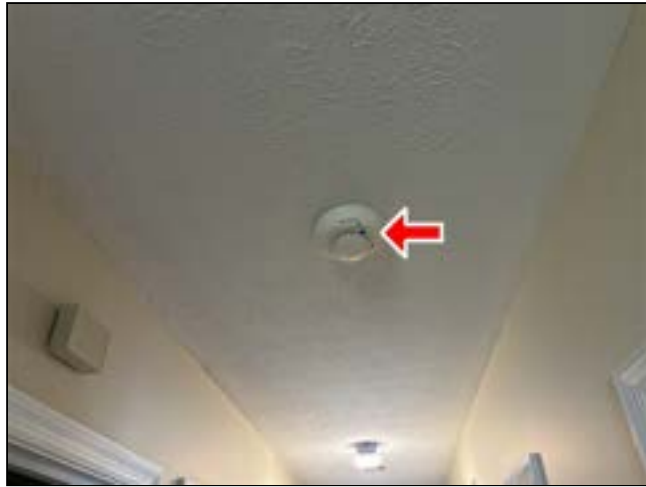
7.8 Item 1 (Picture) be sure to test/replace detectors regularly

We do not test smoke detectors. Periodic testing and/or replacement of the smoke detectors is recommended. Refer to [www.nfpa.org](http://www.nfpa.org) for details. Additional detectors may be needed.

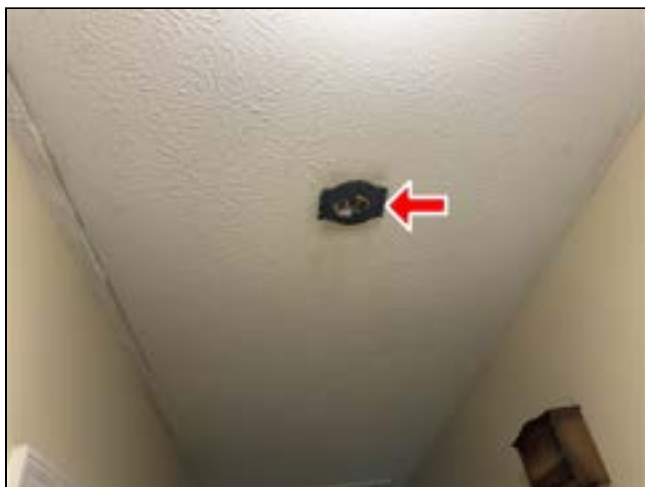
**7.8 Item 2 (Picture) be sure to test/replace detectors regularly**

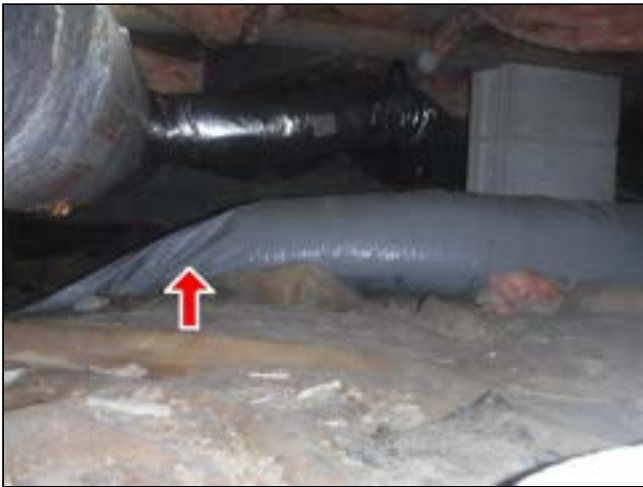
8.3 Item 1 (Picture)

(1) One of the supply ducts in the crawlspace is detached from the trunk line and register. Have a qualified HVAC contractor repair as needed to prevent energy loss or pest intrusion

(2) There is missing, damaged, or displaced insulation at the ductwork in several areas. Have a qualified contractor correct as needed to prevent energy loss or condensation.

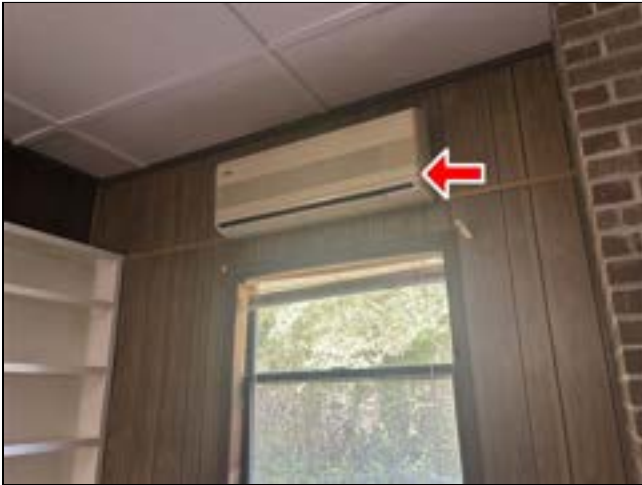
### 8.8 Item 1 (Picture)

(1) The mini-split heat pump was not operational at the time of inspection. Have a qualified HVAC tech evaluate further and repair or replace as needed

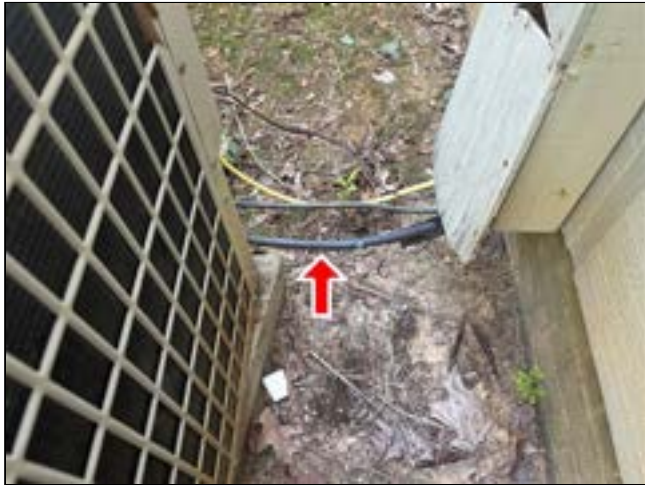
### 8.8 Item 2 (Picture)

(2) The foam sleeve(s) on the suction line(s) is missing or deteriorated in areas. This can cause energy loss and excessive condensation. I recommend repair or replace as needed.

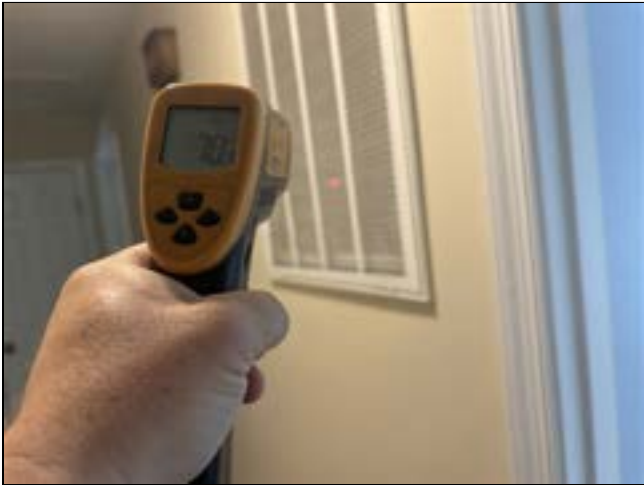
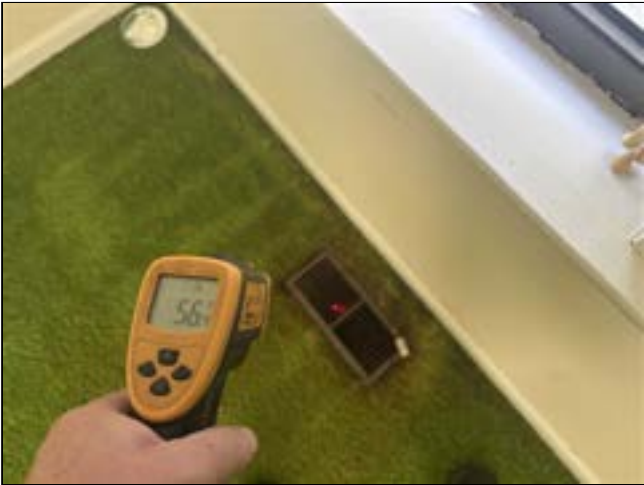
A 14° differential was observed during cooling mode. Readings between 12 and 20° are acceptable. This is a sign that the systems are cooling as designed. I recommend continuing to service and maintain at regular intervals to maximize efficiency and prolong serviceable life

8.9 Item 1 (Picture) A 14° differential was observed during cooling mode

8.9 Item 2 (Picture) A 14° differential was observed during cooling mode

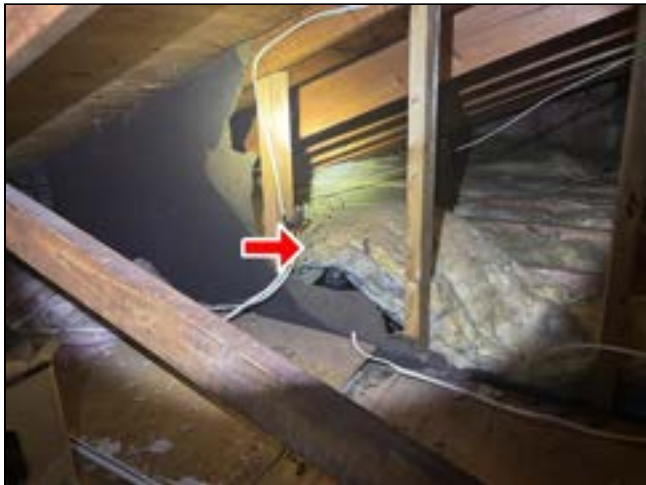
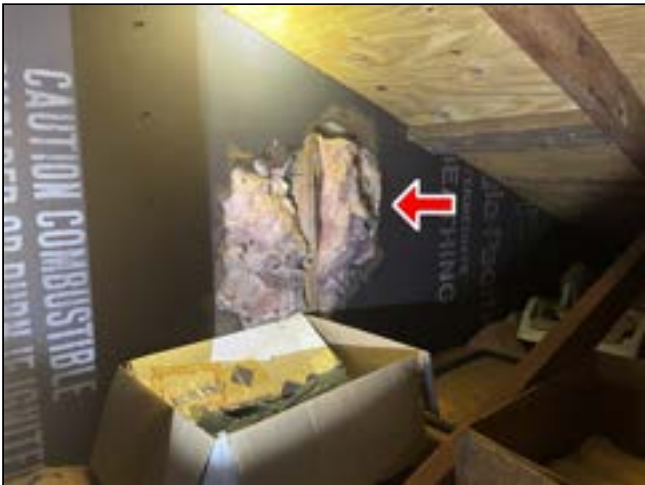
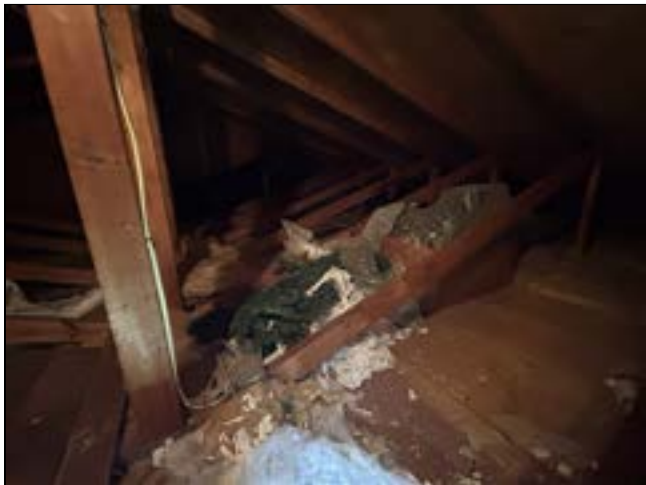
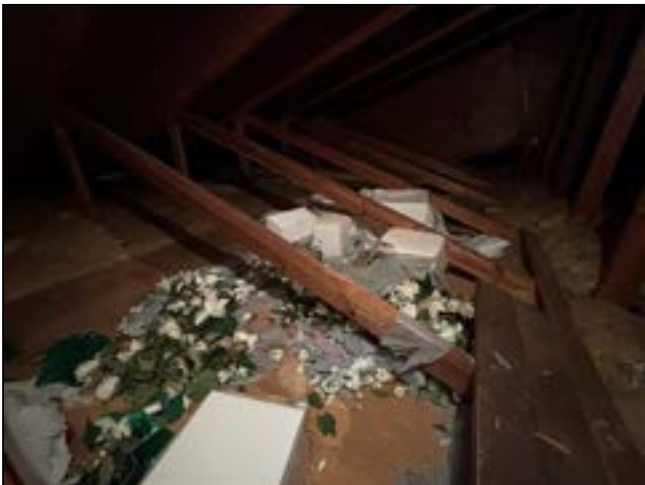
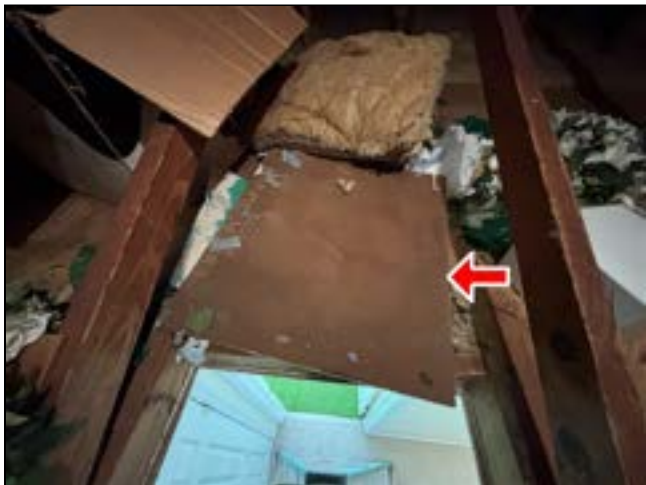
- (1) There is some missing or displaced insulation in the attic(s) and there are stored items on top, compressing it in areas. Heat loss or air transfer can occur. Have a qualified contractor correct as needed.
- (2) Insulation of the attic hatch doors to match the attic's R value is recommended to help conserve energy and prevent heat loss.

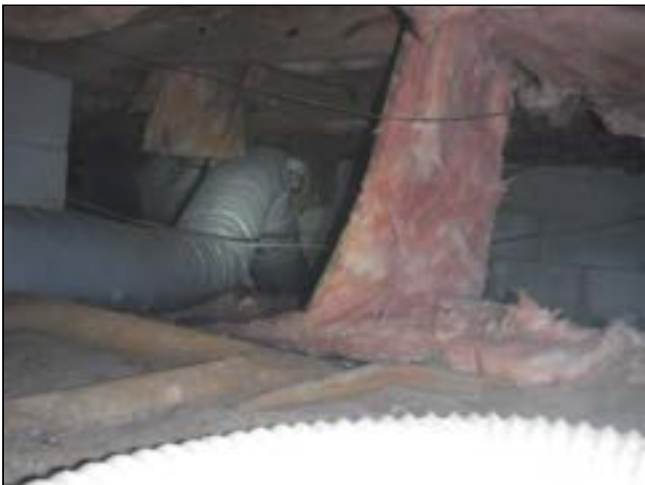
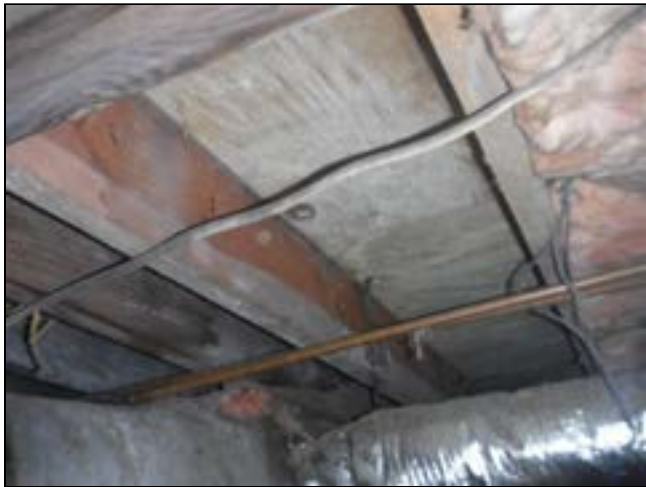
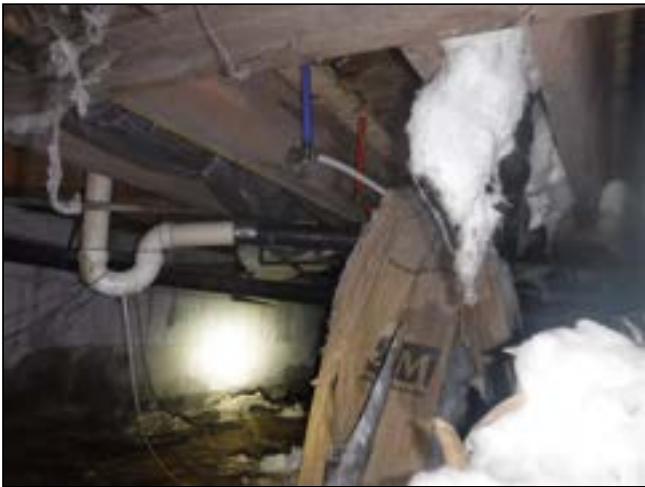
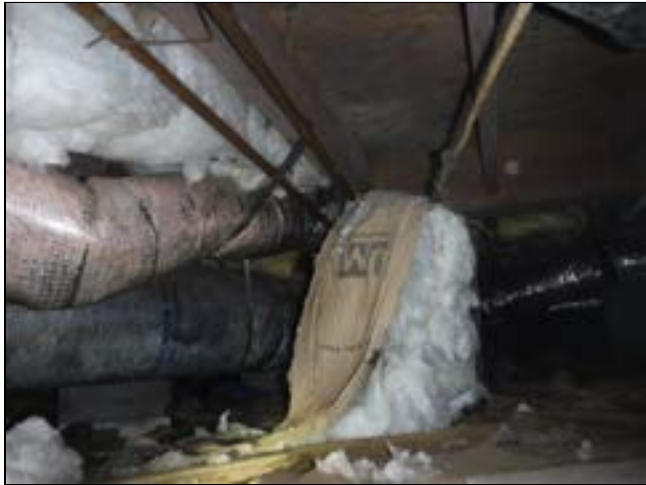
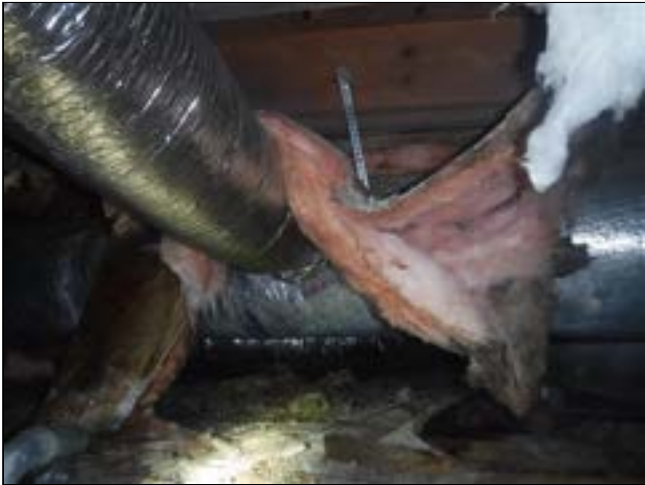
The insulation in the crawlspace is missing or displaced in several areas. Heat loss/air transfer may occur. Also, insulation that has become wet or in contact with fungal/microbial growth may need to be replaced. Have a qualified contractor correct as needed.

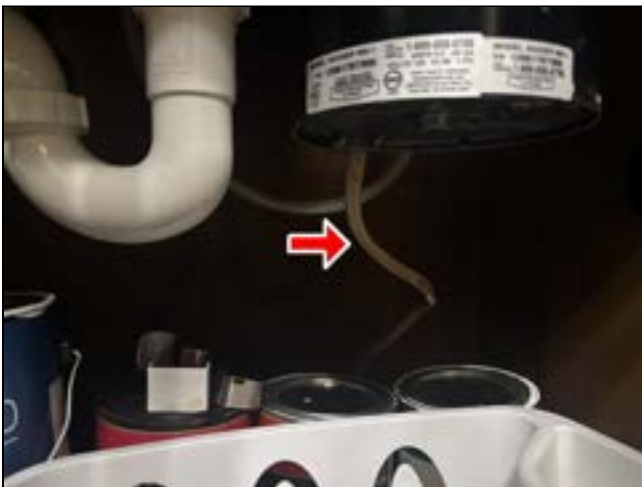
10.1 Item 1 (Picture)

(2) The disposer was very noisy. It is either damaged or has debris stuck inside. Have a qualified contractor repair or replace as needed.

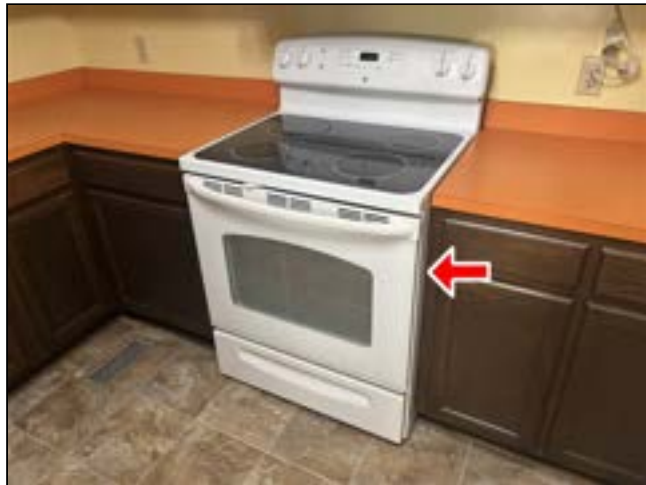
10.2 Item 1 (Picture)

There is no anti-tip device securing the range. This can be a safety hazard especially for the elderly and young children. Have a qualified contractor install an anti-tip device as recommended for safety.

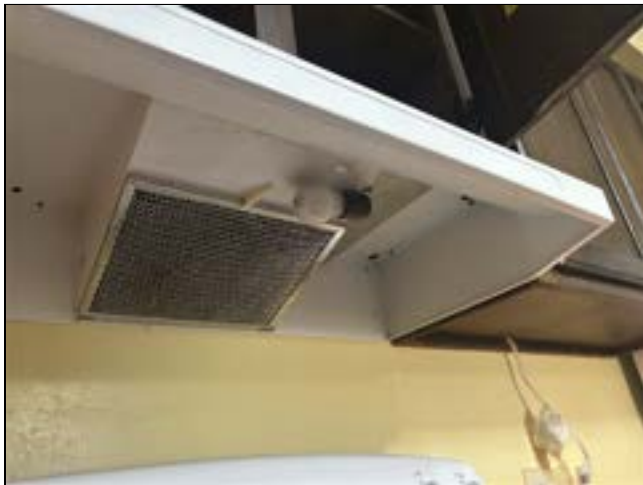
10.4 Item 1 (Picture)

The light bulb for fan did not work when tested. I recommend repair or replace as needed.

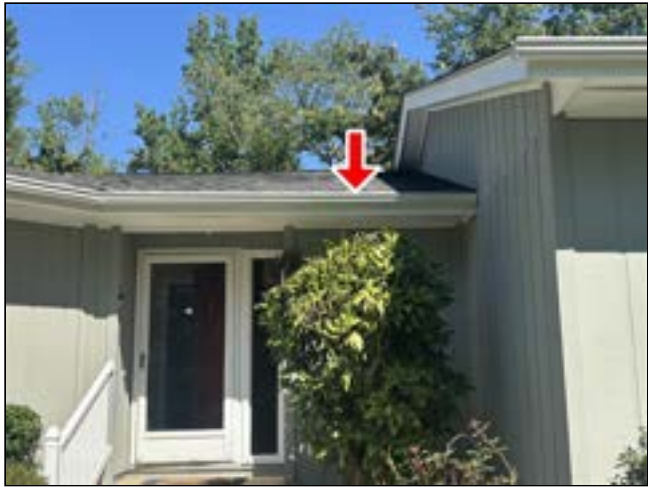
1.3 Item 1 (Picture)

(1) The gutters sag or slope away from downspouts in areas. Have a qualified contractor correct as needed to ensure water drains away from the home as intended

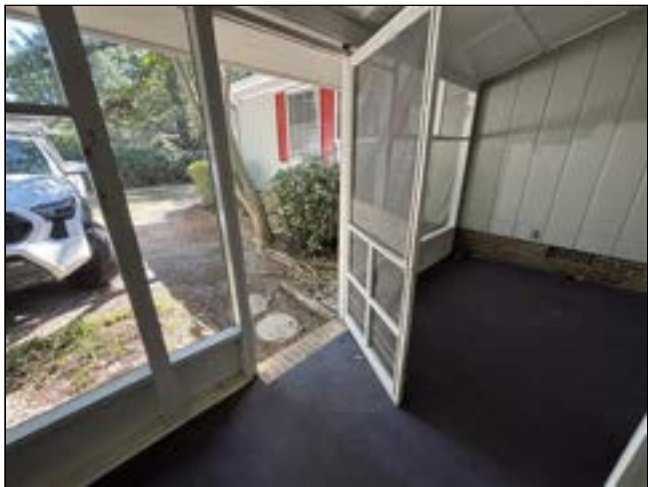
2.1 Item 1 (Picture)

(1) I recommend adjusting the screen door so it doesn't drag on the floor

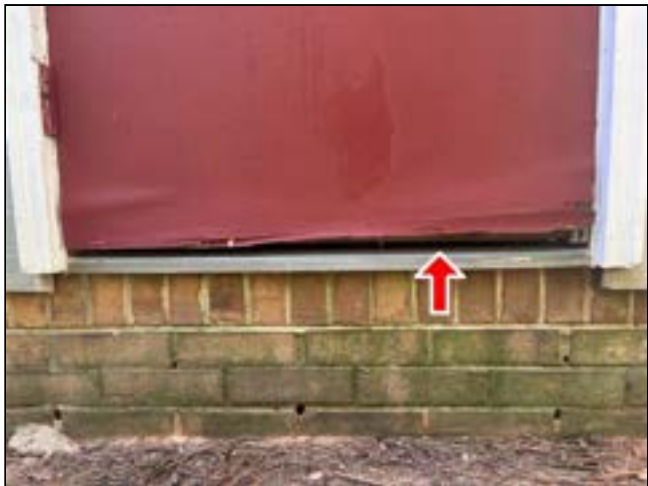
2.1 Item 3 (Picture)

(2) Have a qualified contractor repair or replace the damaged door at the attached storage shed

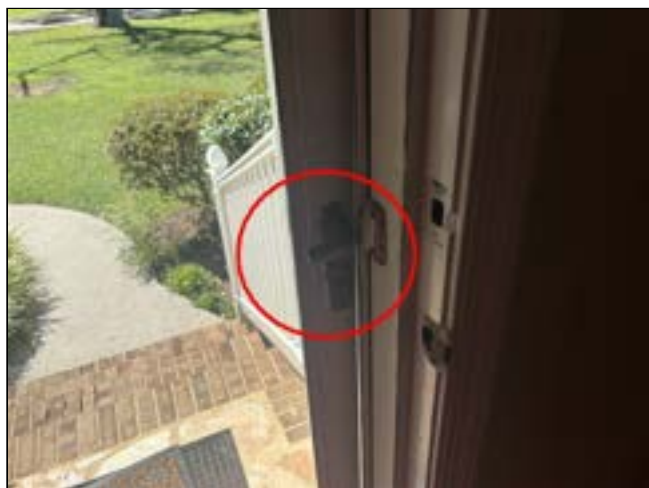
2.1 Item 5 (Picture)

(4) The storm door strike needs adjustment. It does not keep the door latched closed. Have a qualified person adjust or repair as needed.

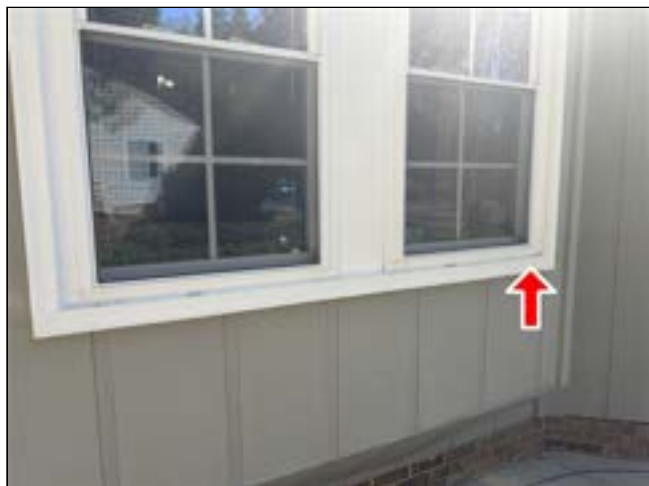
2.2 Item 1 (Picture)

(1) Some windows have deterioration at the sill and trim. Have a qualified contractor repair and paint as needed to prevent water intrusion and/or further damage.

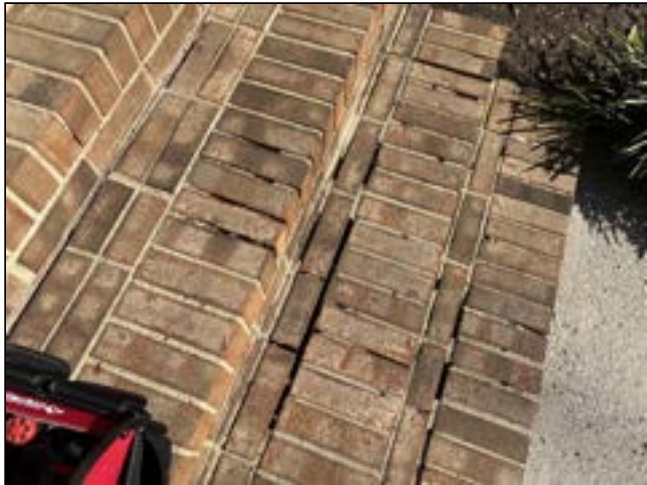
2.3 Item 1 (Picture)

(1) Some of the bricks at the front porch have deteriorated mortar joints. I recommend having a brick mason re-point the joints to restore structural integrity and prevent further deterioration.

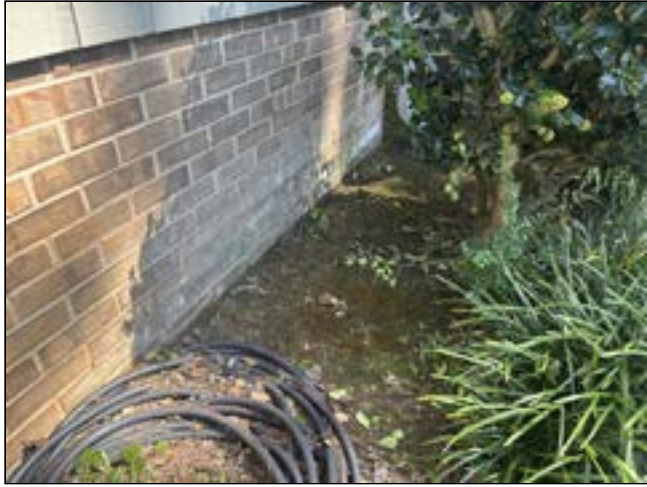
2.4 Item 1 (Picture)

(1) There is some negative grade or "low spots" at areas around the perimeter of the foundation. The ground appears to slope toward the house. This can allow water to collect against the foundation, potentially leading to excessive water intrusion and foundation problems. Have a qualified contractor evaluate and correct as needed to help divert water away from the building.

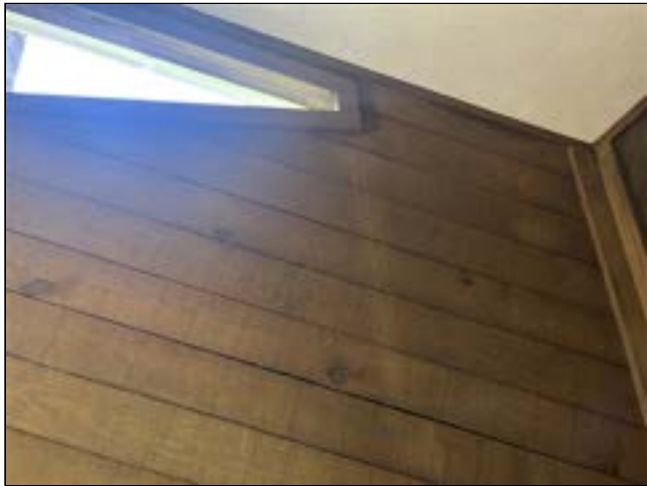
4.1 Item 1 (Picture)

(1) Signs of water intrusion were observed at the den walls (staining and streaking). This could be from power washing or there may be other causes. Have a qualified contractor evaluate and repair all as needed

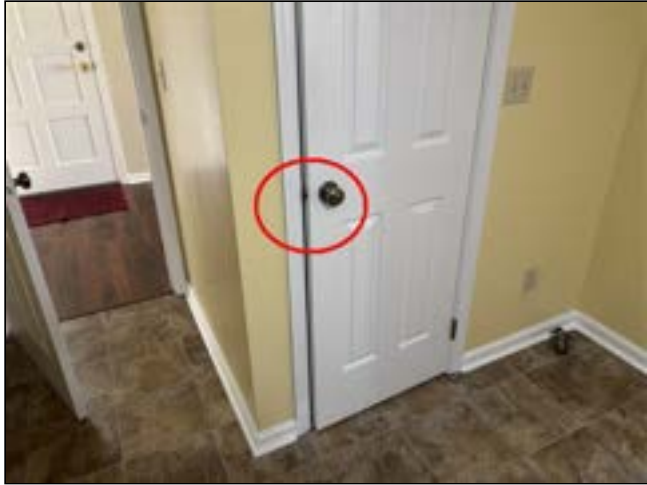
4.5 Item 1 (Picture)

The pantry door needs adjustment. The strike does not keep the door latched closed. Have a qualified person adjust or repair as needed.
