**RVA HomeSpec LLC**  
home inspections

## Inspection Report

1004 Charles St  
South Hill VA 23970

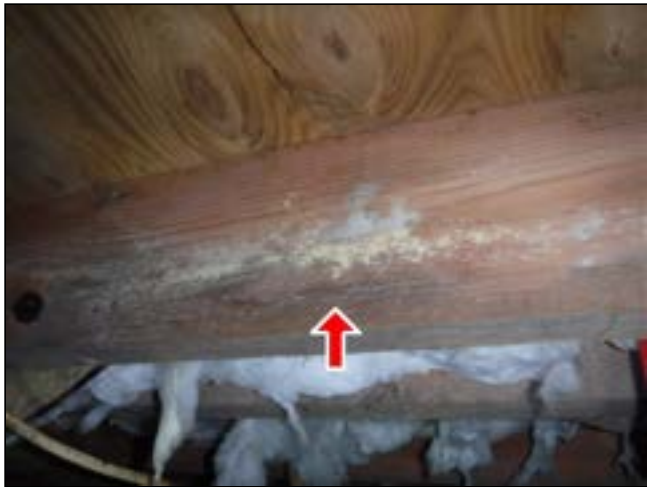
5.0 Item 1 (Picture)

(1) Signs of minor fungal/microbial growth are present on the floor system in the crawlspace in several areas. I did not inspect, test, or determine if this growth is or is not a health hazard, but correction is recommended to prevent potential worsening or structural damage. Have a qualified remediation company evaluate, remove, and clean/treat as needed.

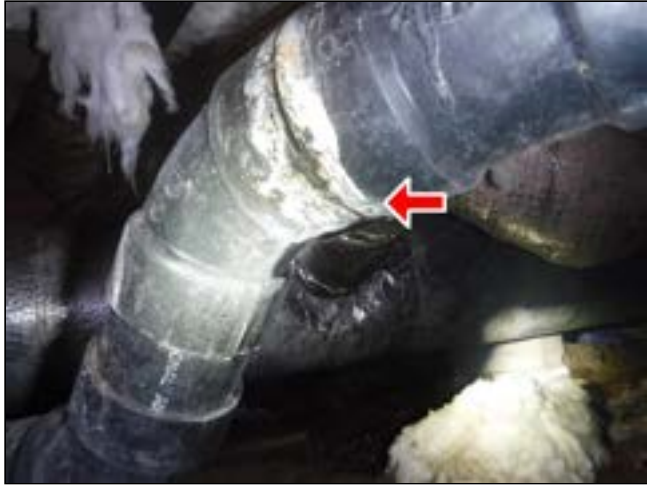
6.0 Item 1 (Picture)

(1) Active leaks were observed in the crawlspace (especially at detached drain for the en-suite bathroom shower). Have a qualified plumber evaluate and repair or replace components as needed.

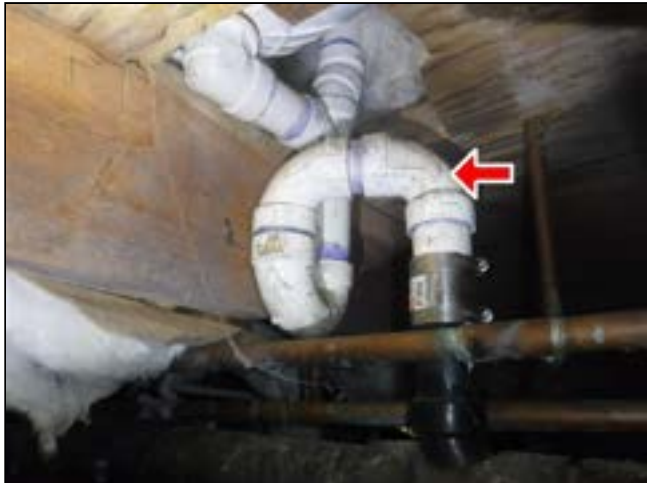
6.0 Item 5 (Picture)

(2) The S-trap configuration at the hall bathtub is no longer permitted and may cause the trap to become empty due to suction when the tub drains. An empty trap can allow sewer gases to enter the home. Have a qualified plumber correct as needed.

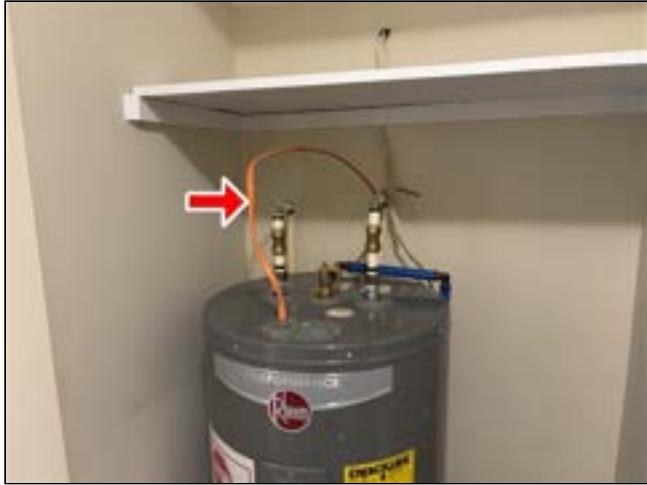
6.2 Item 1 (Picture)

(1) The wiring for the water heater is exposed. This should be inside an appropriate conduit for protection. Have a qualified electrician correct as needed for safety.

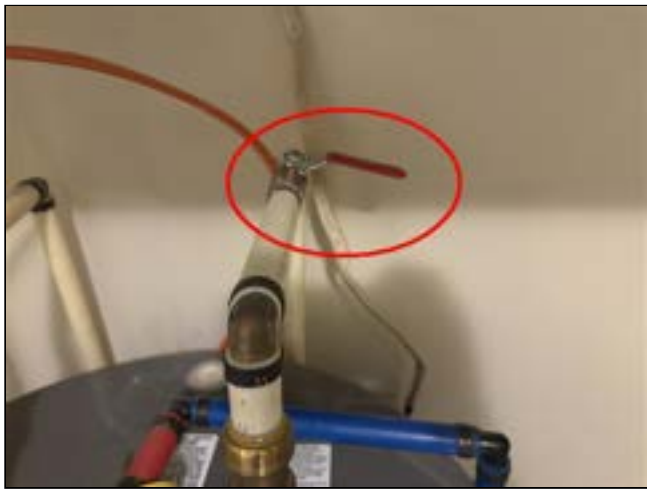
6.2 Item 2 (Picture)

(2) The water heater breaker and water supply were both found to be turned off at the time of inspection. We do not operate shutoff valves or breakers for safety/liability reasons and they may be off for a reason. The unit is newer and likely functional but this could not be verified. I recommend having a qualified person re-commission the system and evaluate further

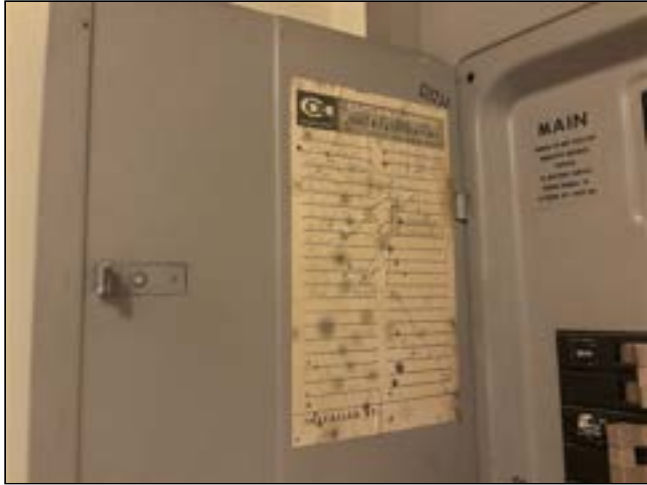
7.1 Item 1 (Picture)

(1) Some labels are present but are incomplete/illegible/confusing. Have a licensed electrician correct the labels to ensure proper circuit identification for all of the circuits.

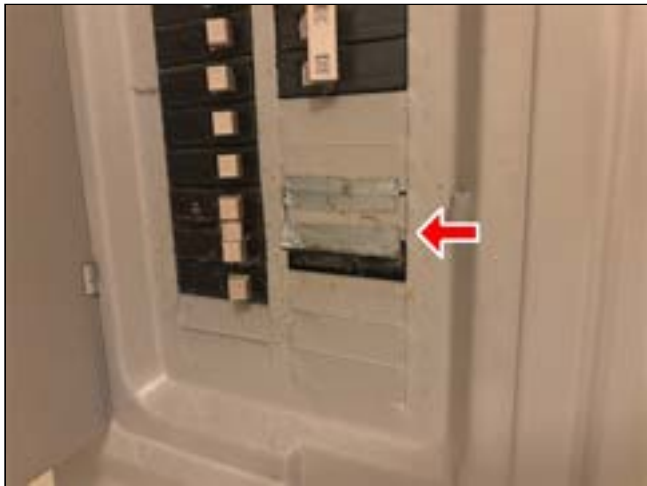
7.1 Item 2 (Picture)

(2) There are missing or incomplete knockout covers. This is a potential safety hazard. Have a qualified electrician install knockout covers for safety.

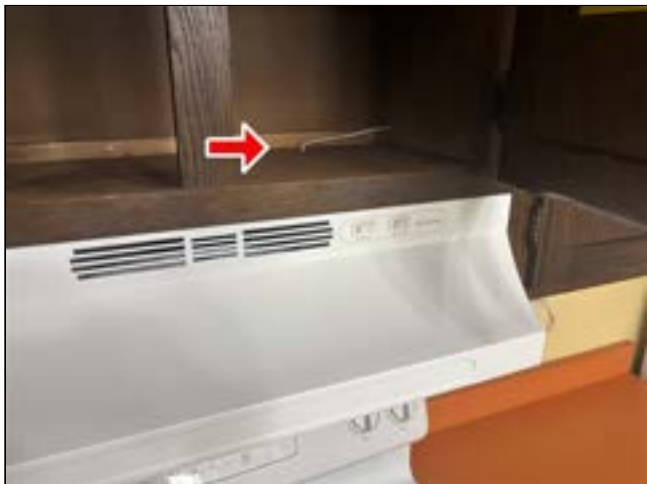
7.2 Item 1 (Picture)

(1) The range hood is hardwired using an extension cord. This is not permitted and is a safety hazard. Have an electrician correct as needed

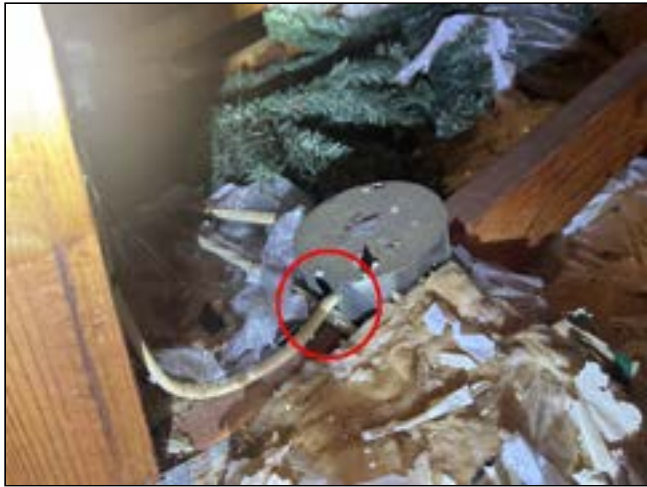
7.2 Item 3 (Picture)

(2) There are missing strain relief bushings/clamps at some junction boxes. Have a qualified electrician

correct as needed to prevent damage to the wiring or the connections inside

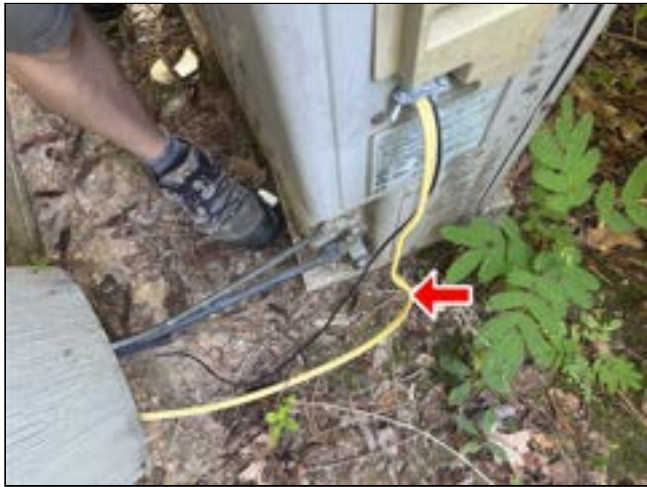
7.2 Item 4 (Picture)

(3) There is an exposed electrical wire at the outdoor mini-split unit. This should be inside an appropriate conduit or otherwise protected to prevent an electrical hazard or damage. Have a qualified electrician correct as needed.

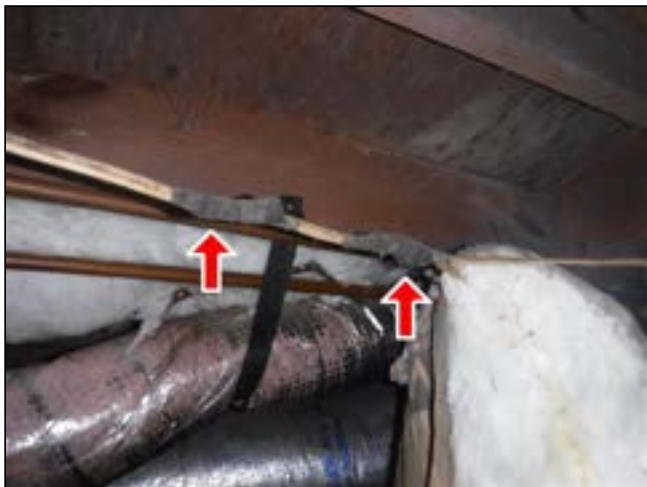
7.2 Item 5 (Picture)

(4) There are exposed or open splices in areas. These are required to be inside covered junction boxes. Have a qualified electrician correct as needed for safety.

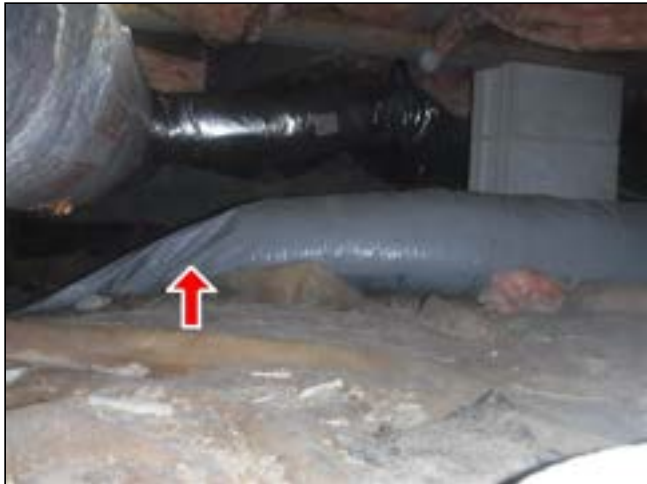
8.3 Item 1 (Picture)

(1) One of the supply ducts in the crawlspace is detached from the trunk line and register. Have a qualified HVAC contractor repair as needed to prevent energy loss or pest intrusion

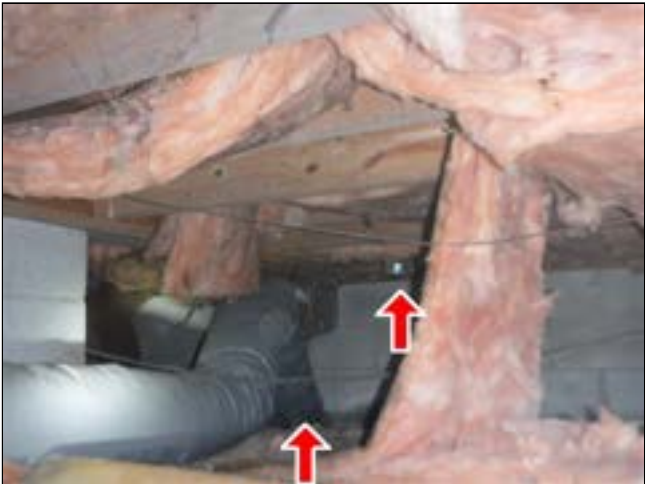
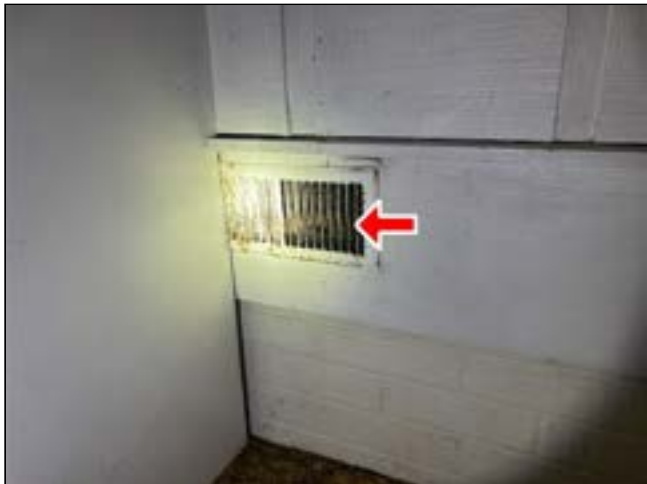
8.3 Item 3 (Picture) view of subject register from inside great room

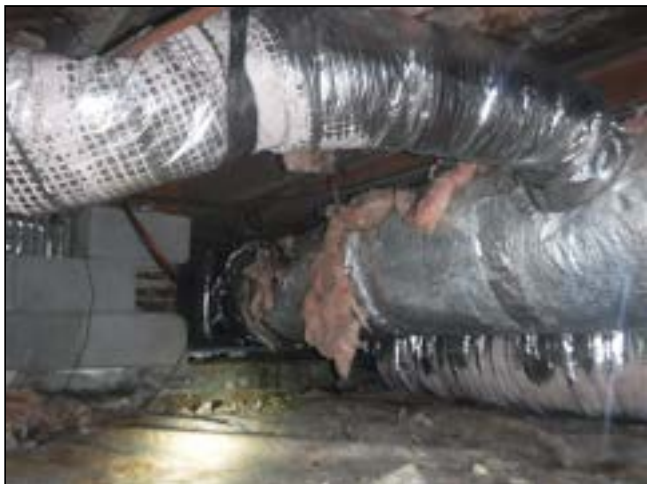
8.3 Item 4 (Picture)

(2) There is missing, damaged, or displaced insulation at the ductwork in several areas. Have a qualified contractor correct as needed to prevent energy loss or condensation.

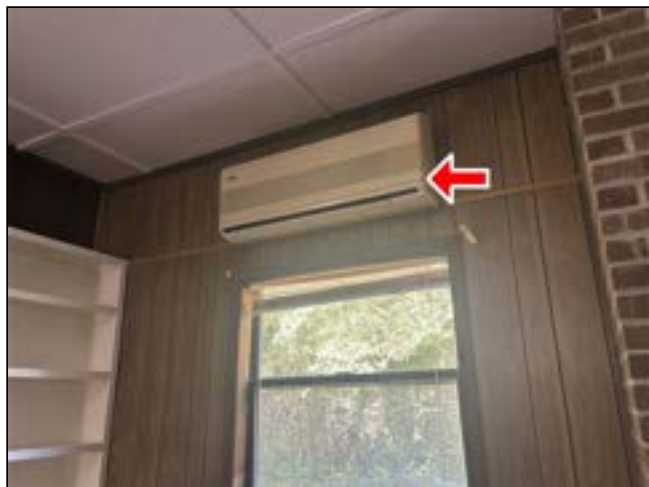
8.8 Item 1 (Picture)

(1) The mini-split heat pump was not operational at the time of inspection. Have a qualified HVAC tech evaluate further and repair or replace as needed

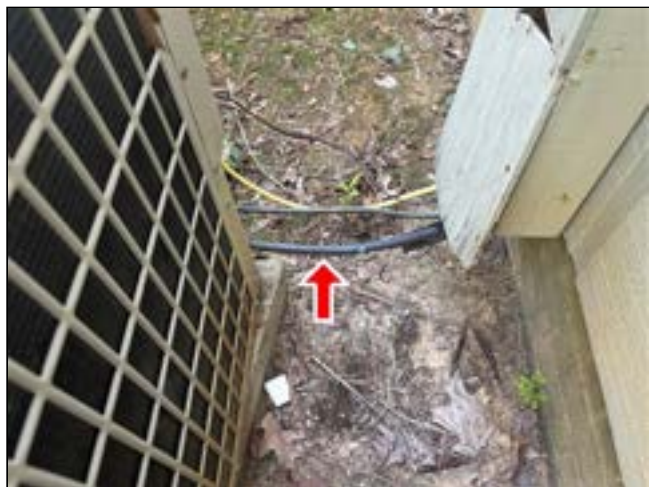
8.8 Item 2 (Picture)

(2) The foam sleeve(s) on the suction line(s) is missing or deteriorated in areas. This can cause energy loss and excessive condensation. I recommend repair or replace as needed.

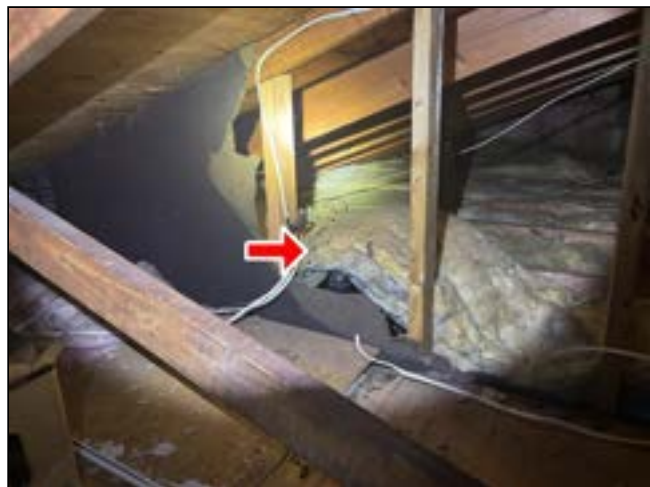
9.0 Item 1 (Picture)

(1) There is some missing or displaced insulation in the attic(s) and there are stored items on top, compressing it in areas. Heat loss or air transfer can occur. Have a qualified contractor correct as needed.

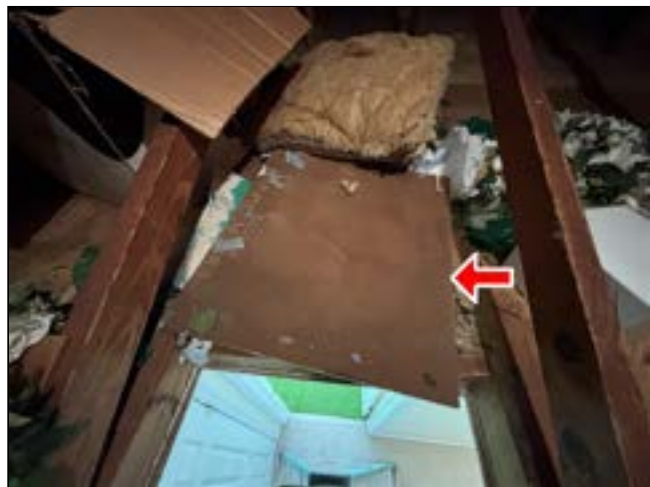
9.0 Item 5 (Picture)

(2) Insulation of the attic hatch doors to match the attic's R value is recommended to help conserve energy and prevent heat loss.

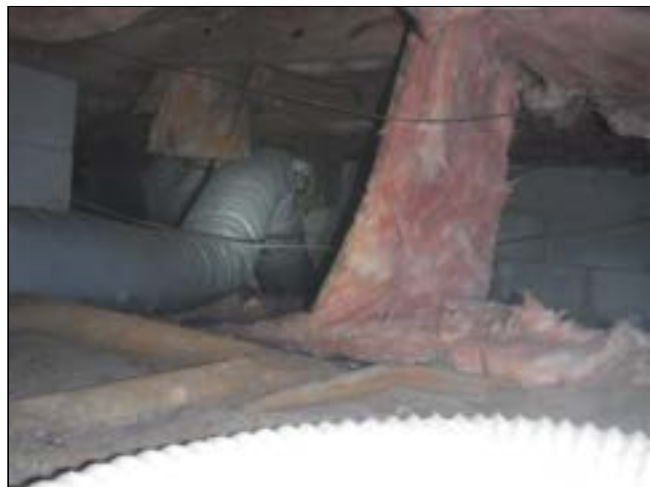
9.1 Item 1 (Picture)

The insulation in the crawlspace is missing or displaced in several areas. Heat loss/air transfer may occur. Also, insulation that has become wet or in contact with fungal/microbial growth may need to be replaced. Have a qualified contractor correct as needed.

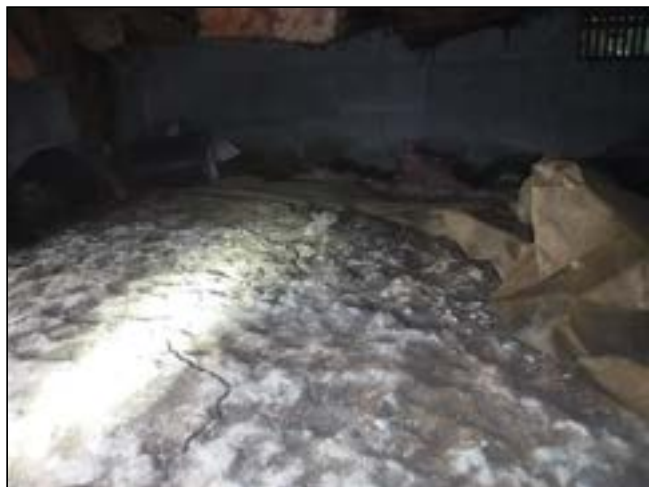
9.2 Item 1 (Picture)

The vapor barrier (plastic) on the ground in the crawlspace is missing or displaced in areas. This should completely cover the ground. A vapor barrier provides added protection to the floor system from moisture or dampness that can enter from the soil. Have a qualified contractor correct as needed.

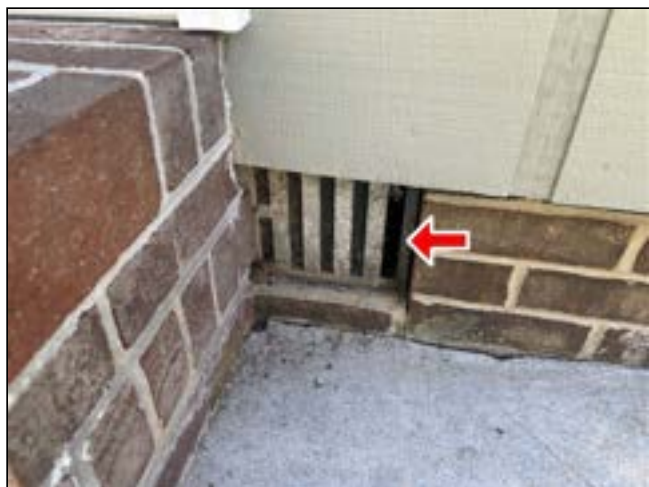
9.3 Item 1 (Picture)

(1) The mesh at the crawl vents is damaged in areas. This can allow pest intrusion. Have a qualified contractor repair as needed

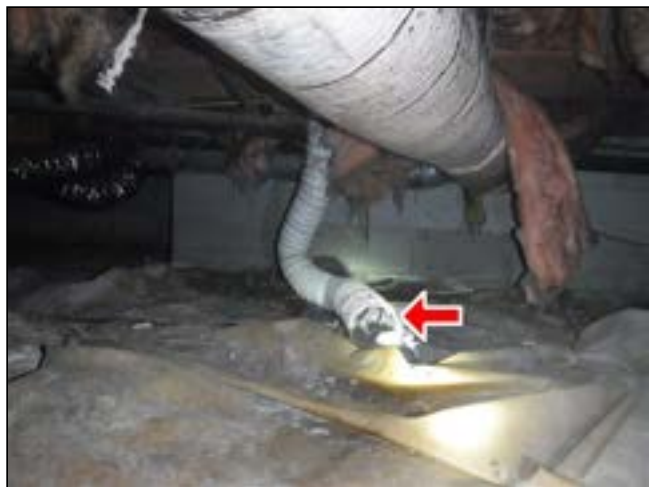
9.4 Item 1 (Picture)

(1) The flexible vinyl duct for the clothes dryer is detached and has completely deteriorated and needs to be replaced. Have a qualified contractor replace as needed to properly exhaust dryer to the outside of home.

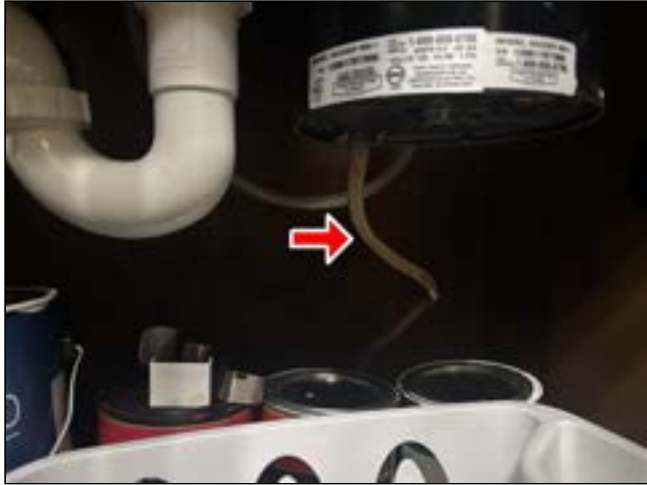
10.1 Item 1 (Picture)

(1) The wiring for the sink disposal is exposed. This should be inside an appropriate conduit for protection. Have a qualified electrician correct as needed for safety.

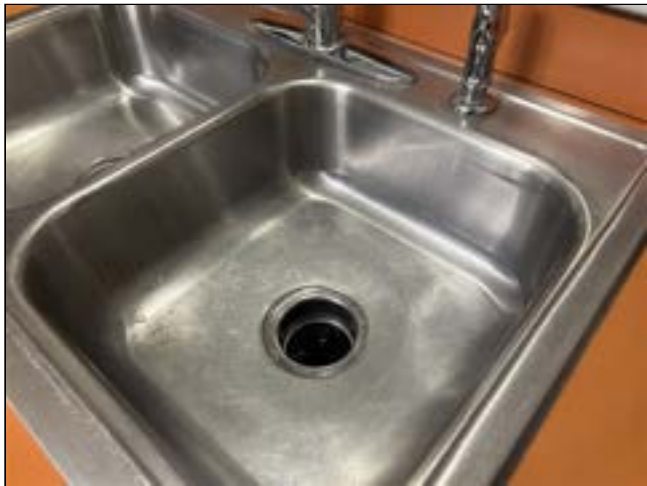
10.1 Item 2 (Picture)

(2) The disposer was very noisy. It is either damaged or has debris stuck inside. Have a qualified contractor repair or replace as needed.

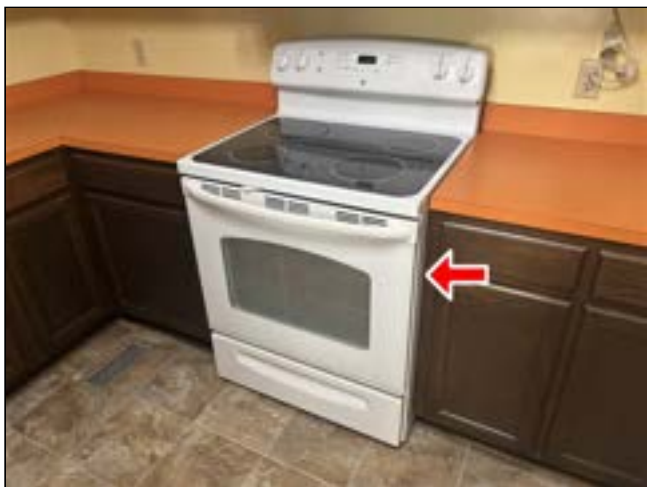
10.2 Item 1 (Picture)

There is no anti-tip device securing the range. This can be a safety hazard especially for the elderly and young children. Have a qualified contractor install an anti-tip device as recommended for safety.

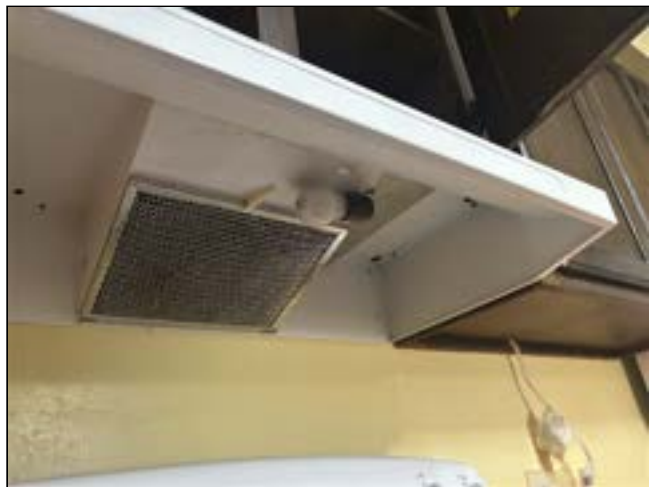
10.4 Item 1 (Picture)

The light bulb for fan did not work when tested. I recommend repair or replace as needed.
