Functional and SIR testing on the Same Assembly under Powered Conditions by Investigating Assembly Processes per IPC Std J-001H -Section 8: Cleanliness

Mike Bixenman, DBA,
Magnalytix, LLC
Nashville, TN, USA

Terry Munson
Foresite, Inc.
Kokomo, IN USA

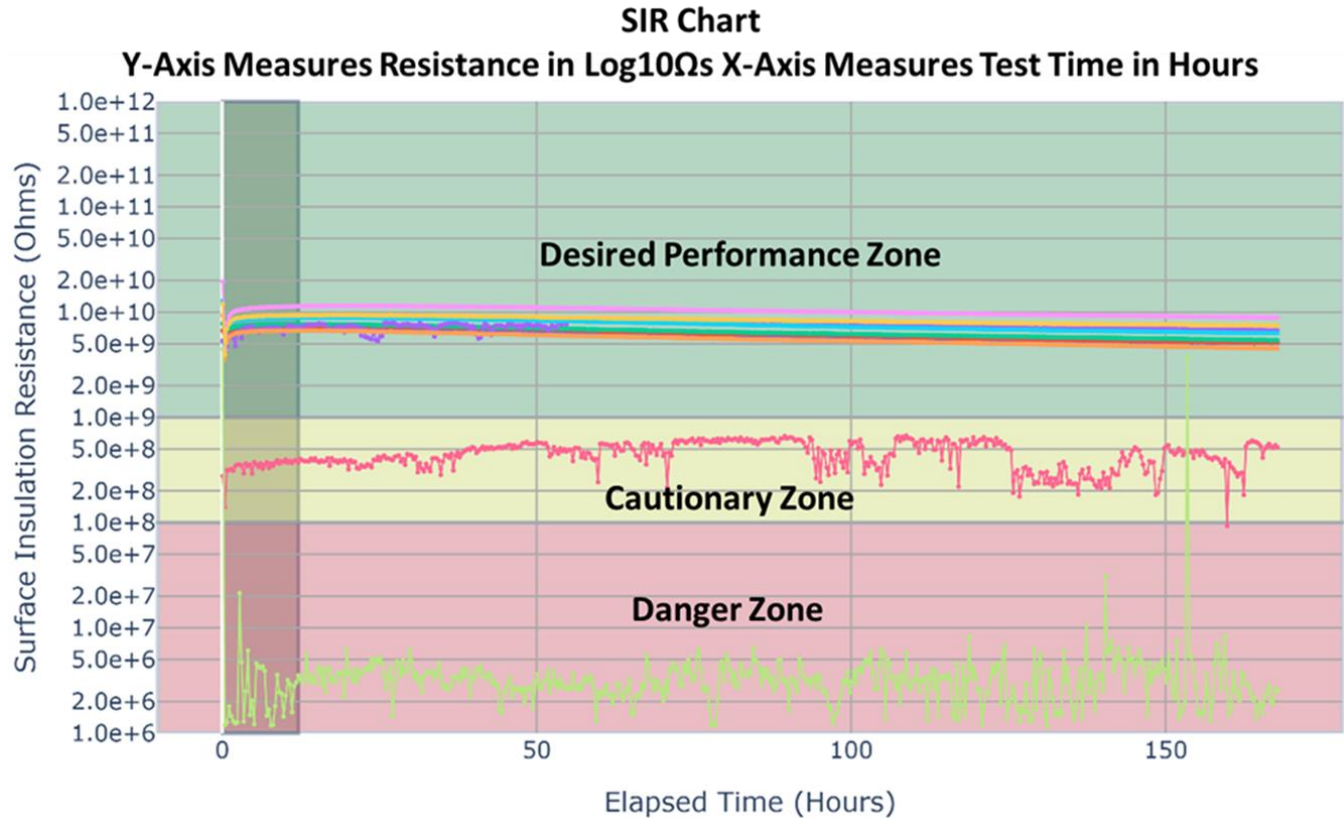
Figure 1: SIR Chart illustrating Danger, Cautionary, and Desired Performance Zones

Testing is commonly performed over 168 hours at 40°C and 90% relative humidity and biased at 5 Volts DC. A test measurement of the insulation resistance is taken every 20 minutes. Insulation Resistance is charted in $\text{Log}_{10}\Omega\text{s}$ on the Y-Axis. Time in hours was charted on the X-Axis. The chart below is divided into three zones:

1. Desirable Performance Range: Green Passing
2. Cautionary Performance Range: Yellow – Passing
3. Danger Zone: Red - Fail

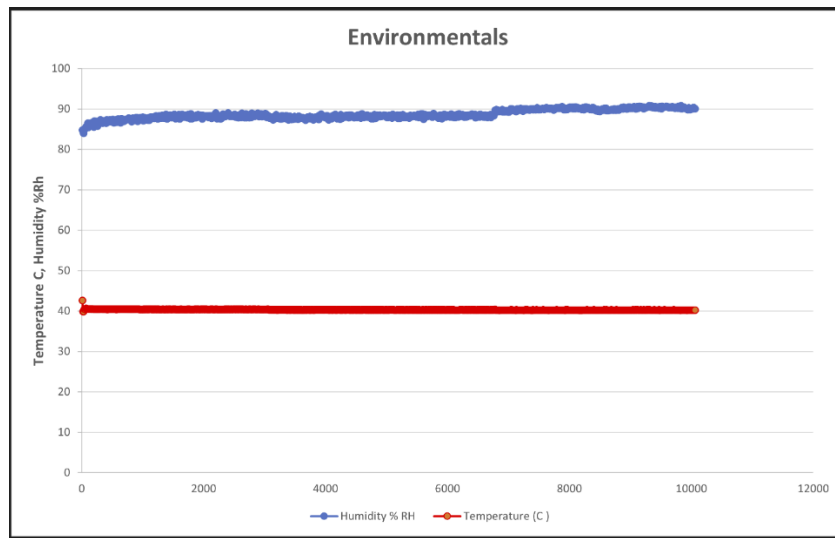
Figure 7: Environmental Conditions over the Testing Period

Four Test Boards were assembled with a ROL0 Low Residue No-Clean SAC 305 Solder Paste. The test boards were *not* cleaned after assembly. The test boards were hooked up to the Functional / SIR Test instrument. The test boards were placed into an environmental chamber at 40°C / 90% Relative Humidity / 5 Volts Bias / 10-minute measurement cycle. The temperature and humidity were charted from sensors placed on the test boards.

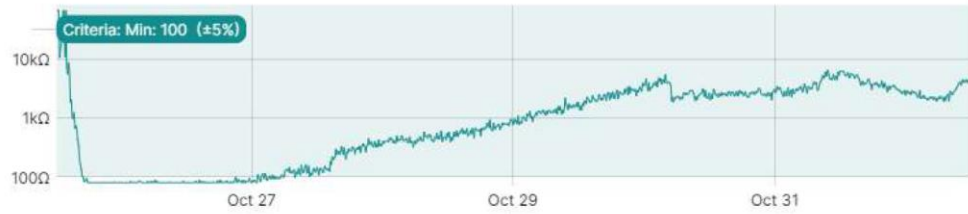
Figure 9: J1 Connector Front Side

The J1 main connector failed SIR testing. This indicates the selective solder flux left active (ionic) flux residue across the thru-hole connections.

- Board 1 left an active residue with a leakage current detected early in the test period, which dropped below 8 Log¹⁰Ωs. SIR slowly improved over the testing period while still showing signs of activity.
- Board 2 was stable and in the desired performance zone but formed a leakage current that dropped insulation resistance by roughly two decades.
- Boards 3 and 4 were stable and in the desired performance zones.

Main Connector SIR FAIL

Criteria	Min: 100 (±5%)
First Failure	10/25/2023, 5:02:52 PM
Standard Deviation	5254.27
Max	65535
Min	80
Average	2029.941351888668

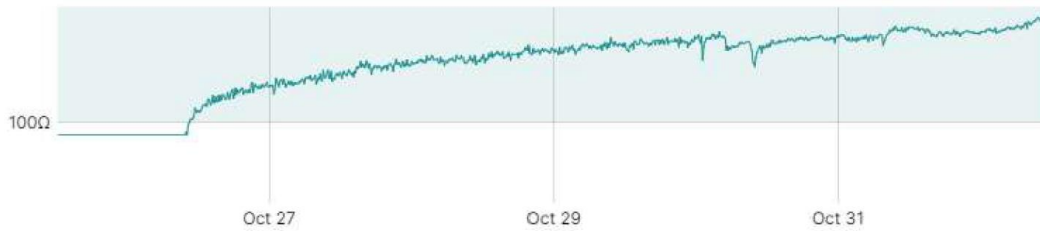
Figure 10: BGA Outer Front Side of the Board

- BGA Outer SIR (U10)
 - Board 1 started in the failure zone while slowly improving to the cautionary zone.
 - The failure was due to flux residues that were not fully outgassed.
 - Boards 2, 3, & 4 were stable and in the desired performance zones.

BGA Outer SIR **FAIL**

Criteria	Min: 100 (±5%)
First Failure	10/25/2023, 12:12:52 PM
Standard Deviation	143.93
Max	637
Min	80
Average	324.85188866799206

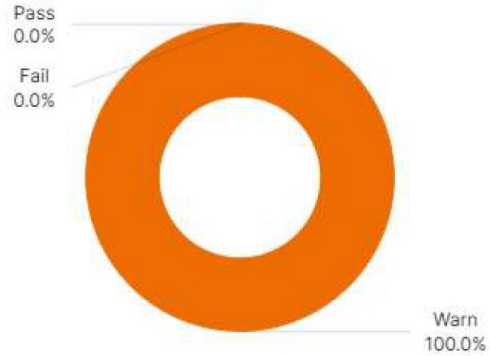
Figure 13: 3.3 V Rail Stats

Criteria	3.135 - 3.465 (±5%)
First Failure	Never
Standard Deviation	0.00
Max	3.322
Min	3.322
Average	3.322000000000012

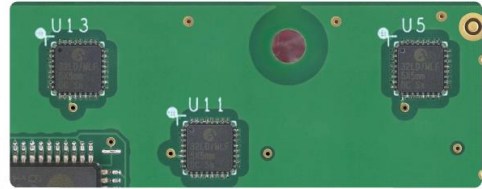
Figure 15: QFNs with Standard Standoff Gaps

Two sets of QFNs were placed on the back side of the test board. U5, U11, and U13 had standoff gaps of 25-50µms. These QFNs failed. Conversely, QFNs U6, U12, and U14 were raised using preforms to a gap of 100-150µms. These QFNs passed—low standoff gaps block flux outgassing. The negative result is higher volumes of flux residues and pockets of active flux.

QFN1 SIR **FAIL**

Criteria	Min: 100 (±5%)
First Failure	10/30/2023, 5:12:52 AM
Standard Deviation	2923.66
Max	65535
Min	80
Average	65394.92047713718

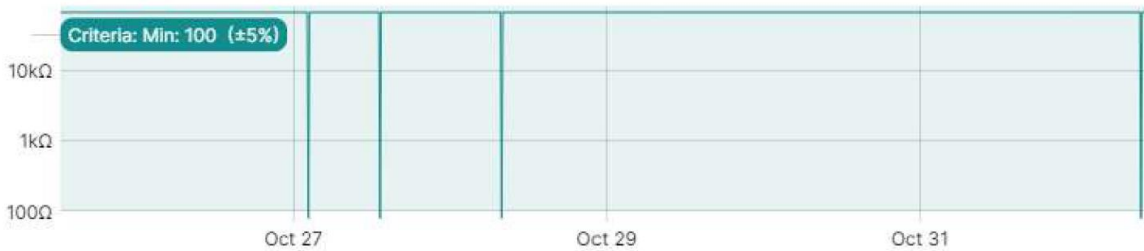
Figure 16: PQFP with a SIR Comb under the Component Termination

- PQFP (U72) SIR has a comb structure under the component termination. The comb structure is sensitive to selective solder flux that wets neighboring components and to wash fluids that are not adequately rinsed. This failure was likely due to selective solder flux wetting to the QFP component. When this occurs, the no-clean flux has not been fully heat-activated, leaving behind an ionic residue susceptible to failures when exposed to harsh conditions.

PQFP SIR **FAIL**

Criteria	Min: 100 (±5%)
First Failure	10/27/2023, 2:12:52 AM
Standard Deviation	4119.16
Max	65535
Min	80
Average	65274.74155069583

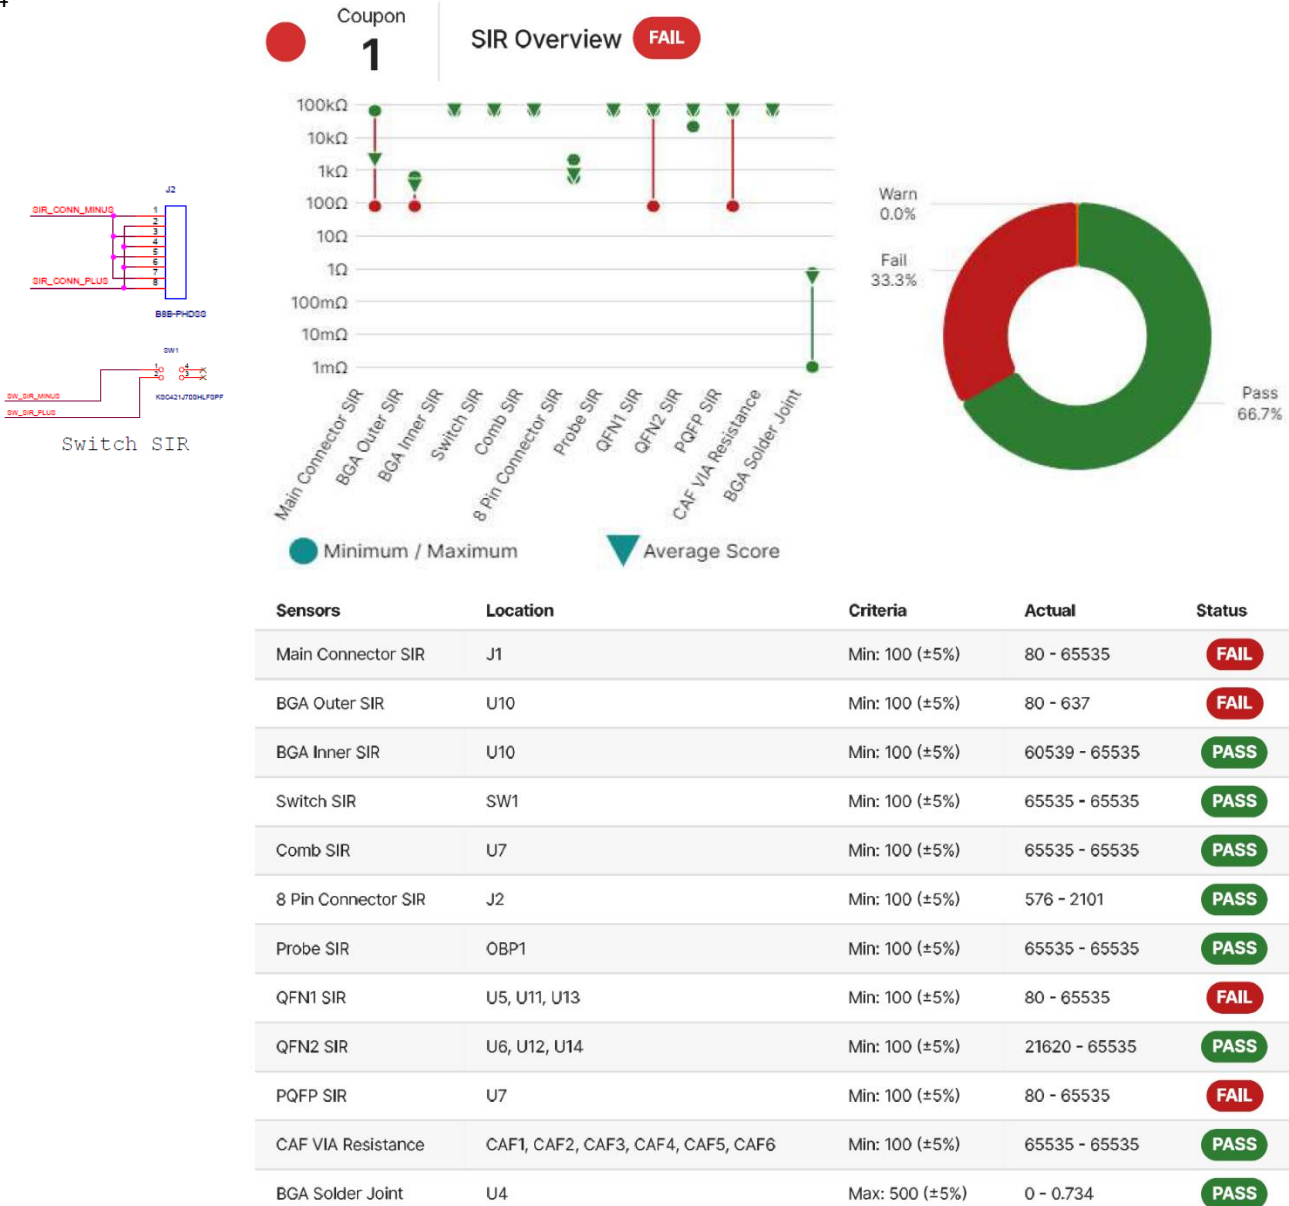
306 **Figure 17: SIR Data Findings for Each Component on the Test Board**

302 Four components failed SIR testing. The data provides insight into the components most susceptible to trapping active

303 residues.

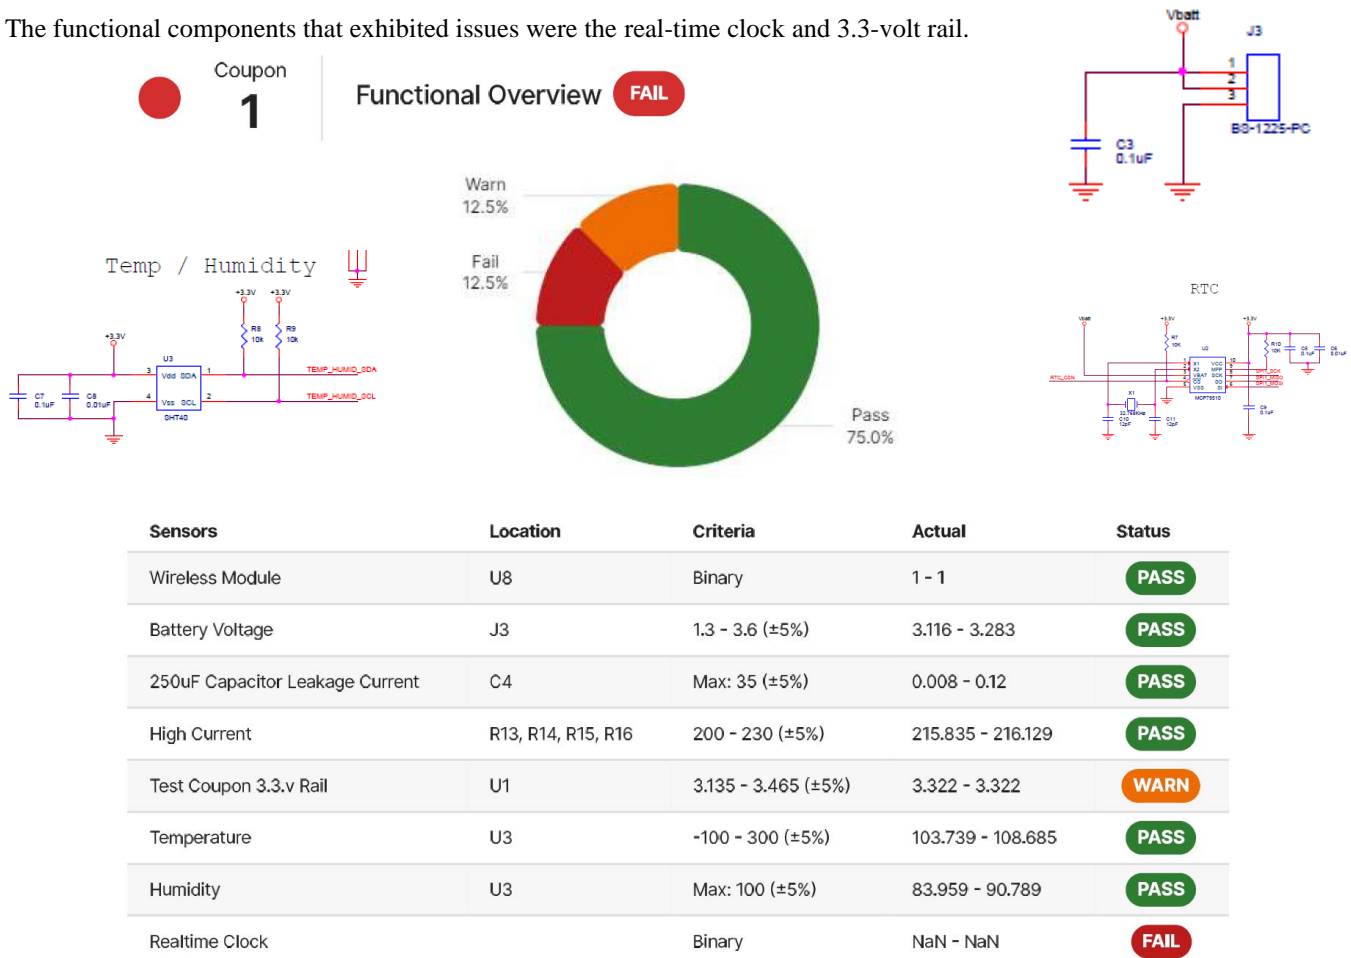
312 **Figure 18: Functional Components on the Test Board**

311 The functional components that exhibited issues were the real-time clock and 3.3-volt rail.

- 342 2. The SIR of the PLCC and QFN show acceptable noisy levels, but the performance of the high impedance R13 -R16,
343 voltage Rail U3, and thermal measurement indicate SMT residues causing leakage performance issues.
