CASE STUDIES

ABATTOIR

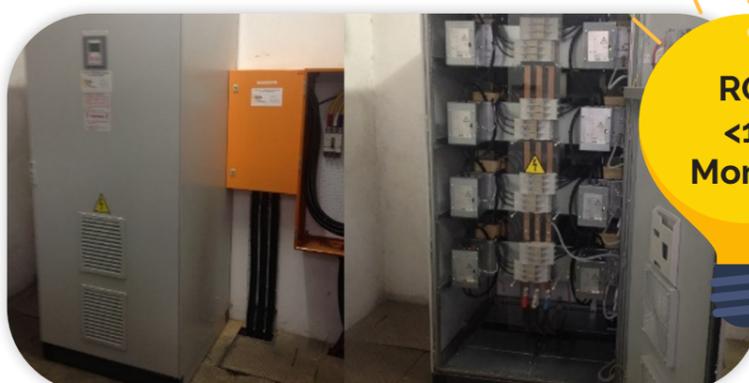
PFC Installation:

We were asked to submit a proposal to supply and install power factor **correction equipment** at one of their plants in Eastern Johannesburg. Following a detailed audit of the requirements, we installed power factor correction equipment.

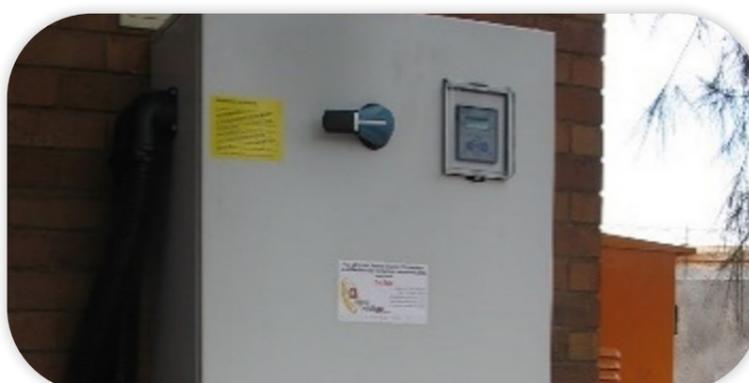
PFC Installation:

The Power Factor on this Farm was very low and therefore installing a 100 kvar PFC panel allowed us to free up **sufficient capacity** on the supply transformer to **add 2 additional coops** of 50,000 chickens.

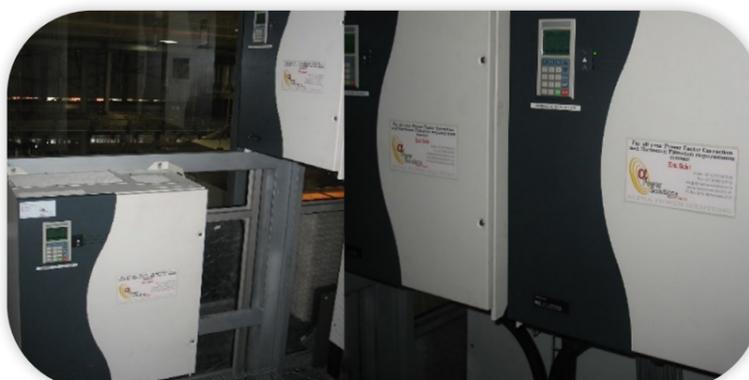
Harmonic Filtration:

An audit revealed **excessive harmonic levels** present in the system.

Active Harmonic filters would have to be installed at various hotspots

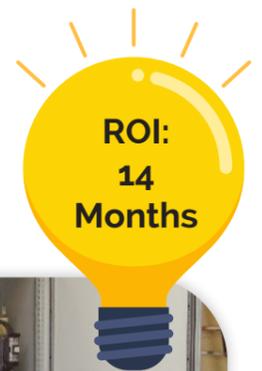
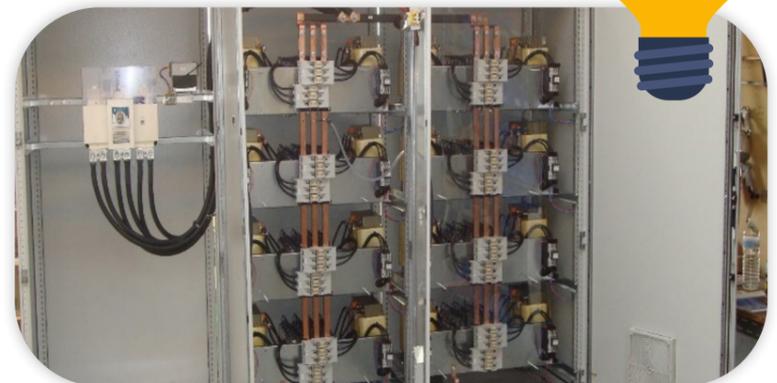
PFC Installation:

By installing a Power Factor Correction System worth R210,000 on 20 February 2016, we helped this customer **reduce his maximum demand by 24%**. This translated into a monthly **reduction in electricity cost of R15,000 per month**.

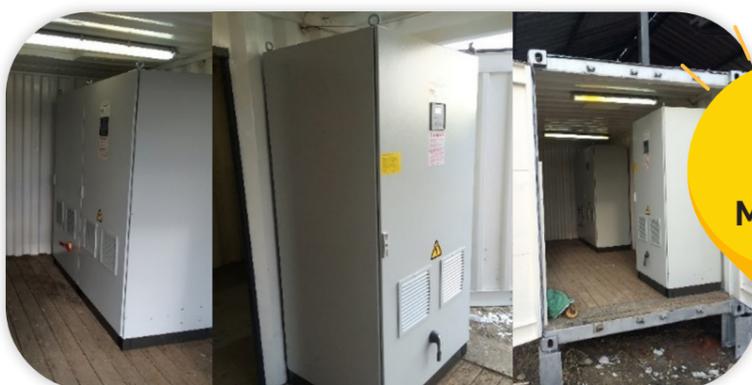
PFC Installation:

By **installing Power Factor Correction**, the mine was able to reduce the load on the **supply transformers by 29%** which allowed them to expand even further without having to increase their Eskom supply.

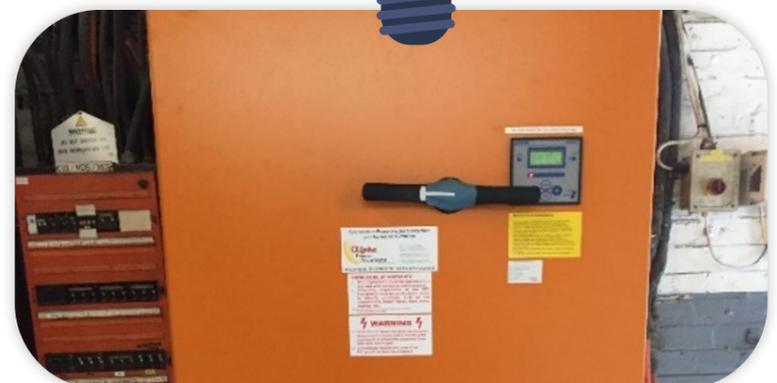
PFC Installation:

By installing a power factor correction system worth **R235,000**, we helped this customer **reduce his maximum demand by 59%**, which translated into a monthly **reduction in electricity costs of R21,000** and an **ROI of 10.3 months**

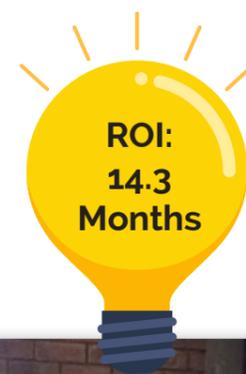
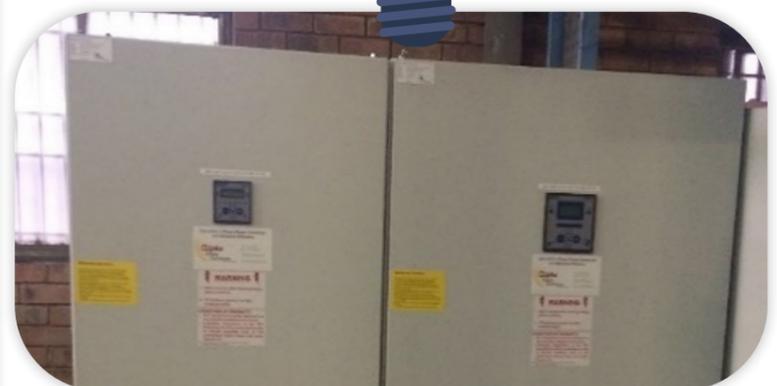
PFC Installation:

A **R 255,000 investment** in PFC equipment in early 2016 resulted in a **monthly saving of R17,500** with a projected **Return Of Investment of 14,3 months**.

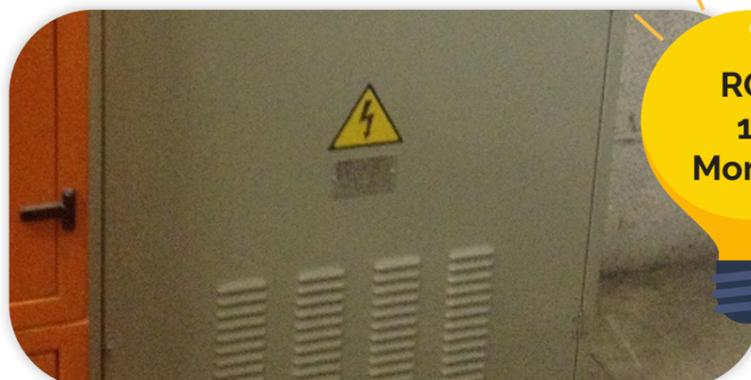
PFC Installation:

We installed a 300 kvar **Power Factor Correction Panel**.

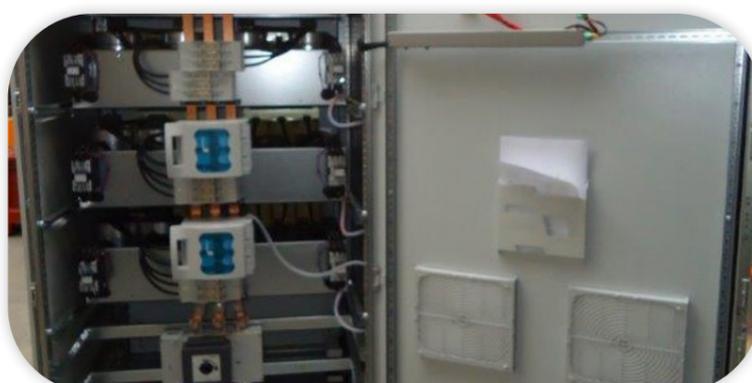
PFC Installation:

By **installing the recommended** Power Factor Correction equipment at a cost of R500,000 the customer was able to add the **factory expansion** he needed **without** a supply upgrade from Eskom.
