VIVID HOME INSPECTIONS

RESIDENTIAL REPORT

1234 Main Street
Cherry Hill, NJ 08002

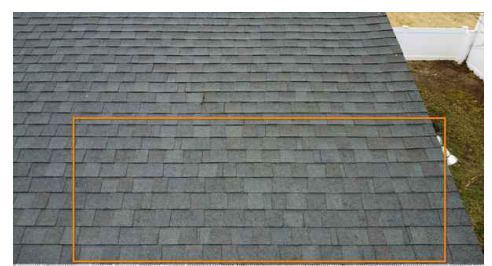
EXCESSIVE GRANULE LOSS

— Marginal Defect

The roof covering exhibited excessive loss of surface granules. Granules serve as a protective layer that shields the underlying material from ultraviolet exposure and normal weathering. When granule loss becomes pronounced, the roofing material may deteriorate more rapidly and become more vulnerable to damage. This condition can shorten the expected service life of the roof covering over time.

Recommendation

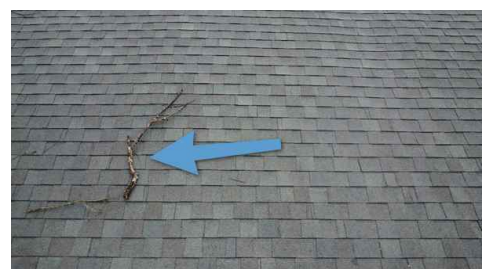
3.1.4 Covering

TREE DEBRIS ON ROOF

Tree debris was observed on the roof surface. Accumulated leaves, branches, and organic material can retain moisture against the roofing material and may contribute to premature deterioration over time. Debris can also obstruct proper drainage and interfere with water runoff. Routine removal of roof debris helps maintain proper performance and prolong the service life of the roofing system.

Recommendation

Contact a qualified professional.

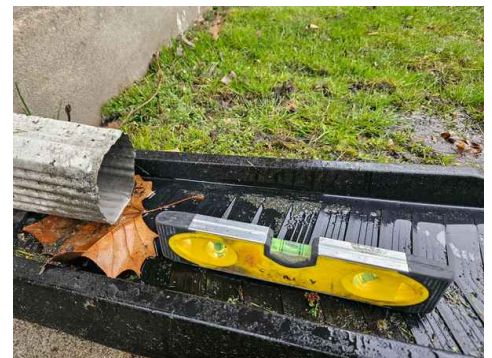
3.3.1 Roof Drainage Systems

DOWNSPOUT EXTENSION - IMPROPERLY SLOPED

Front - Not sloping away from the foundation causing water to pool near the foundation

Recommendation

Contact a qualified gutter contractor

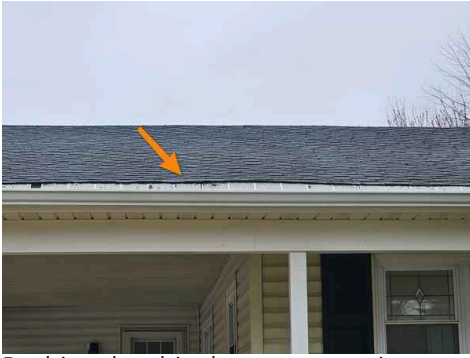
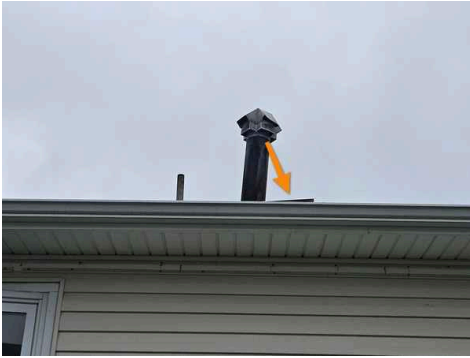
Pushing the shingles up preventing water from discharging off the roof.

Recommendation

Contact a qualified gutter contractor

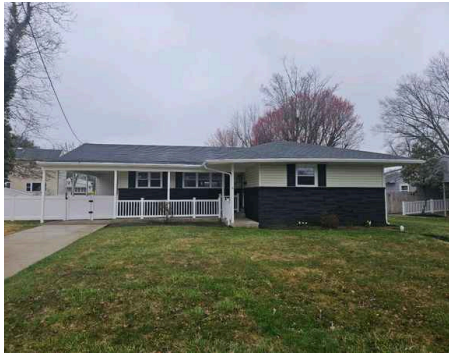
Front

The exterior siding materials were visually inspected for general condition, installation, and signs of damage, deterioration, or moisture intrusion. Observable components were evaluated for issues such as cracking, warping, gaps, or improper attachment that may affect performance. The siding is considered functional unless otherwise noted.

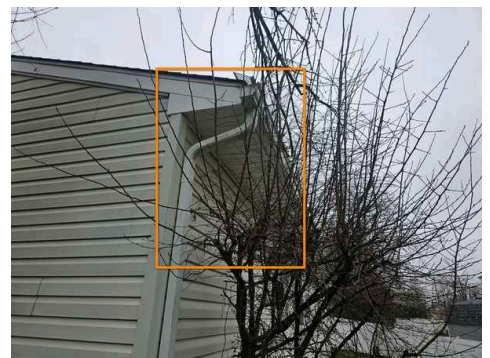
Rear - Recommend trimming the branches back

Recommendation

Contact a qualified tree service company.

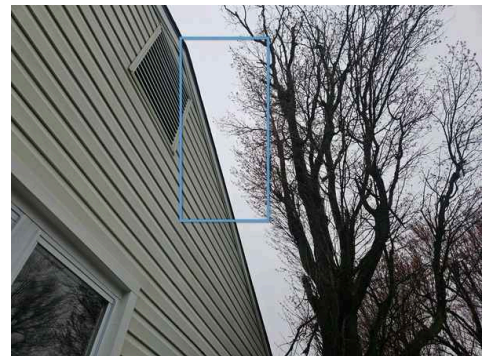
Recommend keeping the branches trimmed back.

Recommendation

Contact a qualified tree service company.

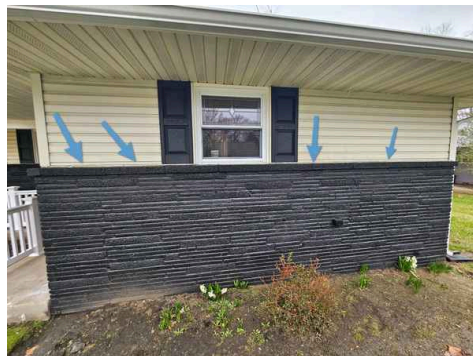
Front - Along the front edge where the vinyl siding meets the stone veneer.

Recommendation

Contact a handyman or DIY project

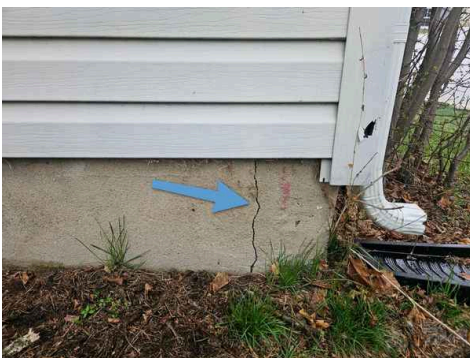
Right Rear

FOUNDATION PARGING – CRACKED AND CHIPPING

Recommendation

Contact a qualified masonry professional.

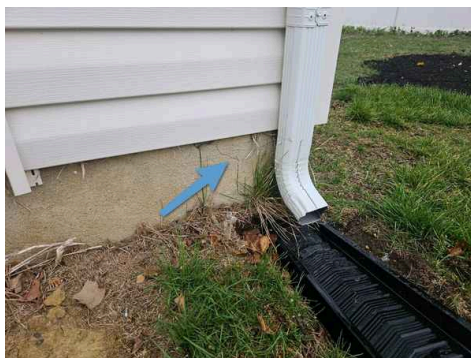
4.7.2 Foundation

Left Rear

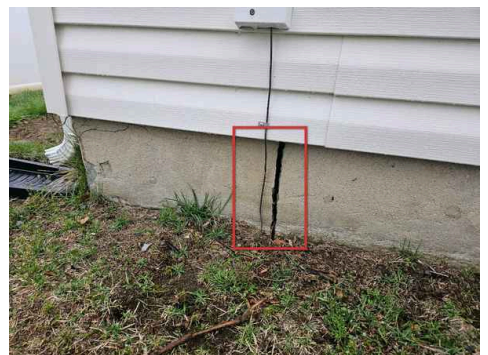
Left Rear

SIGNIFICANT FOUNDATION MOVEMENT OBSERVED

Significant movement was observed at the foundation during the inspection. Noticeable displacement, cracking, and/or misalignment were present in affected areas. The extent of movement exceeded what is typically associated with minor settlement or shrinkage. Continued movement of this nature may impact structural stability and the alignment of building components over time.

Contact a qualified structural engineer.

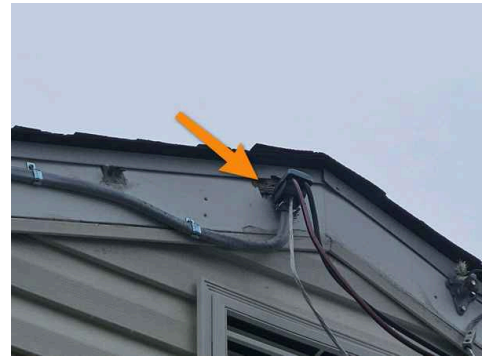
4.9.1 Eaves, Soffits & Fascia

DAMAGED FASCIA

The fascia board was observed to be damaged at the time of inspection. Visible deterioration was noted along the edge of the roof overhang. Damage to the fascia can affect support for the gutter system and may allow moisture to impact adjacent materials. Repair or replacement is recommended to maintain proper function and protection at the roof edge.

Exposed wood behind the metal flashing

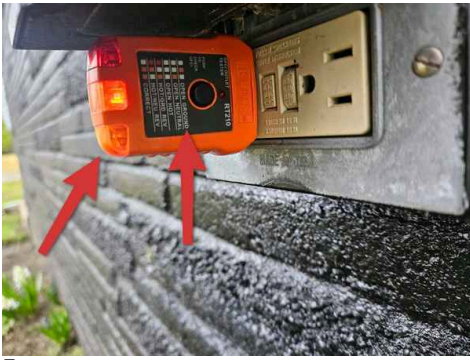
Front

OPEN GROUND CONDITION AT EXTERIOR OUTLET

The exterior receptacle tested with an open ground condition at the time of inspection. This result indicates that the equipment grounding conductor was not properly connected or present. An open ground can affect the safe operation of connected devices and may limit the effectiveness of protective features. Evaluation and correction are recommended to restore proper grounding continuity.

Contact a qualified electrical contractor.

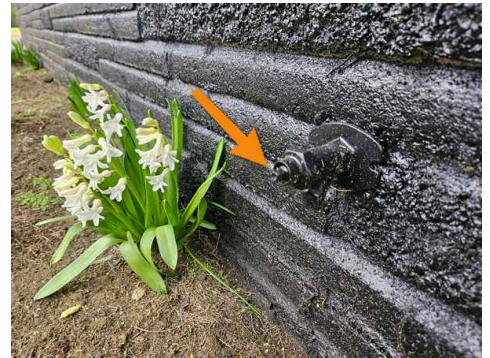
Front - missing handle

Recommendation

Contact a qualified plumbing contractor.

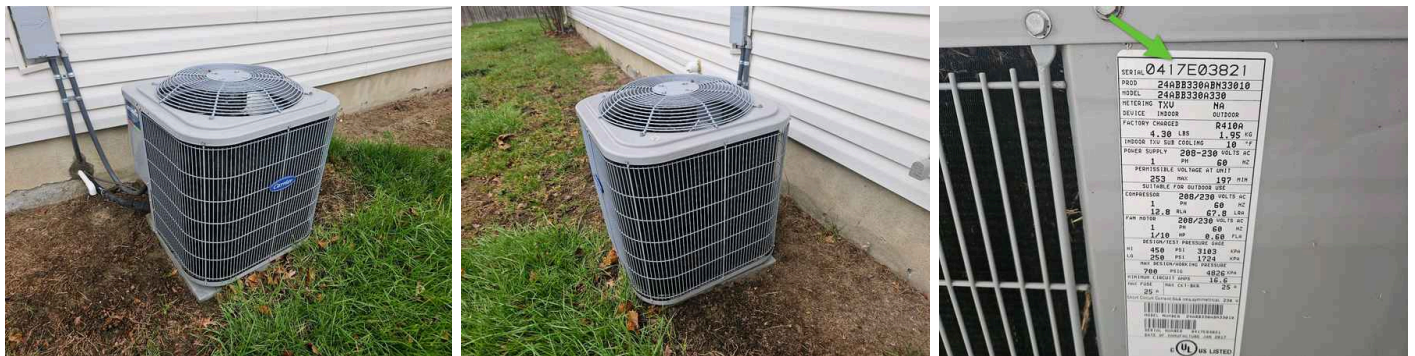
2017

Cooling Equipment: Cooling Equipment Was Inspected

The cooling equipment was visually inspected for proper installation, general condition, and observable performance at the time of the inspection. Components were evaluated for signs of damage, wear, and safety concerns. This inspection was limited to readily accessible and visible elements, and no determination is made regarding concealed defects or long-term reliability. The system is considered functional unless otherwise noted.

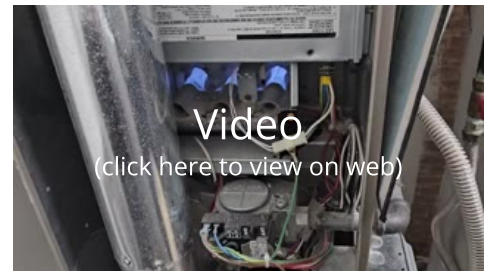
Marginal Defect**HEATING SYSTEM - UNUSUAL NOISES OBSERVED DURING OPERATION**

Unusual noises were heard from the heating system during operation. These noises may indicate wear, loose components, or internal mechanical issues. Continued operation under these conditions may lead to additional wear of system components over time. Further evaluation is recommended to determine the source of the noise.

Contact a qualified HVAC professional.

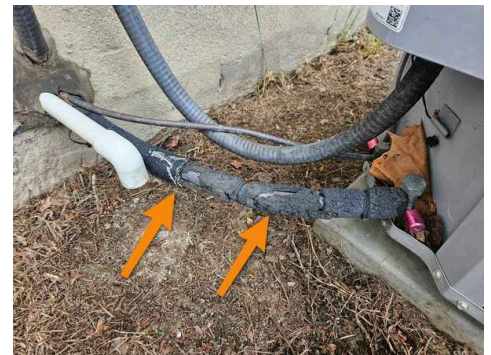
5.2.1 Cooling Equipment

Marginal Defect**REFRIGERANT LINE INSULATION - MISSING OR DAMAGED**

Insulation on the refrigerant suction line was missing or deteriorated. This insulation helps reduce energy loss and prevents condensation from forming on the refrigerant line. When insulation is missing or damaged, system efficiency may be reduced and moisture may develop on the line. Replacing the insulation can help maintain proper system operation.

Contact a qualified HVAC professional.

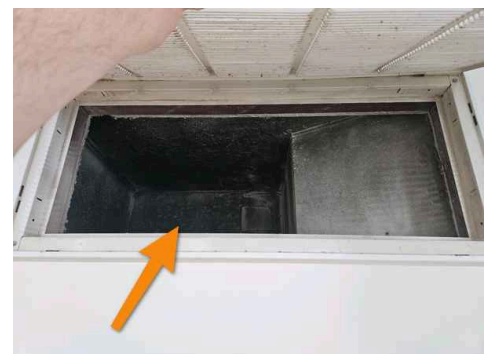
5.3.1 HVAC Filter

Marginal Defect**HVAC AIR FILTER - MISSING**

An air filter was not observed in the HVAC system at the time of the inspection. Air filters are intended to capture dust and debris before the air enters the heating and cooling equipment. Without a filter, dust and debris may accumulate within system components over time. Installing an appropriate air filter can help protect the HVAC equipment and improve system performance.

Recommended DIY Project

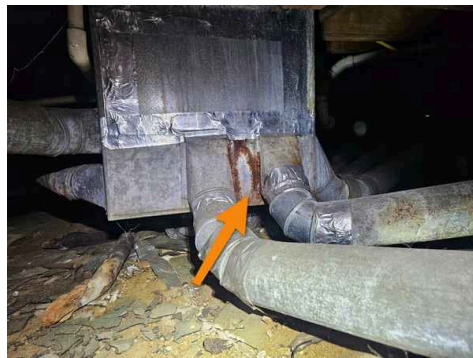
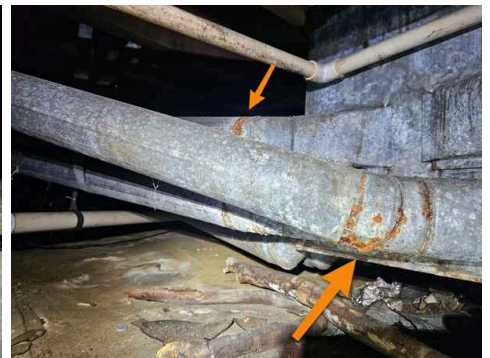
5.5.2 Distribution Systems

HVAC DUCTWORK - DETERIORATED OR CORRODED

Contact a qualified HVAC professional.

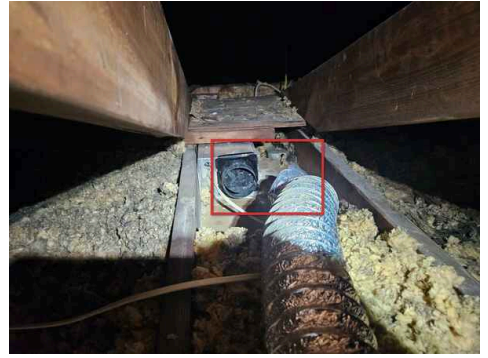
BATHROOM FAN EXHAUSTS INTO ATTIC

The bathroom exhaust fan was observed to discharge directly into the attic instead of venting to the exterior of the home. Exhaust fans are intended to remove moisture-laden air from bathrooms and discharge it outside. When moisture is released into the attic, it can increase humidity levels and contribute to condensation, mold-like growth, deterioration of roof sheathing, and reduced effectiveness of attic insulation.

Recommendation

Contact a qualified general contractor.

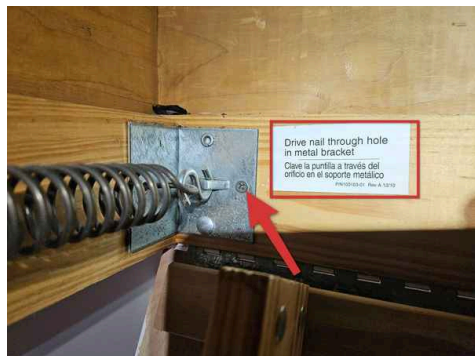
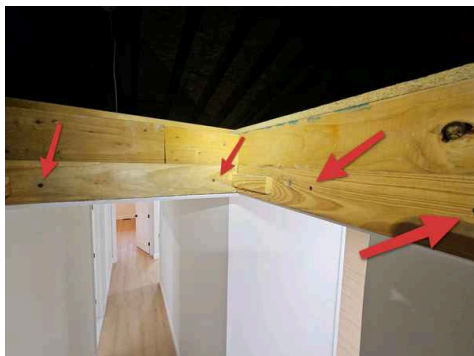
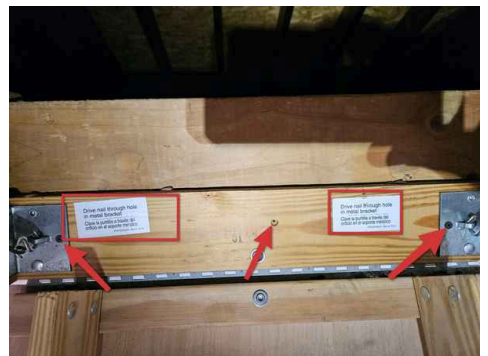
Improper fasteners used to install the folding attic ladder

Recommendation

Contact a qualified general contractor.

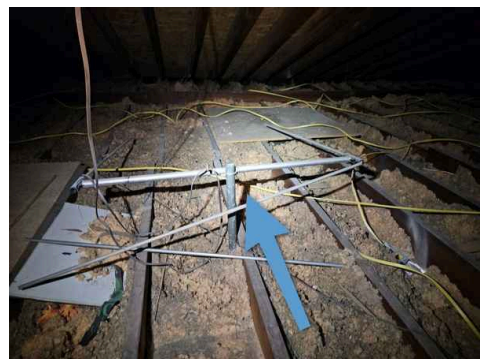
6.1.3 General

OLD ANTENNA ABANDONED IN ATTIC

An old antenna was observed abandoned in the attic. Abandoned equipment and materials left in attic spaces can contribute to clutter and may interfere with access, maintenance, or the installation of insulation and ventilation components. Older antenna wiring or mounting hardware may also become loose or deteriorated over time.

Recommendation

Contact a handyman or DIY project

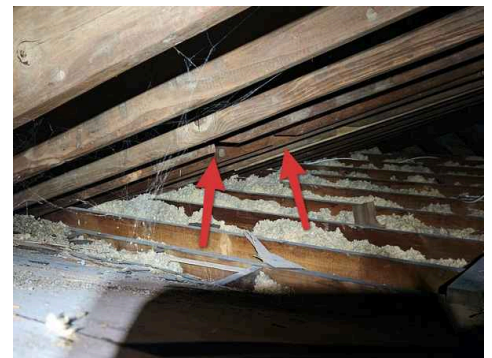
Appears the cut rafters have not been repaired.

Recommendation

Contact a qualified structural engineer.

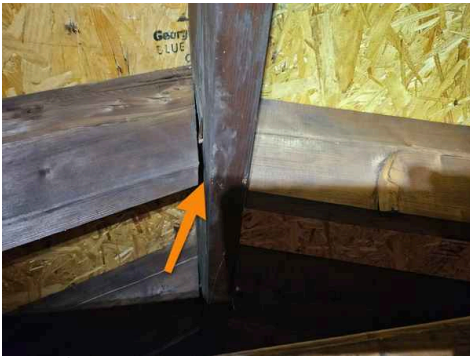
All rafter appeared to be separating from the ridge beam. Recommend installed rafter ties to prevent more movement and separation.

Contact a qualified structural engineer.

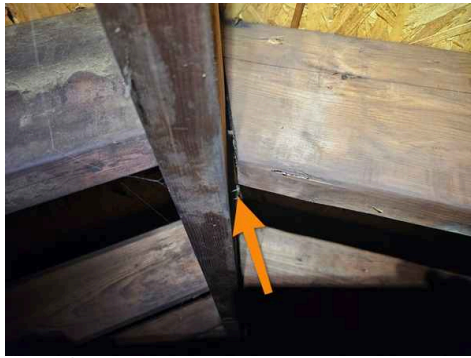
6.2.3 Roof & Attic Structure

All rafter appeared to be separating from the ridge beam. Recommend installed rafter ties to prevent more movement and separation.

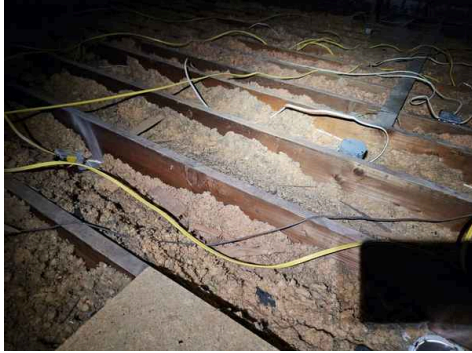
Blown in insulation appeared to be compressed and inadequate throughout the entire attic.

Contact a qualified insulation contractor.

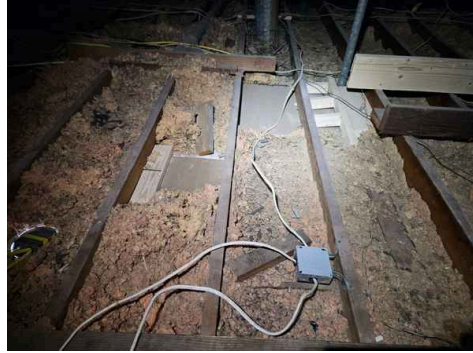
Blown in insulation appeared to be compressed and inadequate throughout the entire attic.

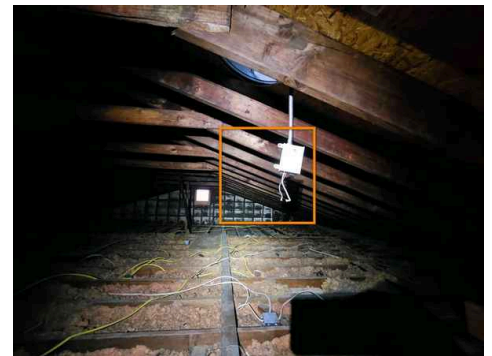
Attic fan installed and not connected to a source of power.

Recommendation

Contact a qualified electrical contractor.

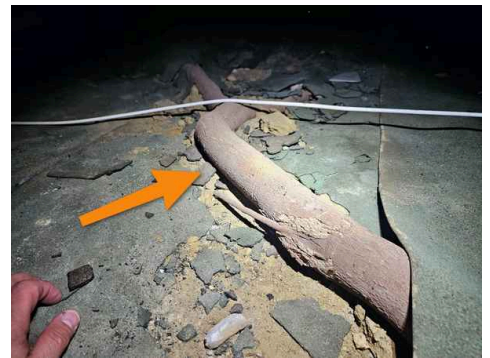
There were roots throughout the crawlspace from the old trees that have been removed around the perimeter of the house.

Recommendation

Contact a qualified landscaping contractor

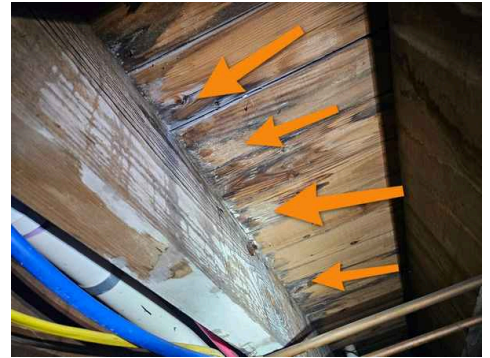
7.1.3 General

POSSIBLE MICROBIAL GROWTH OBSERVED IN CRAWLSPACE

Swab sample taken

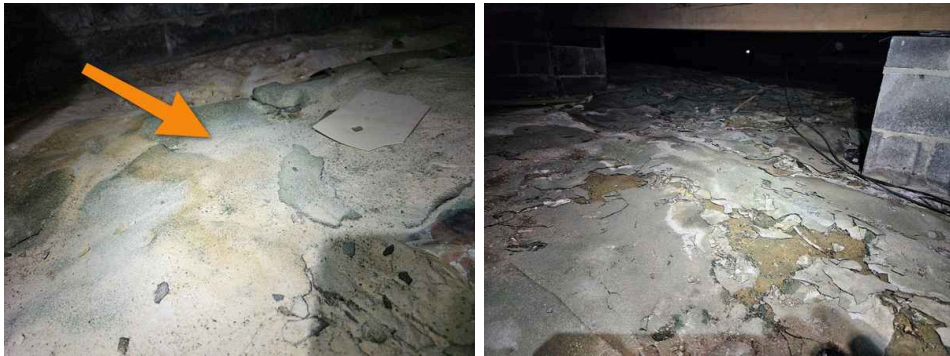
7.2.1 Vapor Retarders

Asphalt material used in which it had dried and became brittle. Recommend having a waterproofing company remove the old vapor barrier and install new 6 mil poly vapor barrier.

Recommendation

Contact a qualified waterproofing contractor

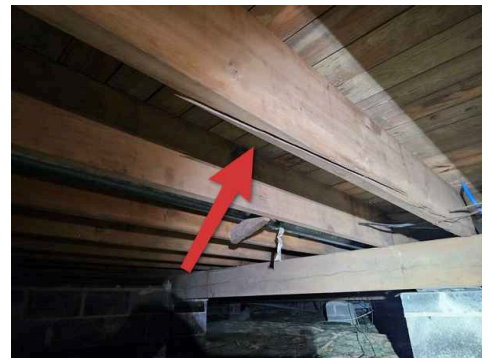
7.3.1 Homes Floor Structure

FLOOR JOIST SPLITTING OBSERVED

A floor joist within the crawlspace was observed to have a visible split at the time of the inspection. Splitting in structural framing members can occur due to drying stresses, loading conditions, or age of the material. Depending on the size and location of the split, the ability of the joist to adequately support loads above may be reduced. Further evaluation is recommended to determine the extent of the condition and whether reinforcement or repair may be appropriate.

Near the front portion of the house.

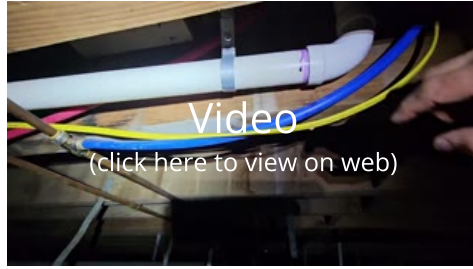
DRAIN PIPE - ACTIVELY LEAKING

An active leak was observed at a section of the drain piping during the inspection. Leakage from drain lines can allow wastewater to escape into surrounding areas and may contribute to deterioration of nearby building materials if the condition continues. Continued moisture exposure may also create conditions that promote material damage or biological growth. Drain piping is intended to safely carry wastewater away from the home without leakage. Further evaluation and repair of the affected drain line is recommended.

See video

Contact a qualified plumbing contractor.

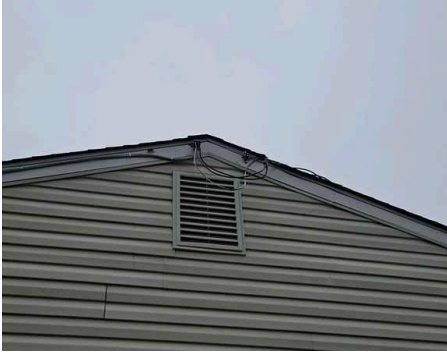
Service Entrance: Electrical Service Conductors

Overhead, 120 Volts

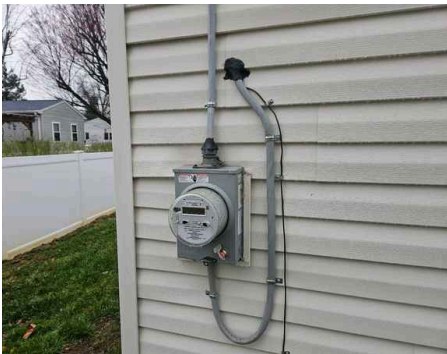
I inspected the electric meter and base for visible signs of damage, deterioration, or improper installation. The inspection included checking that the meter was securely mounted, properly sealed, and free of significant rust, corrosion, or gaps that could allow moisture or pests to enter.

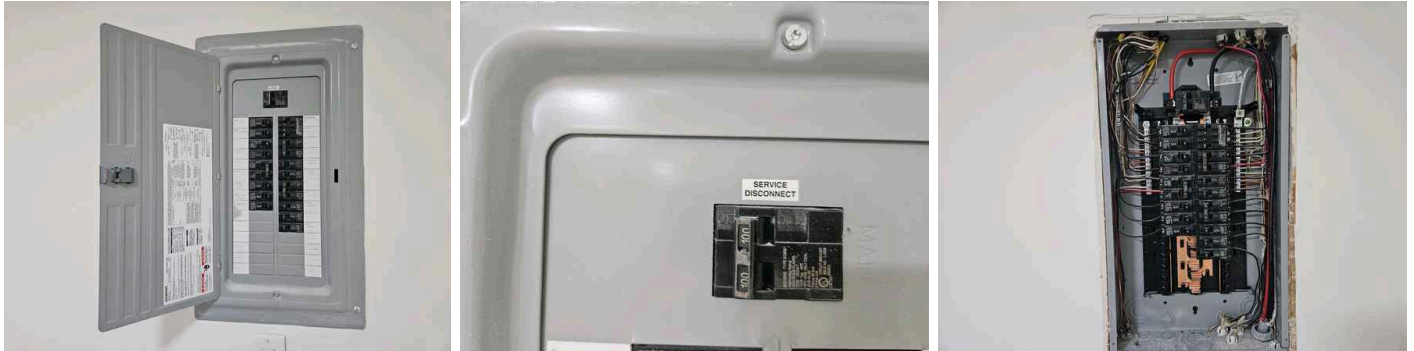
I inspected the electrical panel(s) and overcurrent protection devices (circuit breakers and/or fuses). The inspection included checking for proper labeling, visible signs of overheating, corrosion, or damage, double-tapped breakers, missing knockouts, and confirming the main service disconnect was accessible.

This was a visual, non-invasive inspection; voltage, current, or individual breaker testing was not performed. Any concerns regarding outdated equipment, improper installations, or safety hazards are noted in this report. If deficiencies are found or suspected, further evaluation by a licensed electrician is strongly recommended.

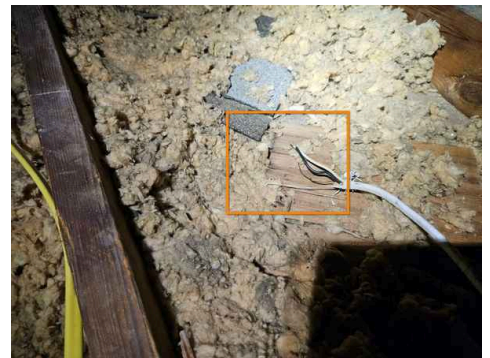
Wires should terminate in a junction box and wires capped off

Recommendation

Contact a qualified electrical contractor.

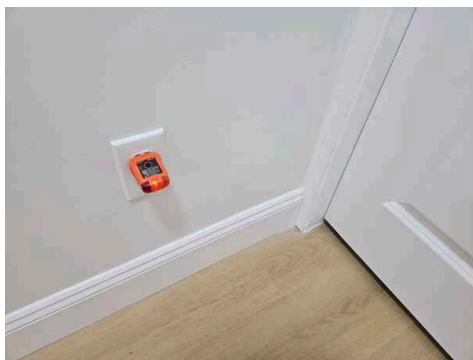
Foyer

Testing indicated an open ground condition at the outlet. This condition may affect the performance of connected devices. The issue may be related to wiring configuration. Further evaluation is recommended.

Contact a qualified electrical contractor.

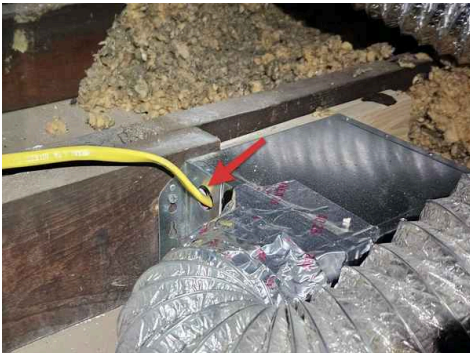
MISSING WIRE CLAMPS AT TERMINATION

Wires should be secured by the proper clamp to prevent movement. The vibration of the fan and the sharp metal of the box will eventually "cut" through the sheathing of the wire lead to possible electrical shock.

Contact a qualified electrical contractor.

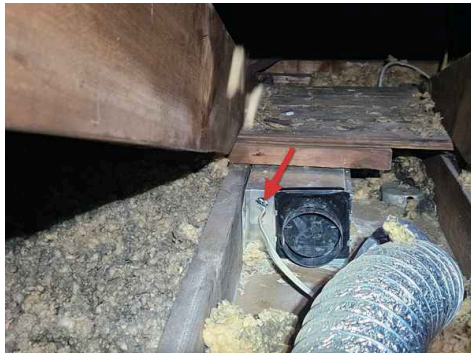
Wires should be secured by the proper clamp to prevent movement. The vibration of the fan and the sharp metal of the box will eventually "cut" through the sheathing of the wire lead to possible electrical shock.

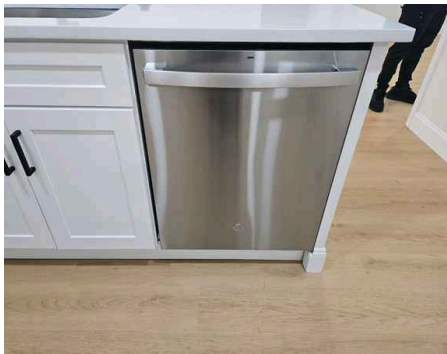
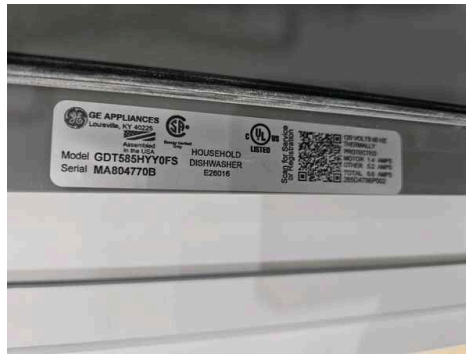
Dishwasher: Inspected Dishwasher

The dishwasher was run through a short cycle to verify basic functions, including water intake, cycling, and drainage. This was not a full performance test, and no determination is made regarding cleaning effectiveness or future reliability.

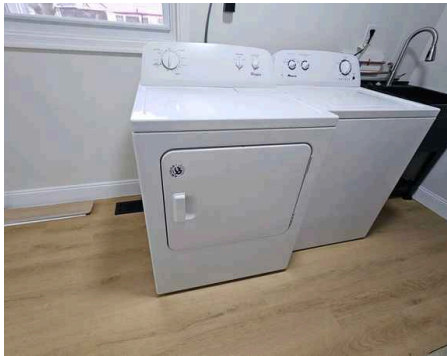
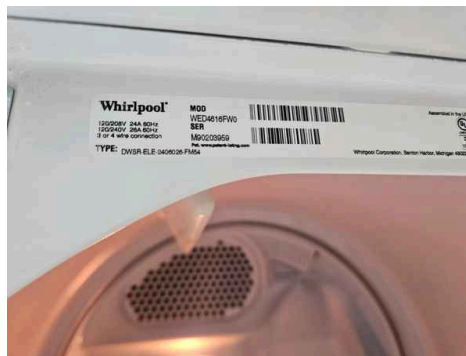
Clothes Dryer: I Inspected The Dryer

The dryer was operated to verify heat production and basic venting. This inspection does not determine the internal condition or full integrity of the vent system. The vent termination was checked for airflow and signs of clogging. Regular vent cleaning and maintenance are the homeowner's responsibility, as lint buildup can reduce efficiency and create a fire hazard. Routine maintenance is strongly recommended to help ensure safe operation and proper ventilation.

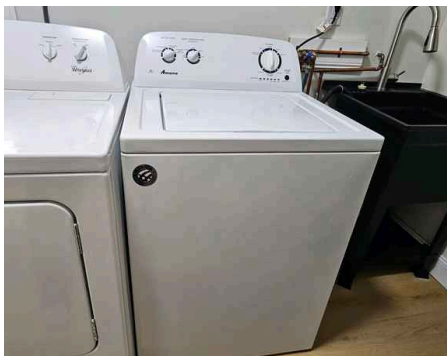
Clothes Washer: I Inspected The Washer

I ran the washer on a short cycle to verify basic functionality and to check for visible leaks. At the time of inspection, the unit operated as expected with no apparent water leakage. This check does not guarantee long-term performance or detect internal defects. Regular monitoring and maintenance are recommended.
