Blacks Fork Canal Company Spring 2026 Maintenance

Lower Waste Canal – Cleaned From Moyes Ditch diversion off County Road 243 to just before County Road 253.

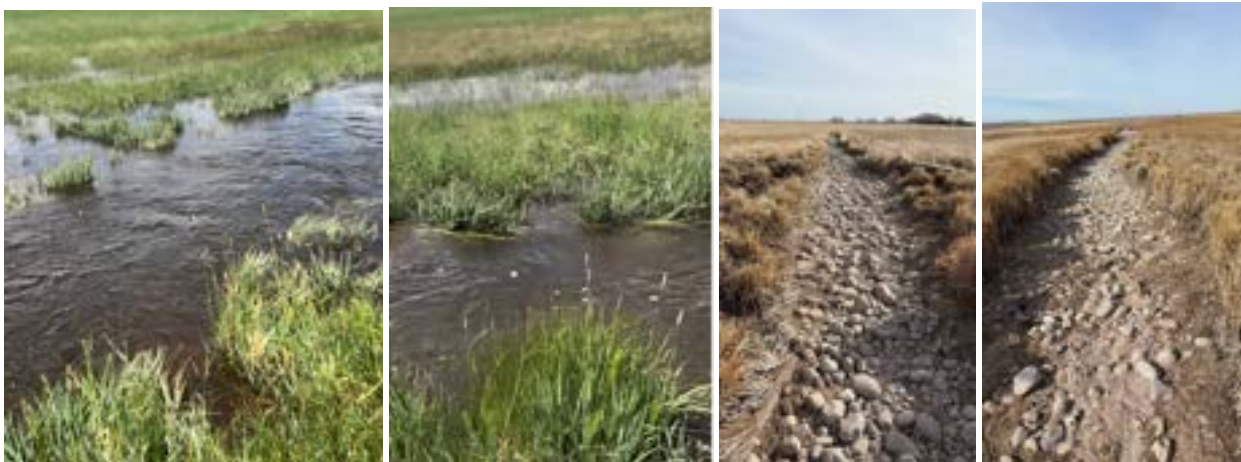
Before-

Problems – Willows backing up the flow, catching trash, unregulated ponds filling beside the canal, narrow banks and low areas due to cattle crossings leaking excess water.

This particular spot narrowed the canal down to 3.5 feet, and water would spill over the banks into several ditches on both sides and would not return to the canal.

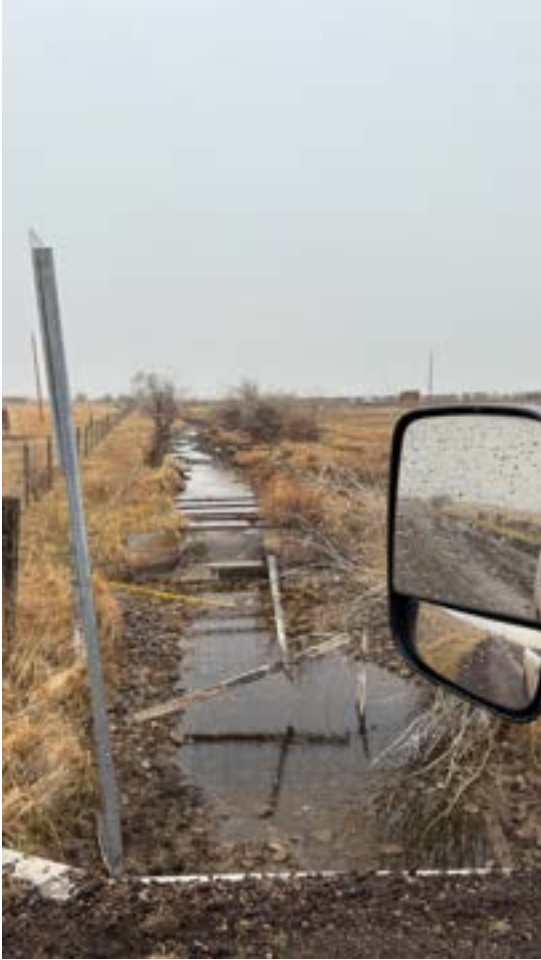
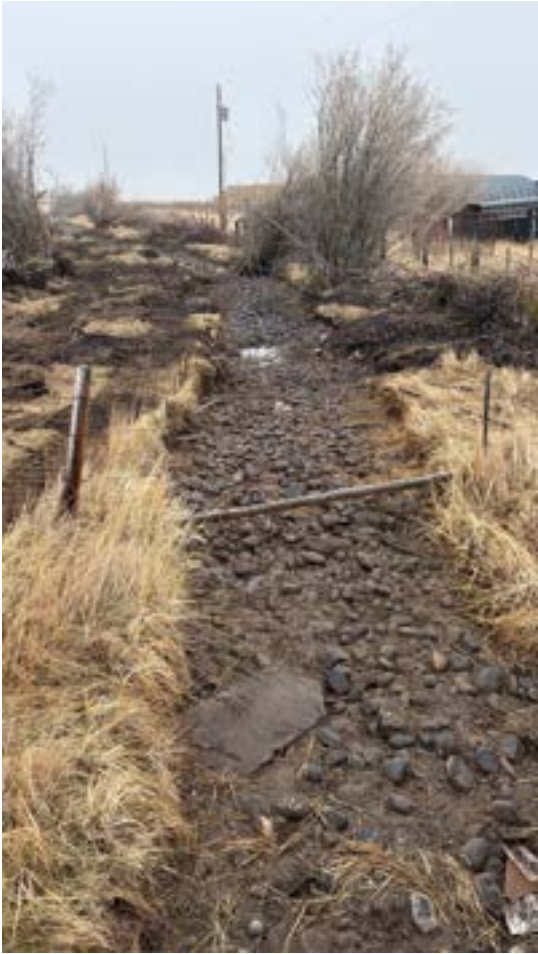
Waste Canal at County Road 243 – Willows cleaned, and ditch widened. Water would jump the bank into the Moyes Ditch

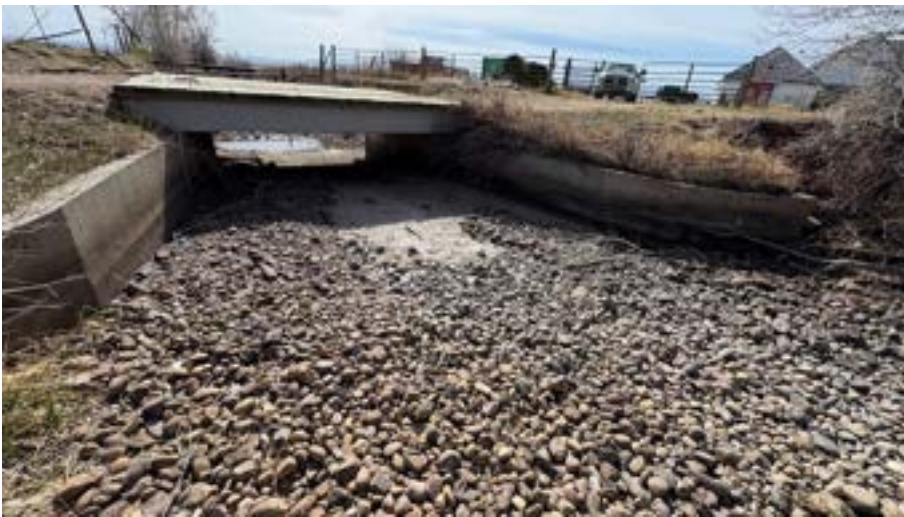
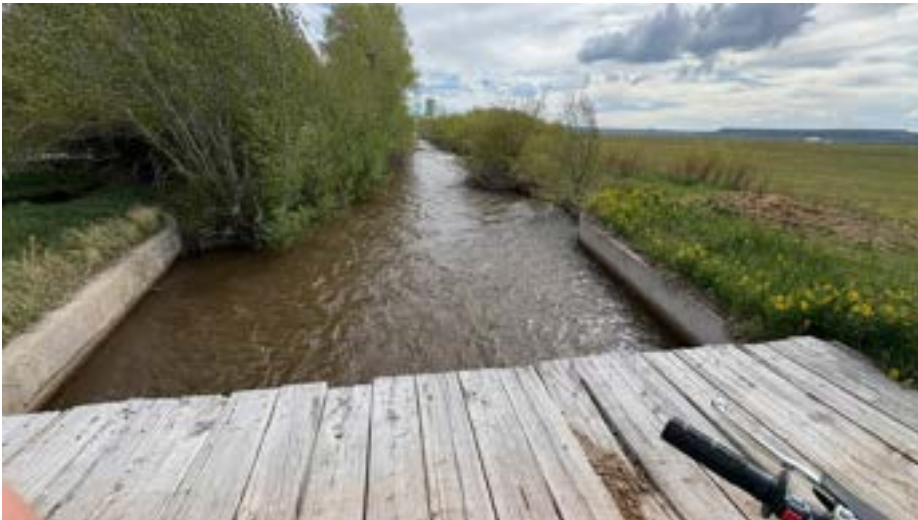
Before

Diversion below Richins Bridge -

Identified in Engineering Report with bad flume readings and built up rock.

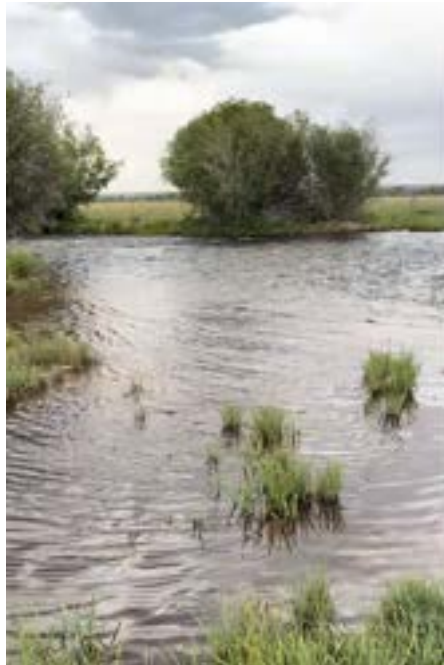
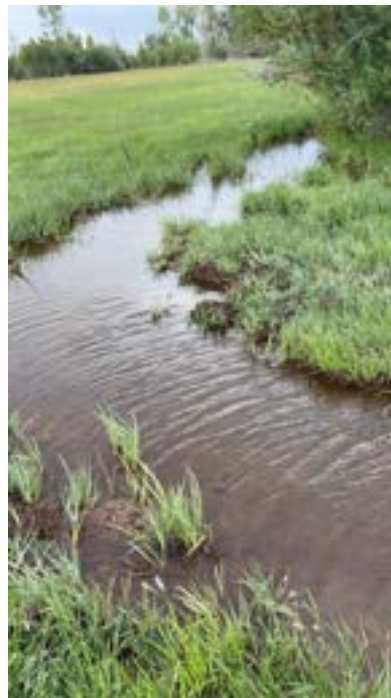
Before (Best is video from my phone) –

Problem – Water was leaking out through tractor crossing and several areas on the banks due to cattle coming in and out of the canal. Also headgate #7 has been plugged due to cattle moving rock into the ditch.

Fix – Crossing lowered and bank restored. A 9” channel was dug down the middle of the canal to fix the bank with rock and silt. The diversion above Headgates #5, 6, and 7, was cleaned out and rock and ditch fixed for #7.

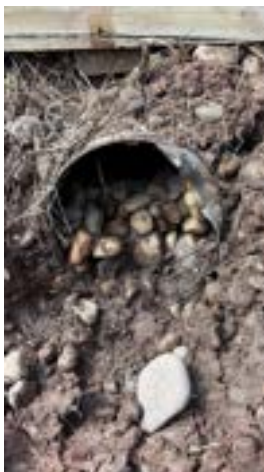
Anything over 200 cf/s of water and this crossing leaks upwards of 10 feet of water

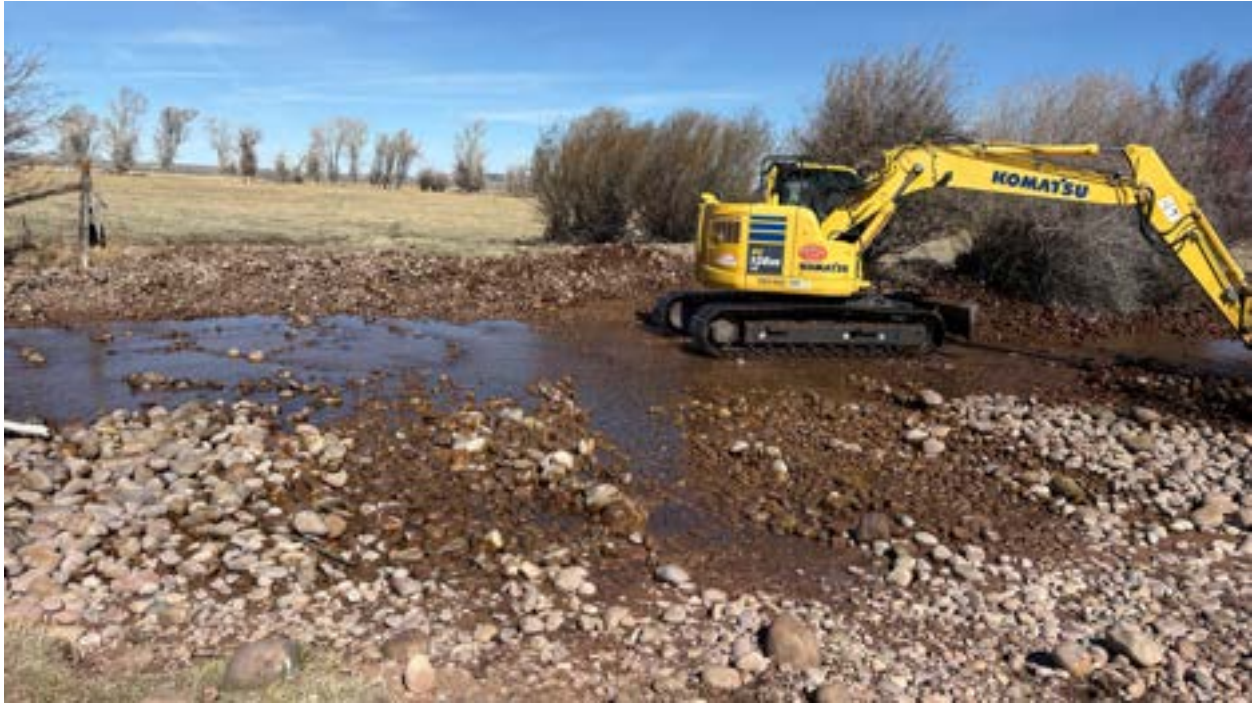
Afterwards -

This picture was taken halfway through fixing the culvert at #7, Flow through headgate was restricted 100% by rock. Culvert was buried in rock
