# Test Report

## Simulated landing with a defect landing gear on AGAT

**Flight Test Engineering ApS**

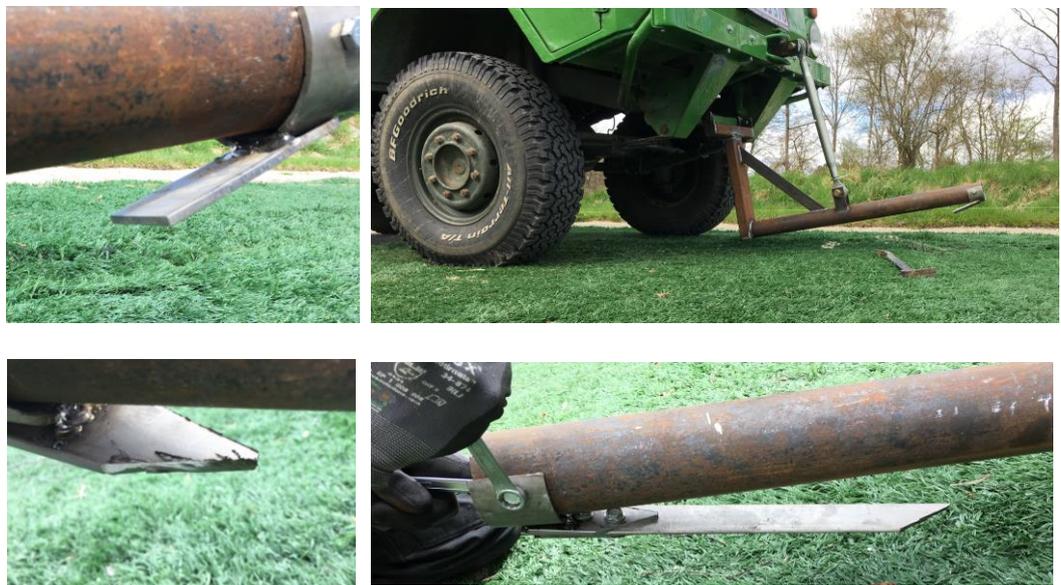
Picture of different devises installed on the Volvo Valp to simulate a damaged helicopter landing gear.

The rather violent looking test devises was developed after use of more landing gear-like used test-parts, as they had zero effect on the AGAT during the first test runs, even with full weight of the front part of the Volvo lifting the wheels to provide full weight pressure on the test subject toward the impact zone and attempt to damage and eventually penetrate the AGAT.

The test equipment was a Volvo Valp installed with several different devises to simulate a damaged landing skid.

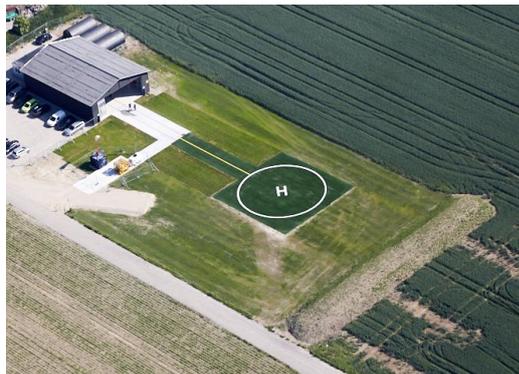
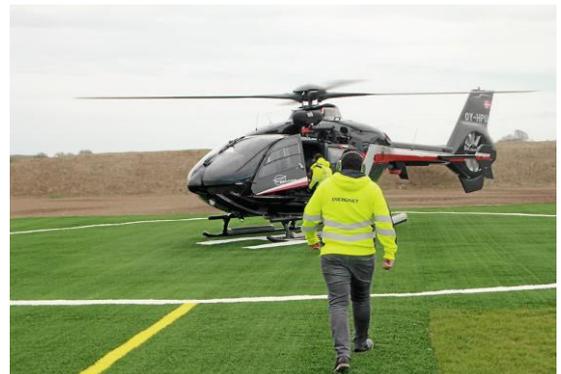
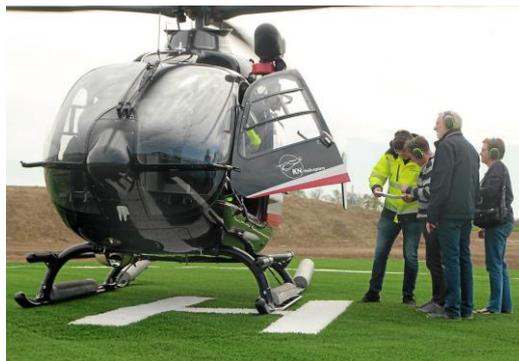
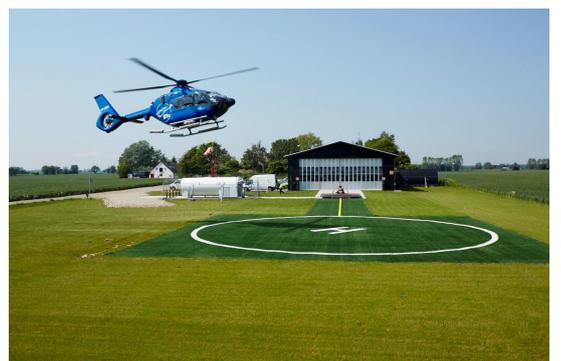
The latest installation installed by Evergreen Aviation has been at a hospital in Aabenraa and for a commercial helicopter company at Roedvig. The Roedvig installation is daily used and has within the first 2 months accumulated 350 operations and expect within a year to reach close to 3000 operations.

Picture of Roedvig installation 2018.

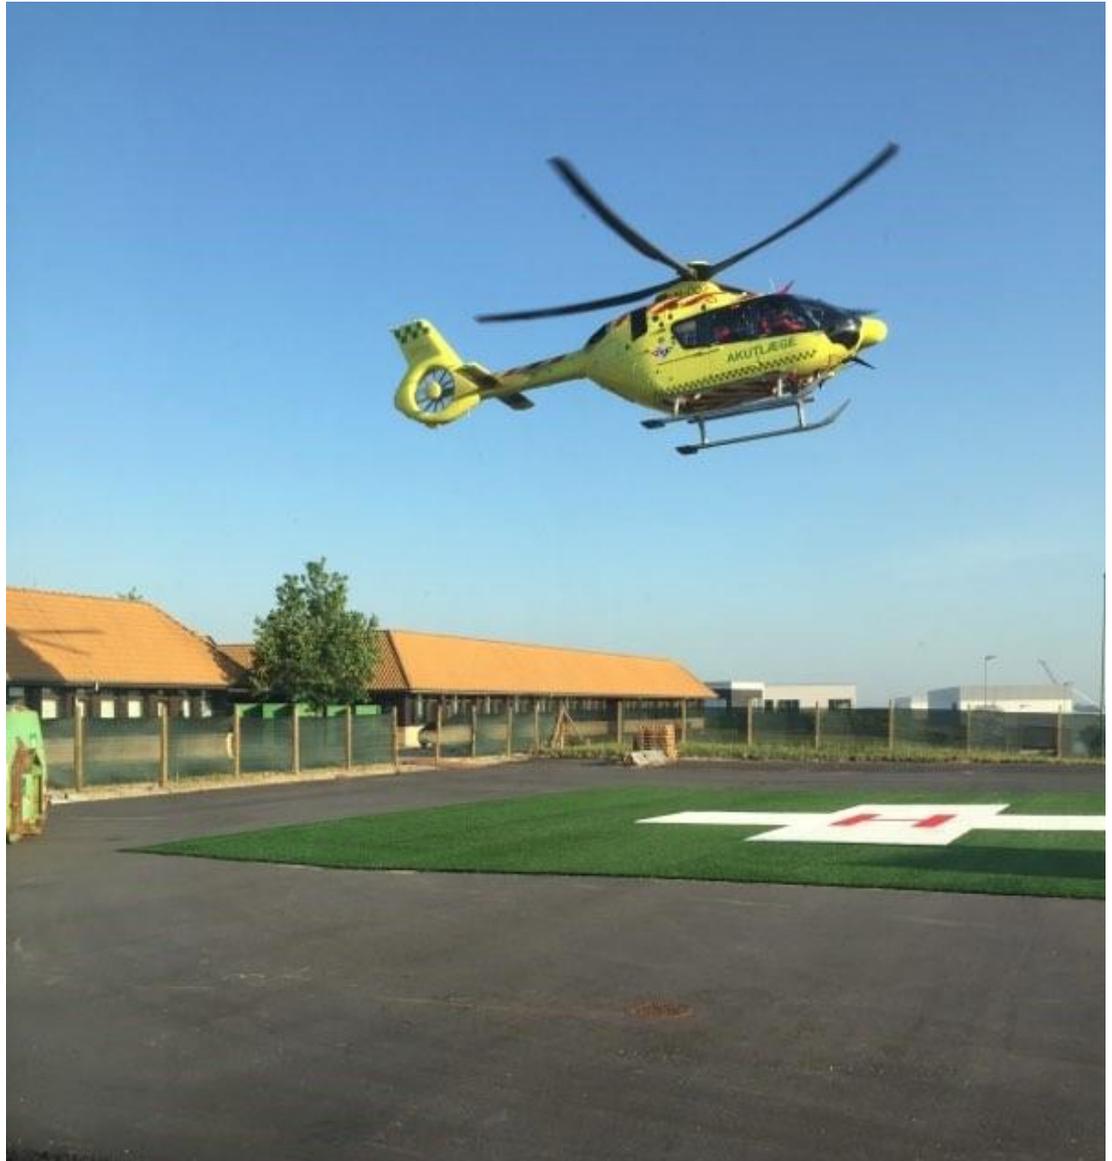
The testing was performed to show if the simulated landings performed with a defect landing gear system, where the wear pads have split due to wear, would have an effect on the AGAT and be a safety factor for the helicopter, crew and/or surroundings.

Simulated defect wear pads or the bolts to hold the wear pads is part of the test to show the reaction of the AGAT during forced landings.

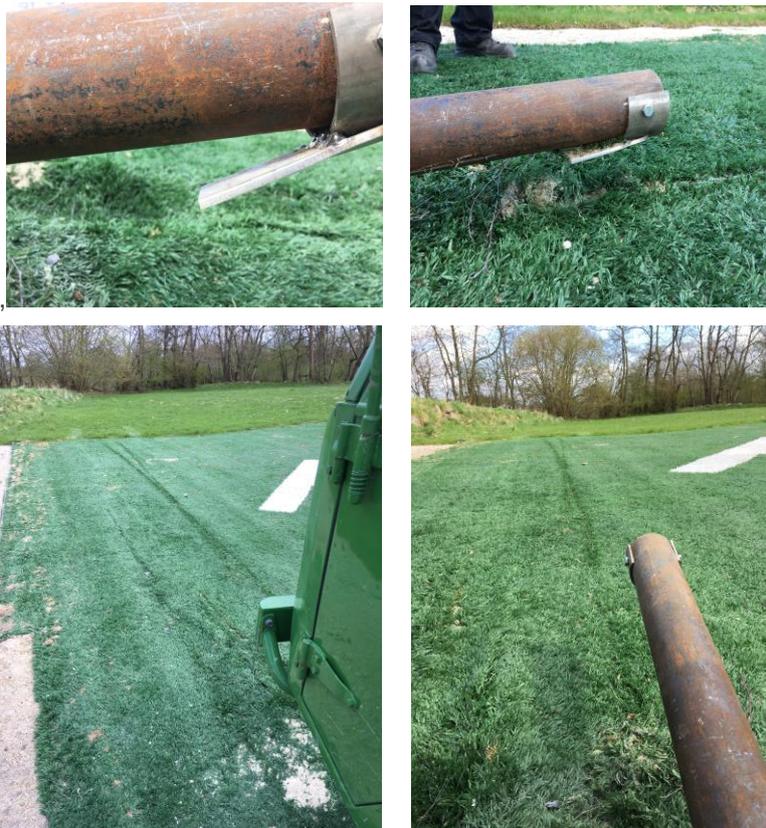
Even with several runs in the same path, the setup had none or minor effect on the AGAT installation. Due to the heat generated of the friction and the straight edge of the metal test part, left minor change to a small line in the AGAT, where straws had been cut/pulled apart due to friction. No rupture of the AGAT installation was seen. The first 4 pictures below show the first set of runs and the next 4 pictures show the result with maximum pressure applied vertically after several runs.

First test layout of simulated damaged wear-pad and result on the AGAT

The first test was performed to simulate a defect landing gear, with bolts and slightly damaged “wear-pad like” metal parts. The test showed however no effect on the AGAT and modified more violent devises were hereafter manufactured to generate an effect on the AGAT.

Test one risk factor for helicopter and surroundings. Severity 1, Probability 2-3 during full down auto rotation training.

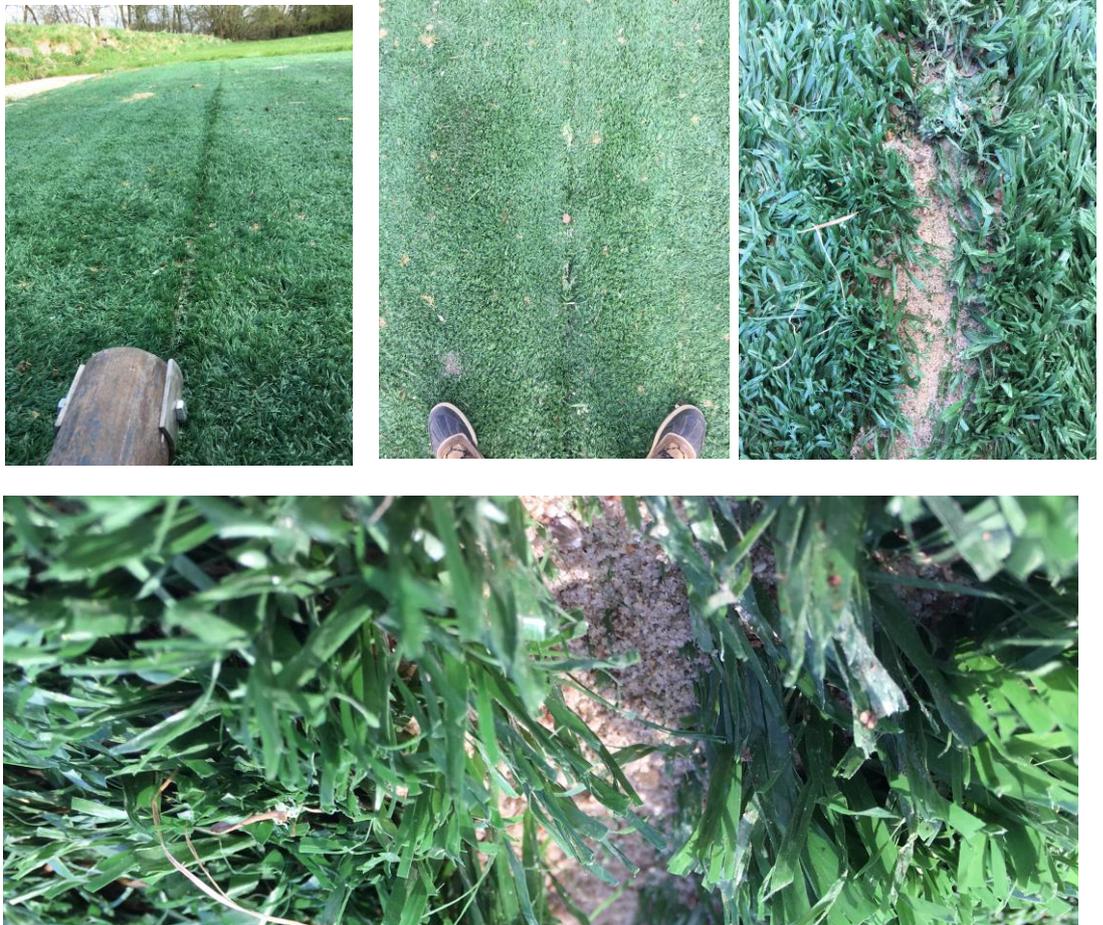
Additional pictures of the first test layout of simulated damaged wear-pad and result on the AGAT.

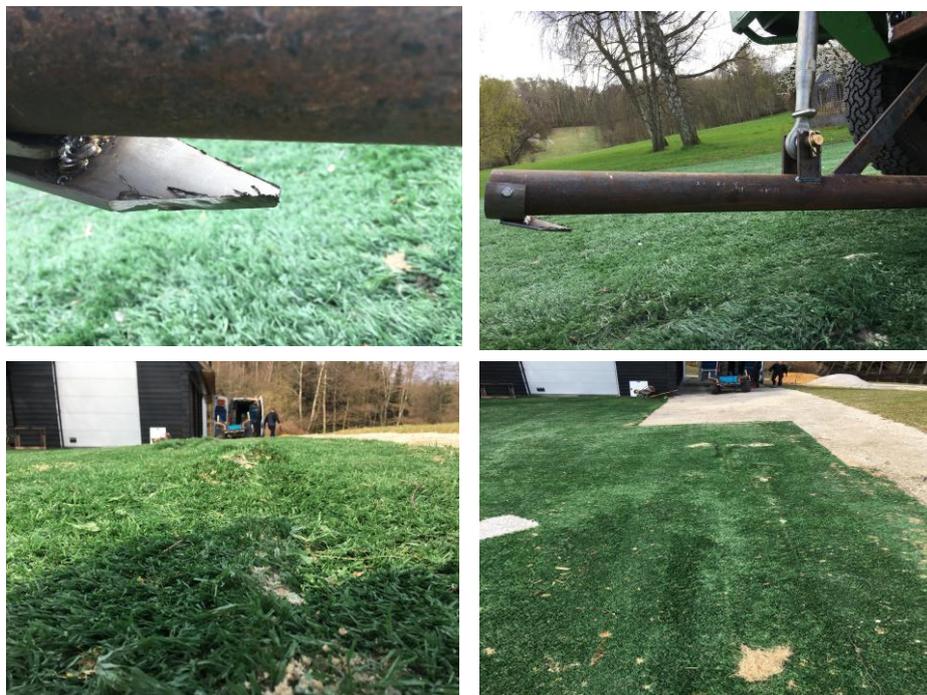
The second test was performed with a modification of the test two setup, to stress the AGAT installation with a modification of the same part, cut in 45 deg to generate a sharp object direct into the direction of the “impact” direction.

Result was the same as for test one, only a trail of removed straws, but no penetration, only a sliding run on top of the infill sand which cover approximately 2 cm of the 5 cm long straws.

Pictures of the second test layout of sharpened wear-pad and result on the AGAT.

Test two risk factor for helicopter and surroundings. Severity 1, Probability 2-3 during full down auto rotation training.

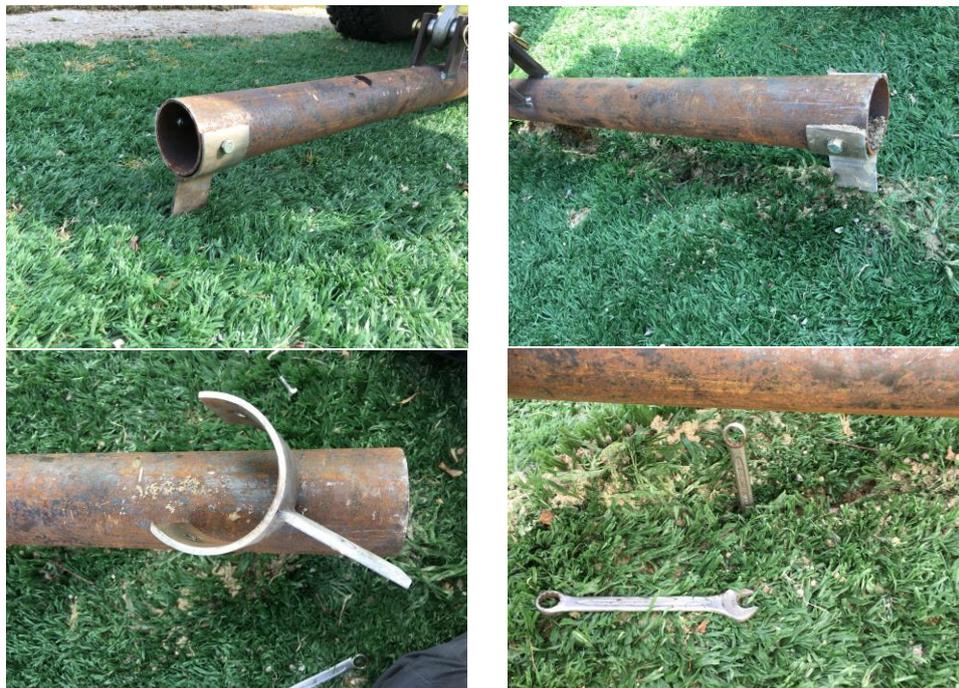
The test was performed with a “dull” vertical metal part to determine the possibility to penetrate the sand and AGAT fabric and the result of the rupture over a longer distance. With an estimated 750-1000 kg vertical pressure, the pulled vertical metal part penetrated the installation fully, but left the installation in its position, just leaving a sliced installation as if it had been cut with a sharp knife.

Pictures of the third test layout of a vertical metal part.

Test three risk factor for helicopter and surroundings. Severity 2-3, Probability 1

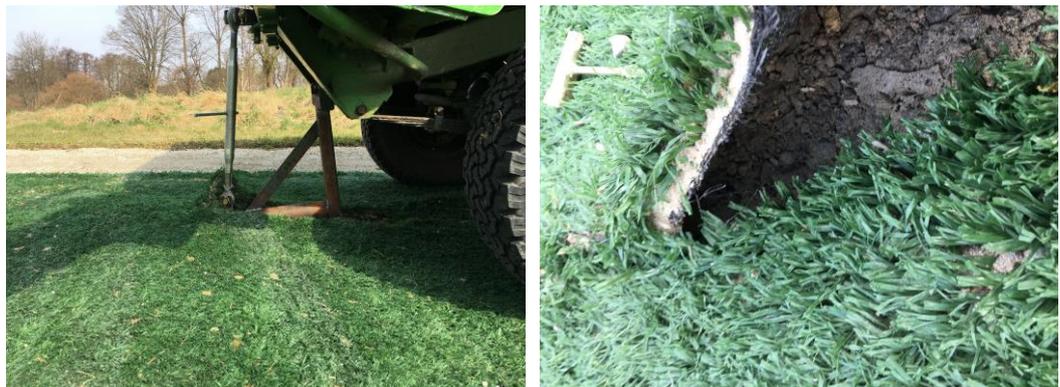
As the test during the first three test didn't show any medium to severe safety risks, an additionally separate test was performed to observe what would happen in the likelihood if the AGAT was penetrated and with high force was lifted and dragged/pushed to achieve a dangerous situation for the helicopter and/or surroundings. From test three the fine line cut in the AGAT was opened by a tool and the test equipment was manually driven into the hole and from here high force was used to drive toward the unbroken AGAT. Only with high force from the Volvo Valp (low gearing low shift), further penetration of the AGAT was possible and the AGAT at the end of a longer run would raise approx. ¼-½ foot.

This could theoretically escalate letting the AGAT fold in front of the "helicopter", but seen from the test a more cutting reaction of the AGAT was more likely. With the force required to perform the test, a helicopter landing performing a rupturing and full penetration of the AGAT with this force, would during landing on normal soil/grass result in a very high twisting torque resulting in a ground roll. Such a landing would most likely be catastrophic on any surface.

Worst case testing, result after executing the test of a setup pushing force below the AGAT with full test equipment structure below the AGAT.

Worst case test risk factor for helicopter and surroundings. Severity 4, Probability 0-1

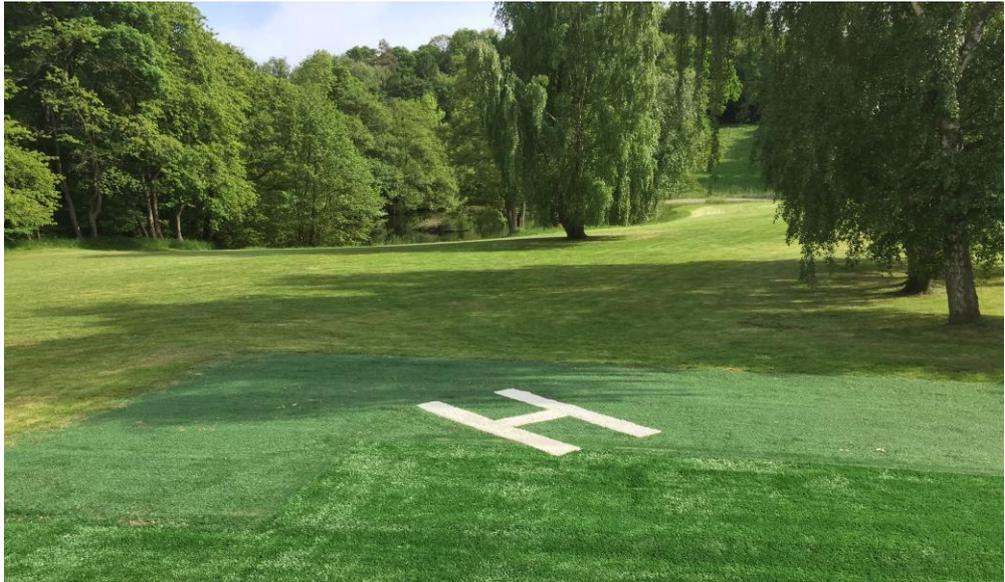
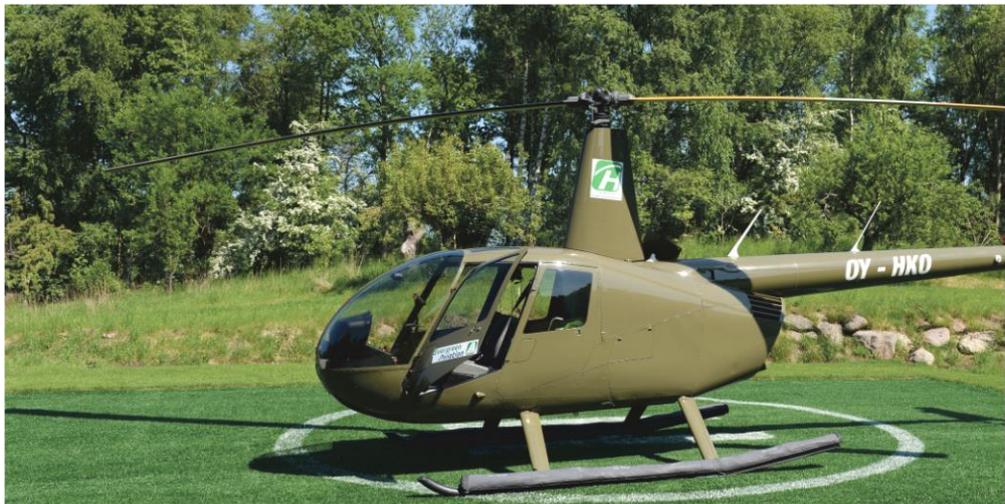
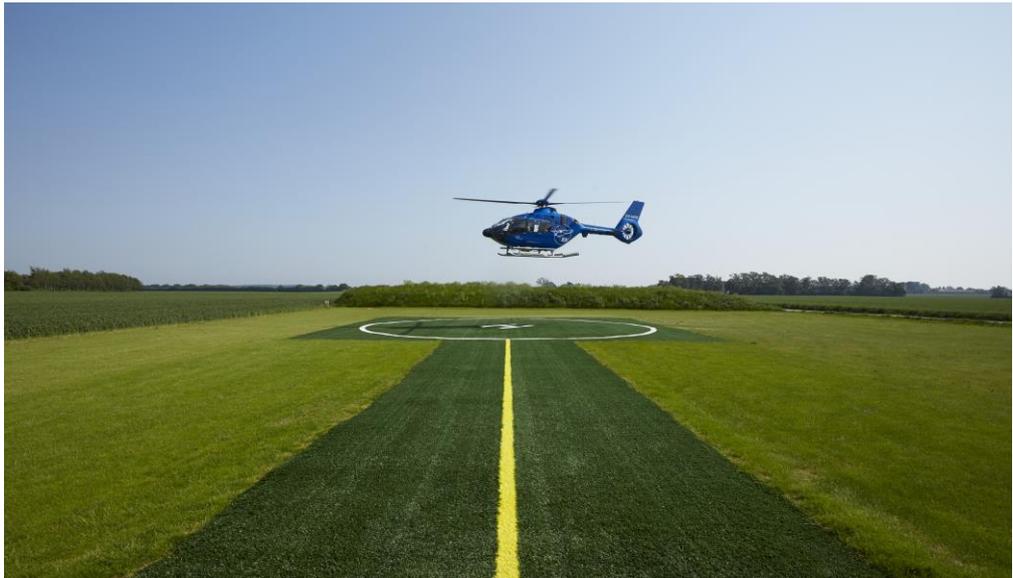
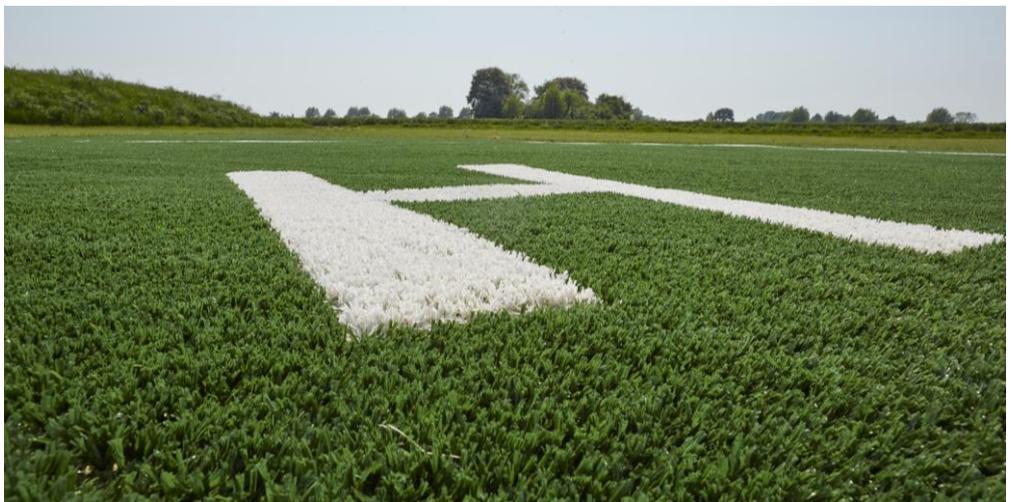
The AGAT helipad was reestablished with a new part of AGAT glued to the remaining installation close to the H-symbol in the middle of the installation. See the picture below and note the slightly difference in color due to the direction of the straw and the fading due to normal UV influence.
