# INSPECTION REPORT

# Inspection Report

Job Address: Private (Minnesota)

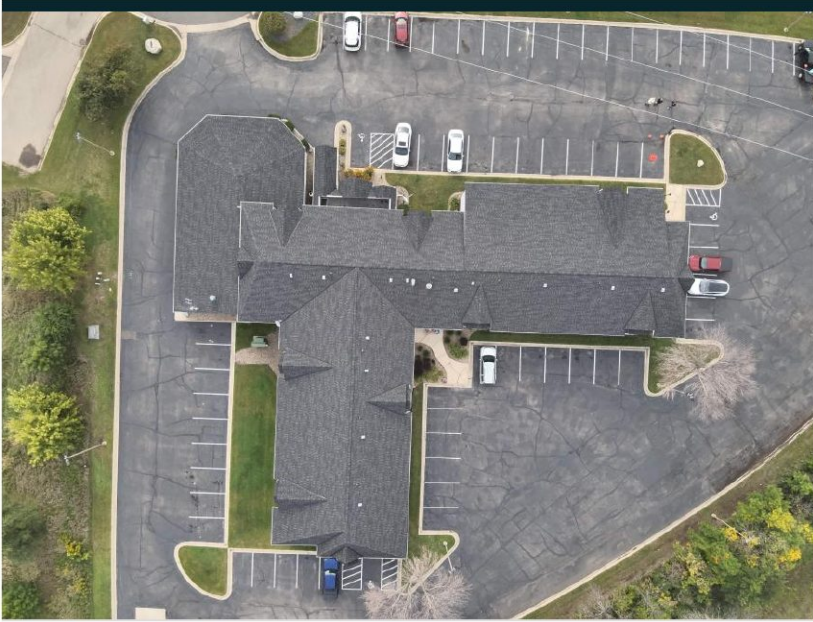
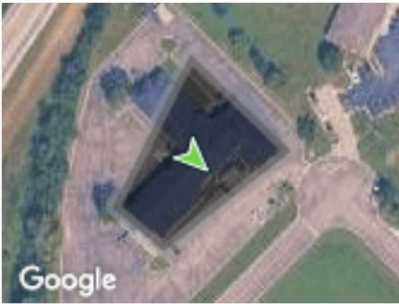
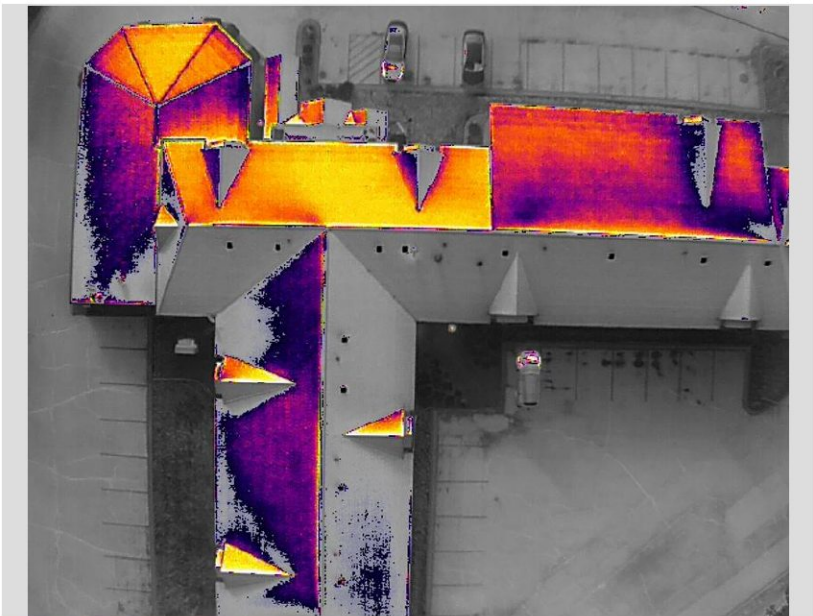
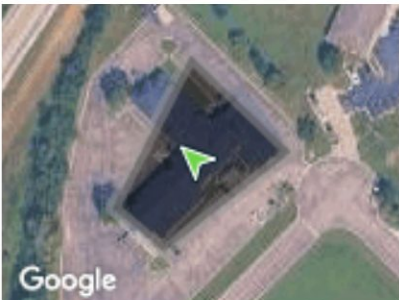
## FS001-T

Brian Nagorski  
09/15/2026 11:01 AM CDT  
Thermal Aerial overview of the hotel.  
- Lots of cold spots, something to keep an eye on.

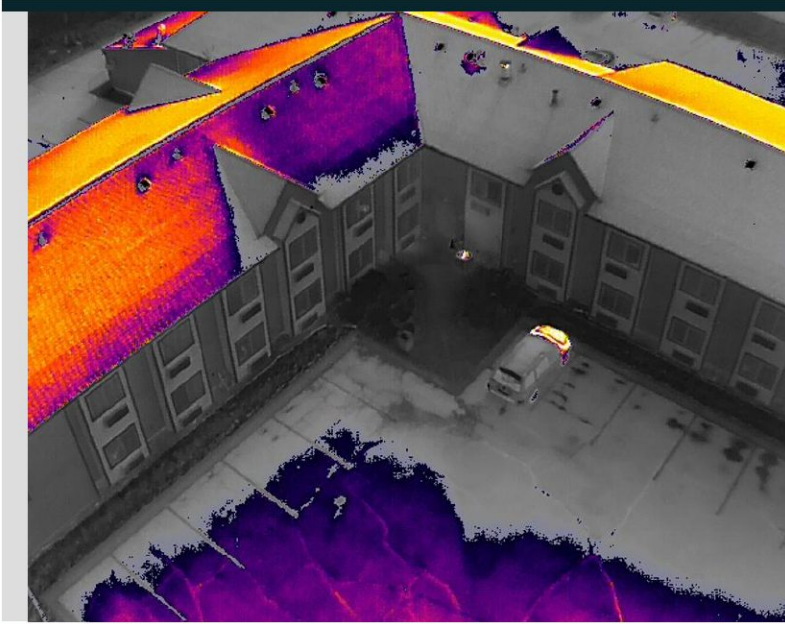
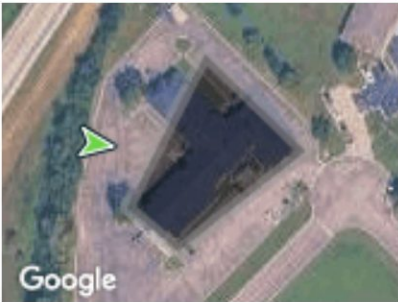
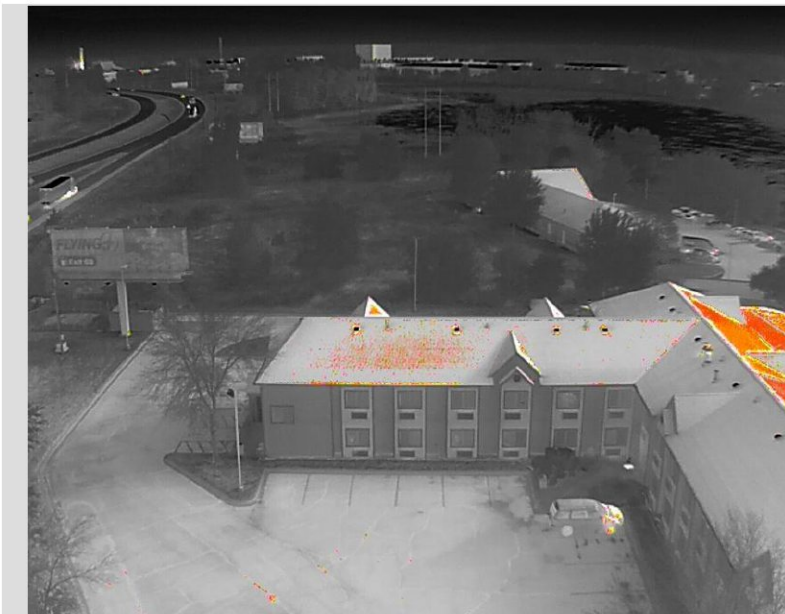
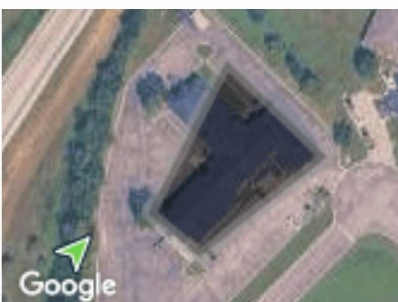
## LM020-T

Brian Nagorski  
09/15/2026 11:22 AM CDT  
This is also showing trapped moisture, could  
be from insulation or beneath the shingles

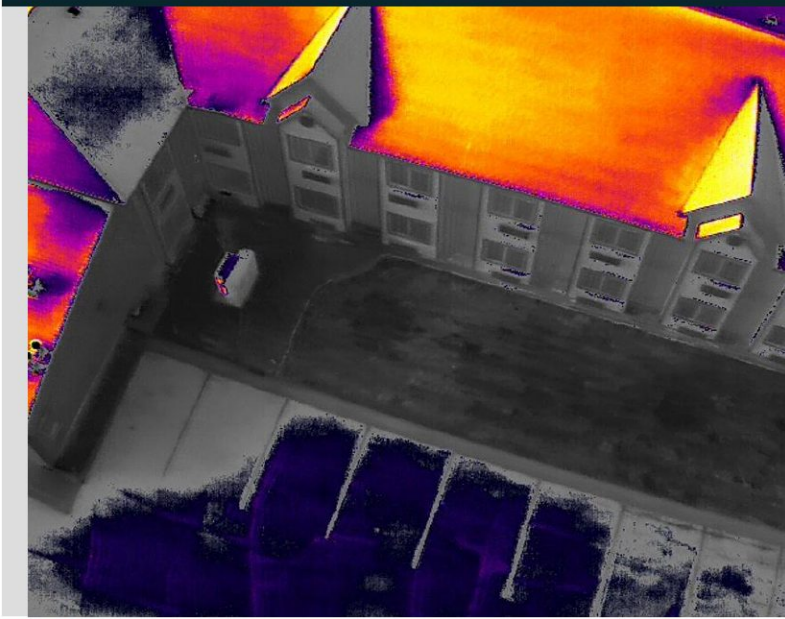
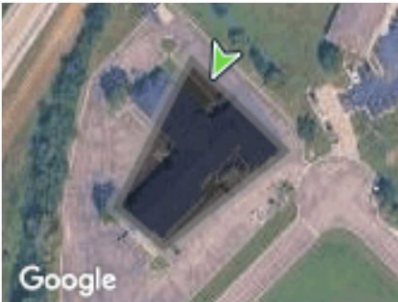
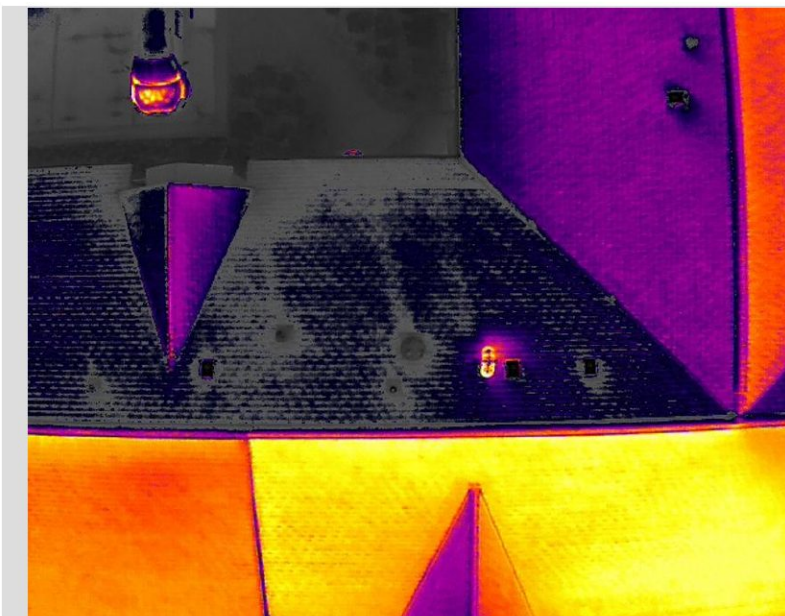
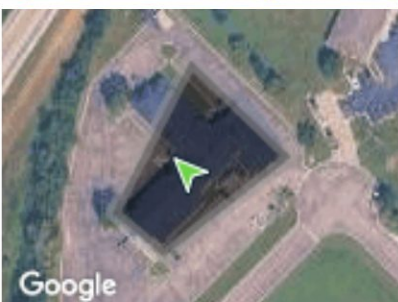
## LM081-T

Brian Nagorski  
09/15/2026 11:38 AM CDT  
Moisture/water intrusion detection on the  
rear elevation.

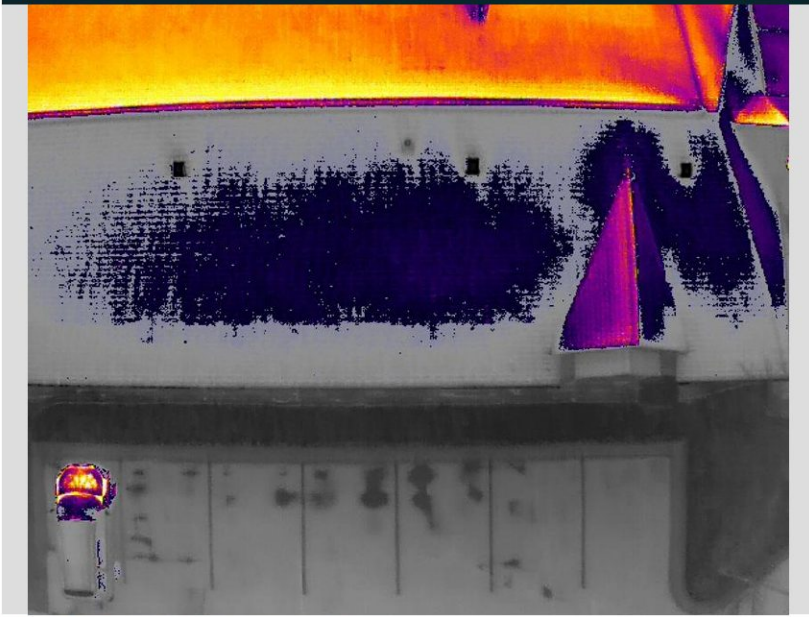
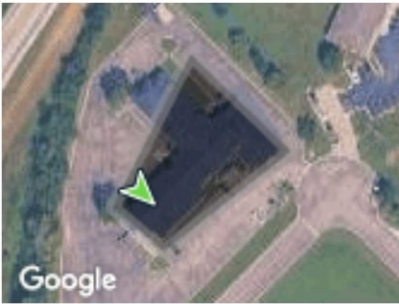
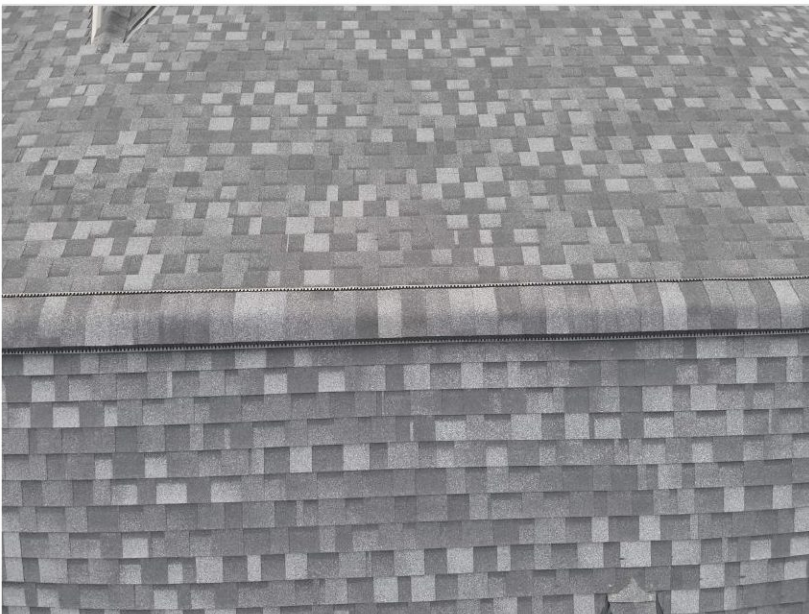
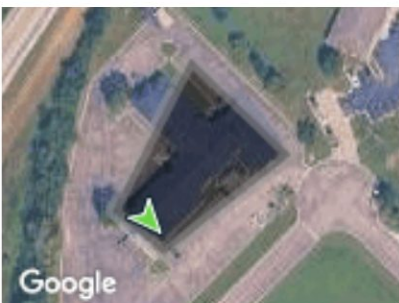
## PO007

Brian Nagorski  
09/15/2026 11:45 AM CDT  
Cracked/missing shingle

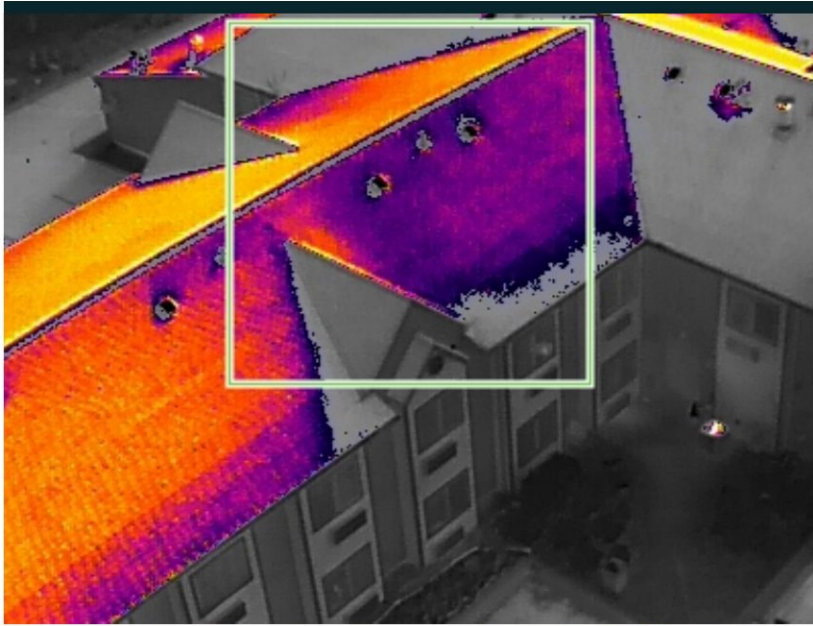
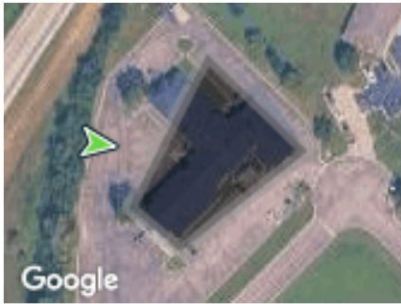
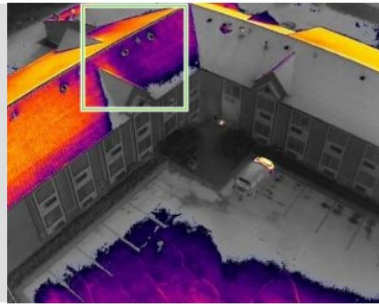
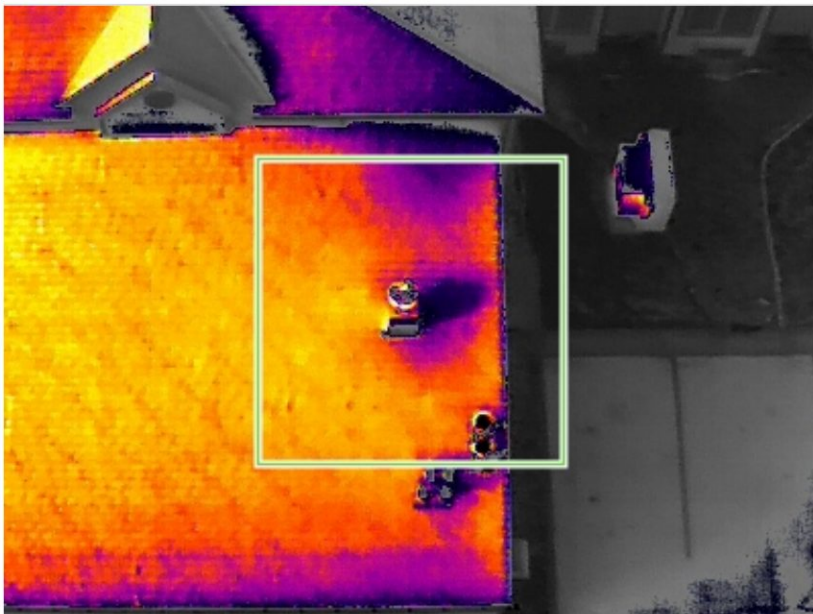
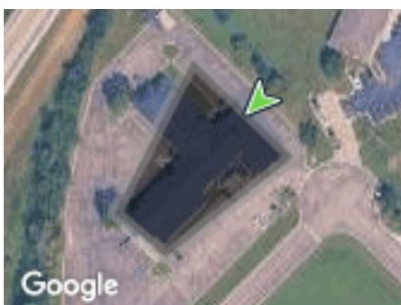
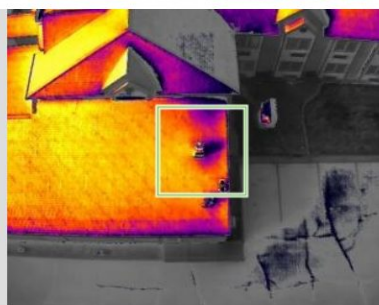
## LM061-T-1 MOISTURE SURVEY

Brian Nagorski  
09/15/2026 11:35 AM CDT  
Don't worry this is just a shadow.

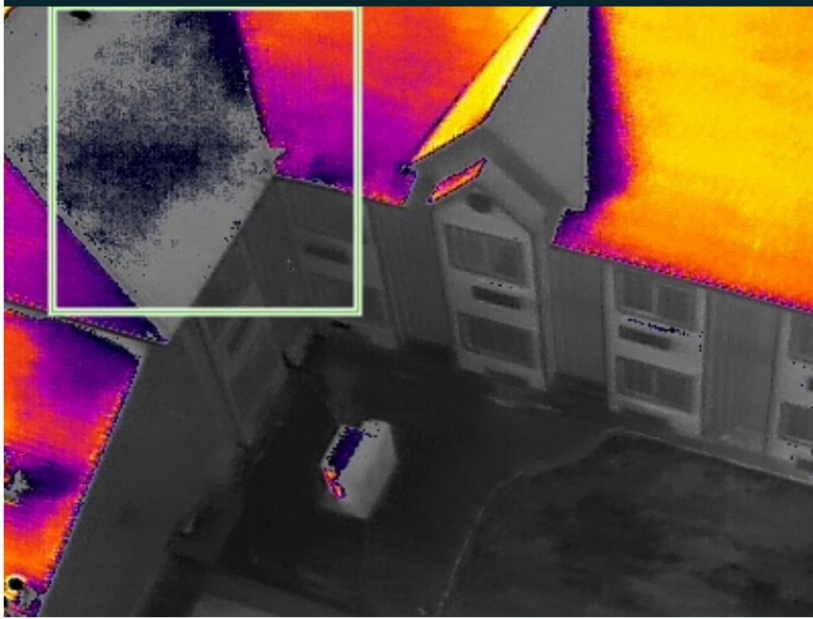
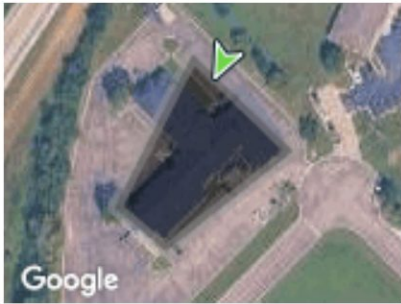
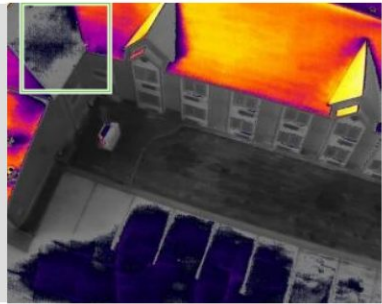
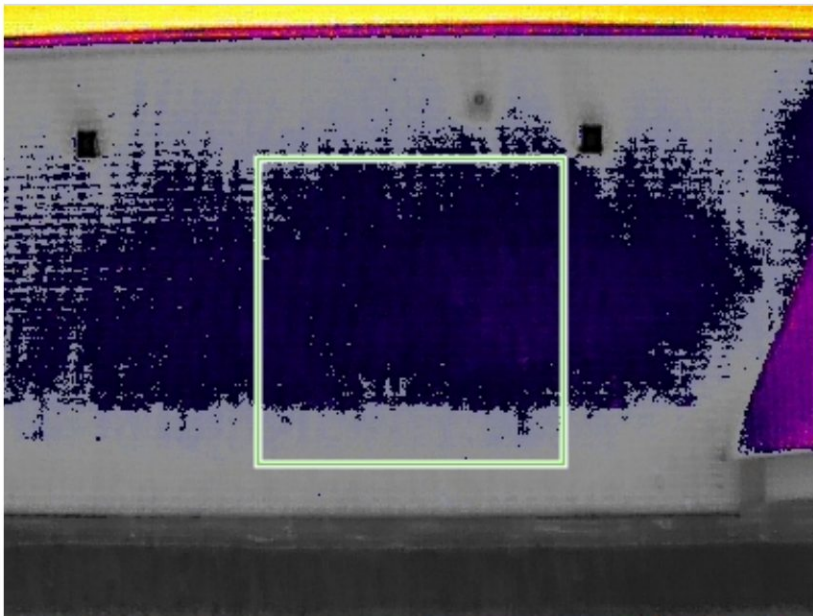
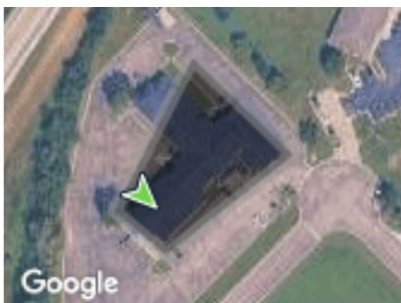
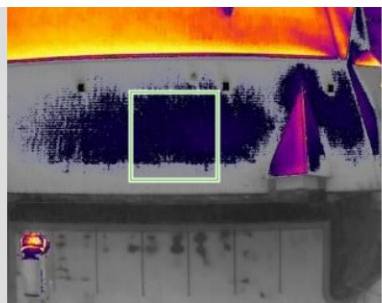
## LM090-T-1 MOISTURE SURVEY

Brian Nagorski  
09/15/2026 11:39 AM CDT  
More moisture intrusion on the rear  
elevation.
