# Executive Summary

## Engineer's Inspection Review

123 Main St, Your City, TX, 12345

### 0.0 - Background and Purpose

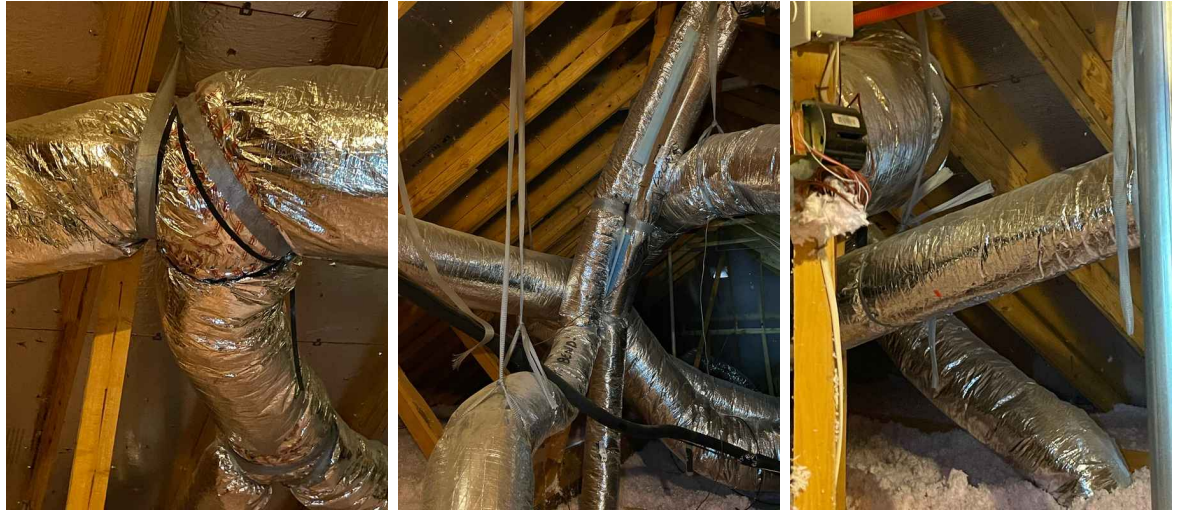
**1: Duct cleaning is recommended**

Inspector has discovered evidence that the HVAC duct system should be cleaned. This includes either a visual investigation of the plenums through access ports (if available) or supply vents that are dirty, dusty, and/or clogged with debris.

Recommendation: Contact a qualified HVAC professional.

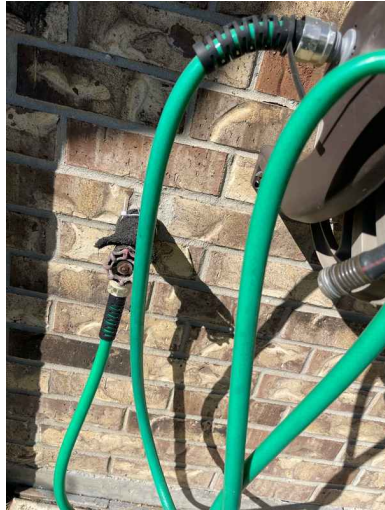
**1: Low pressure and/or flow to faucet(s)**

Low water pressure / flow to one or more faucets. This may be due to a clogged water supply pipe, a clogged inline filter, or a broken fixture. Recommend further investigation by a plumbing contractor.

Recommendation: Contact a qualified plumbing contractor.

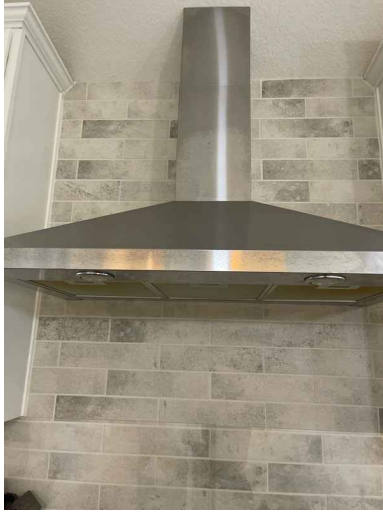
**1: Filter needs cleaning**

The vent hood filter is dirty and/or old. It needs to be cleaned or replaced.

Recommendation: Recommended DIY Project

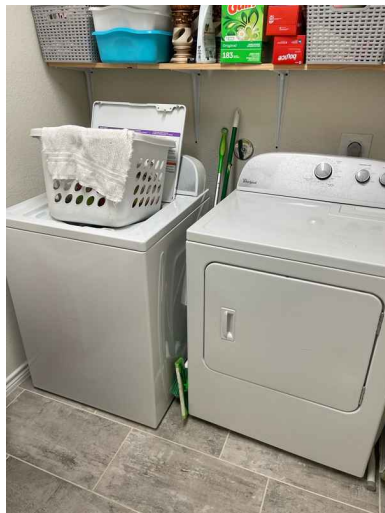
*Exhaust is not visible:*

The washer and/or dryer are blocking the exhaust from being fully examined.

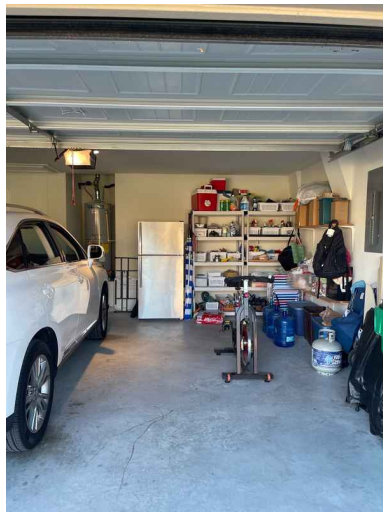
Garage

### *Obstructed by personal effects:*

The area is obstructed by or filled-with personal effects and cannot be inspected. Recommend owner remove personal effects to allow for property testing.
