Thermography Report 248 Steelcase Rd. E., Markham

Inspection Date: February 10, 2026

Company:
Arbutus Real Estate
333 Denison St.
Markham, ON
L3R 2Z4

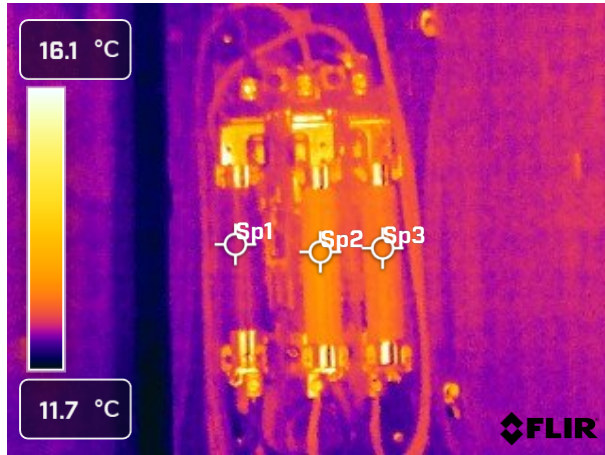
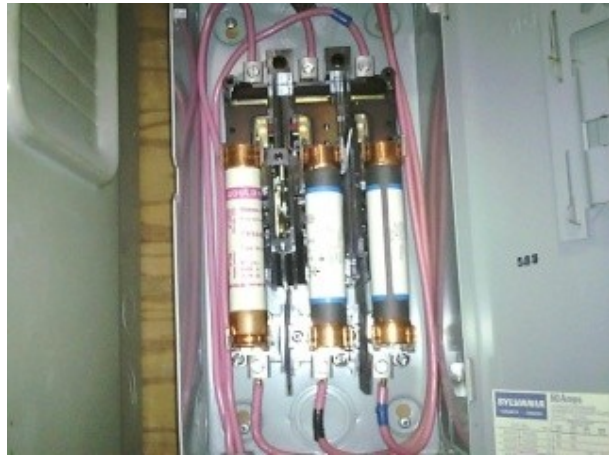
Measurements		Sp1	12.4 °C	Sp2	13.1 °C	Sp3	12.9 °C
Measurements									
Sp1	12.4 °C								
Sp2	13.1 °C								
Sp3	12.9 °C								
Visual Inspection Notes:	No anomalies found								
Corrective Action:									
Created	2026-02-10 10:25:00 AM

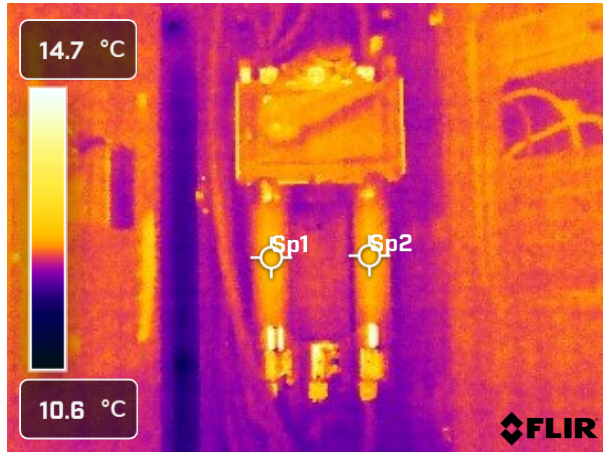
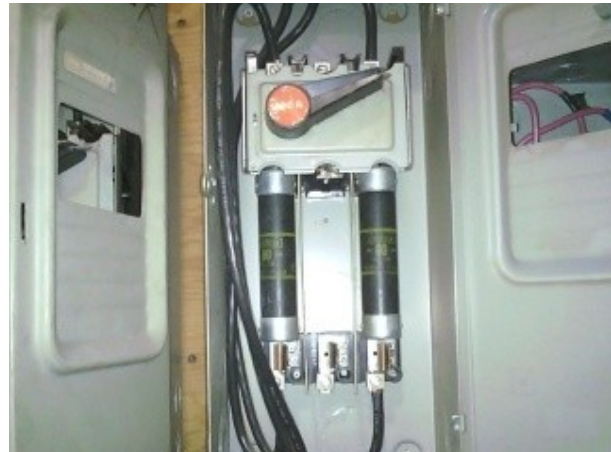
Measurements		Sp1	12.5 °C	Sp2	12.6 °C
Measurements							
Sp1	12.5 °C						
Sp2	12.6 °C						
Visual Inspection Notes:	No anomalies found						
Corrective Action:							
Created	2026-02-10 10:25:23 AM

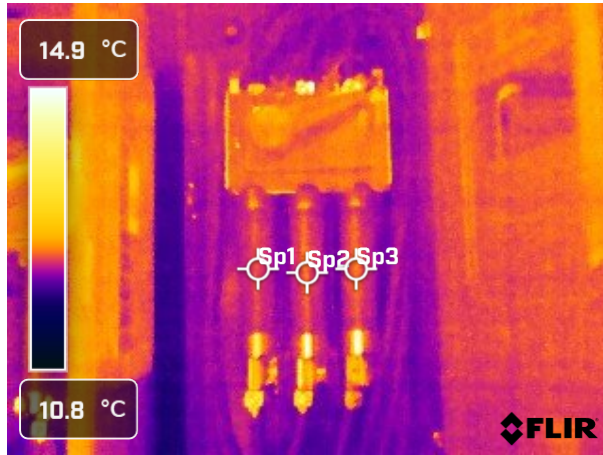
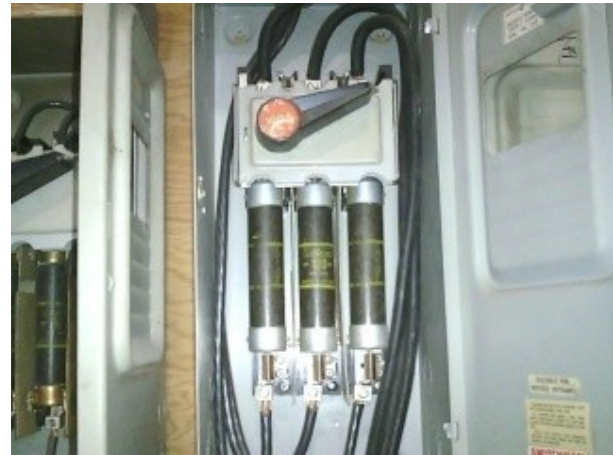
Measurements		Sp1	12.4 °C	Sp2	12.5 °C	Sp3	12.5 °C
Measurements									
Sp1	12.4 °C								
Sp2	12.5 °C								
Sp3	12.5 °C								
Visual Inspection Notes:	No anomalies found								
Corrective Action:									
Created	2026-02-10 10:25:50 AM

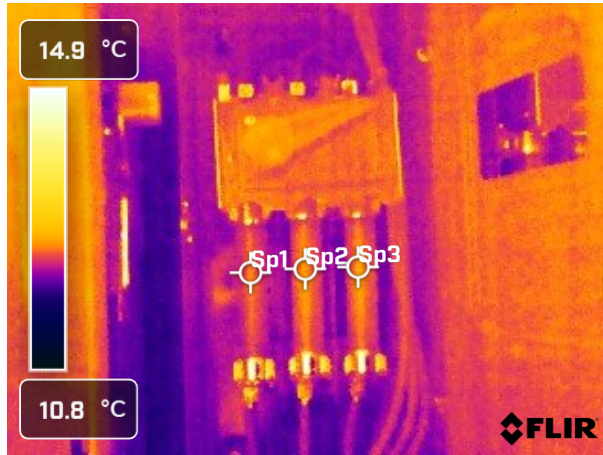
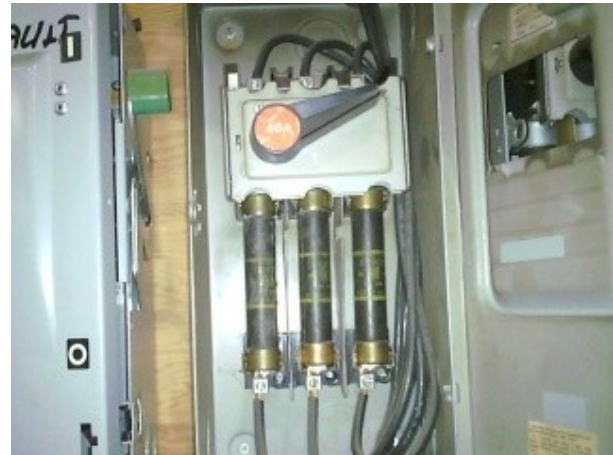
Measurements		Sp1	12.6 °C	Sp2	12.7 °C	Sp3	12.8 °C
Measurements									
Sp1	12.6 °C								
Sp2	12.7 °C								
Sp3	12.8 °C								
Visual Inspection Notes:	No anomalies found								
Corrective Action:									
Created	2026-02-10 10:26:43 AM

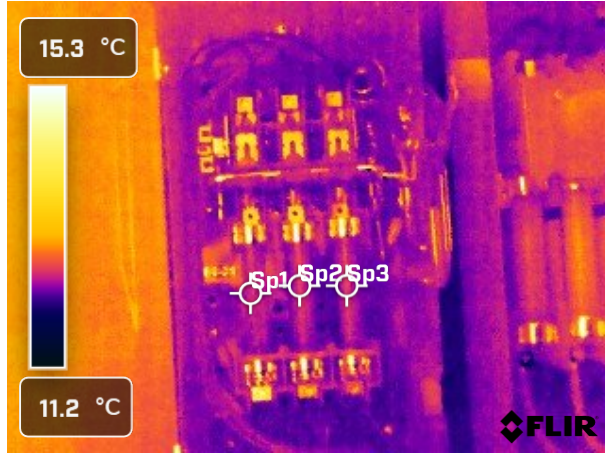
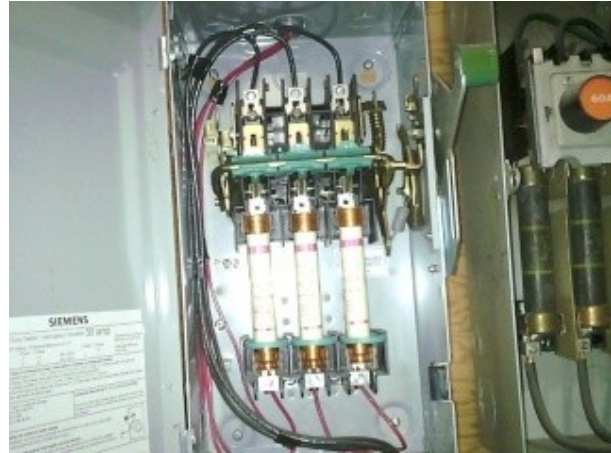
Measurements		Sp1	12.5 °C	Sp2	12.6 °C	Sp3	12.7 °C
Measurements									
Sp1	12.5 °C								
Sp2	12.6 °C								
Sp3	12.7 °C								
Visual Inspection Notes:	No anomalies found								
Corrective Action:									
Created	2026-02-10 10:35:57 AM

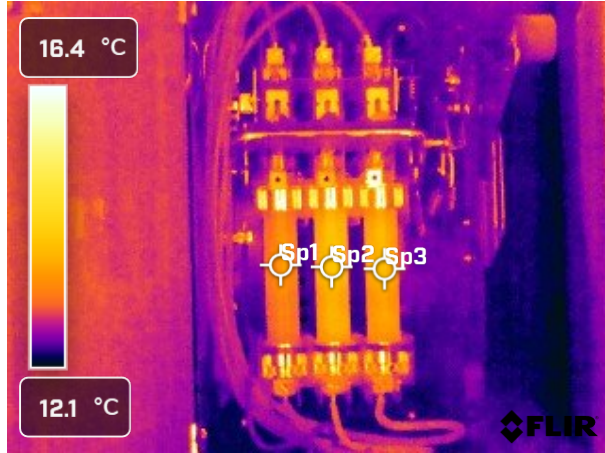
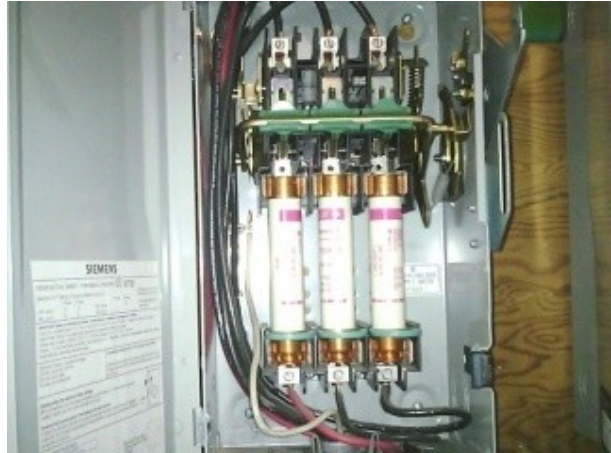
Measurements		Sp1	13.6 °C	Sp2	14.1 °C	Sp3	13.9 °C
Measurements									
Sp1	13.6 °C								
Sp2	14.1 °C								
Sp3	13.9 °C								
Visual Inspection Notes:	No anomalies found								
Corrective Action:									
Created	2026-02-10 10:36:21 AM

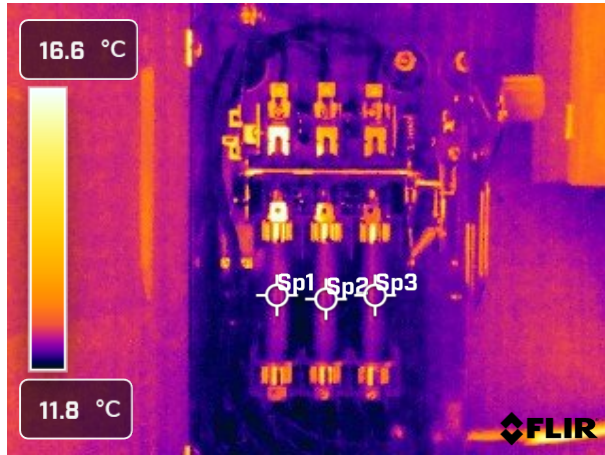
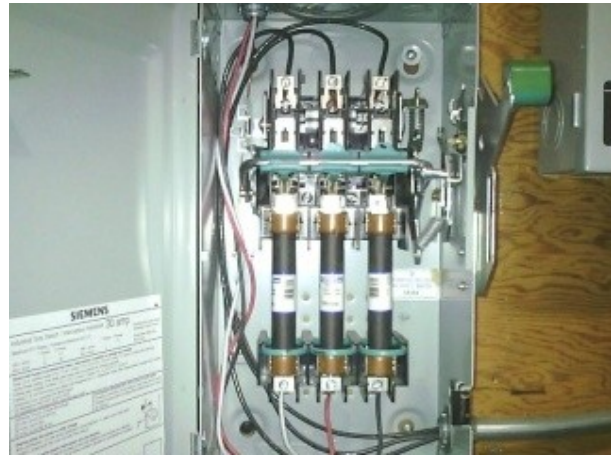
Measurements		Sp1	12.3 °C	Sp2	12.1 °C	Sp3	12.2 °C
Measurements									
Sp1	12.3 °C								
Sp2	12.1 °C								
Sp3	12.2 °C								
Visual Inspection Notes:	No anomalies found								
Corrective Action:									
Created	2026-02-10 10:37:01 AM

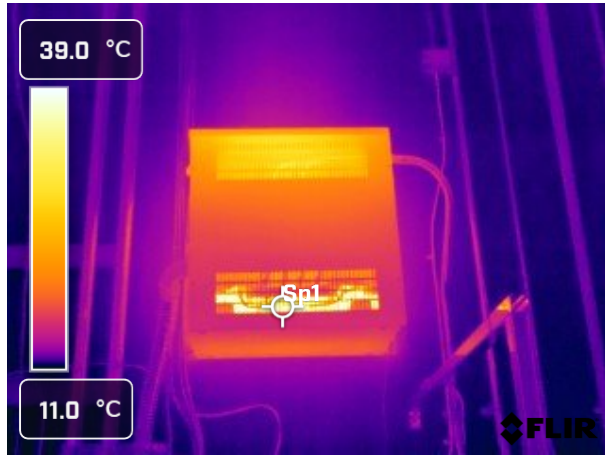
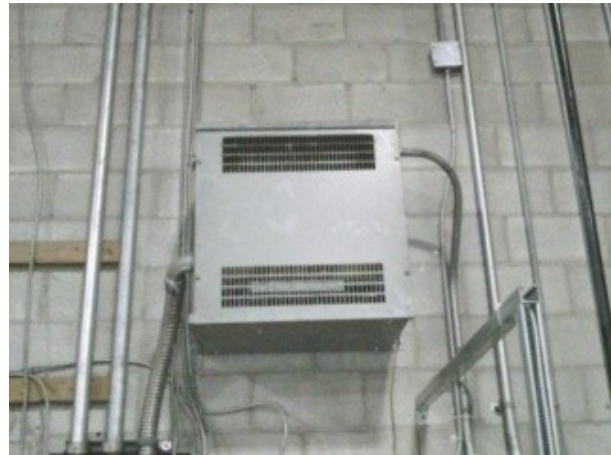
Location: Warehouse - Main Distribution - Transformer					
Equipment	<i>Hammond 45kva transformer</i>				
Minimum temp.	10.9 °C				
Maximum temp.	52.5 °C				
Measurements:	No hot spots detected				
	<table border="1"> <thead> <tr> <th colspan="2">Measurements</th> </tr> </thead> <tbody> <tr> <td>Sp1</td> <td>36.9 °C</td> </tr> </tbody> </table>	Measurements		Sp1	36.9 °C
Measurements					
Sp1	36.9 °C				
Visual Inspection Notes:	No anomalies found				
Corrective Action:					
Created	2026-02-10 11:47:07 AM

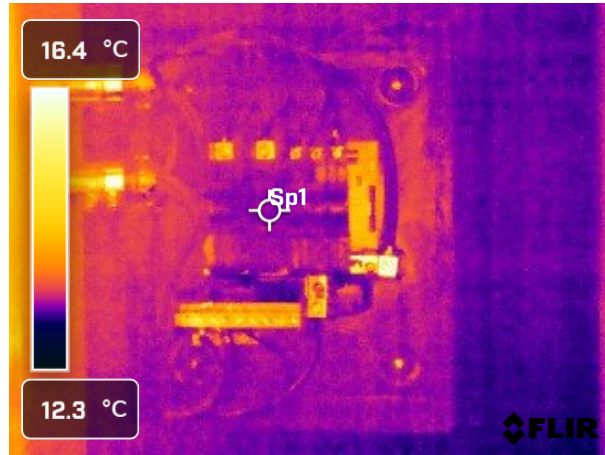
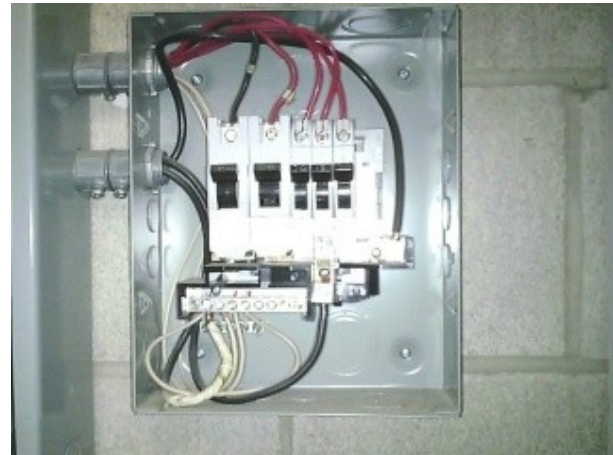
Location: Closet in Warehouse - Panel A Pony Panel					
Equipment	<i>Federal Pioneer 120/240V 70A breaker panel</i>				
Minimum temp.	12.9 °C				
Maximum temp.	18.9 °C				
Measurements:	No hot spots detected <table border="1" style="margin-left: auto; margin-right: auto;"> <thead> <tr> <th colspan="2">Measurements</th> </tr> </thead> <tbody> <tr> <td>Sp1</td> <td>13.3 °C</td> </tr> </tbody> </table>	Measurements		Sp1	13.3 °C
Measurements					
Sp1	13.3 °C				
Visual Inspection Notes:	No anomalies found				
Corrective Action:					
Created	2026-02-10 11:21:49 AM

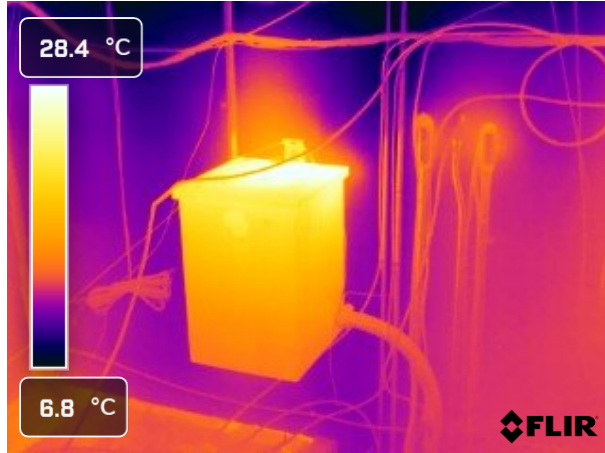
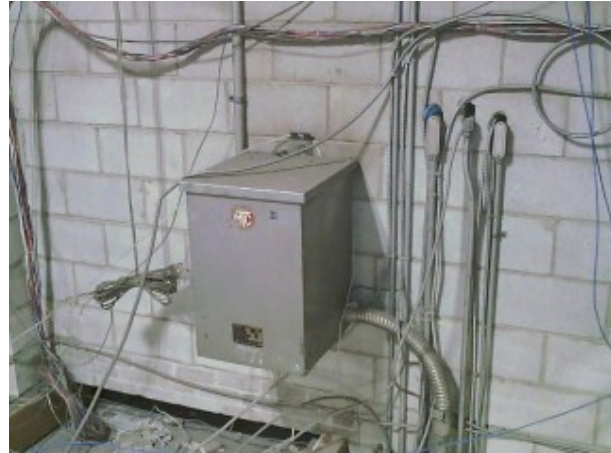
Location: Warehouse next to mezzanine Transformer	
Equipment	<i>Unable to read manufacturing label</i>
Minimum temp.	5.4 °C
Maximum temp.	30.3 °C
Measurements:	No hot spots detected Measurements
Visual Inspection Notes:	No anomalies found
Corrective Action:	
Created	2026-02-10 11:52:04 AM

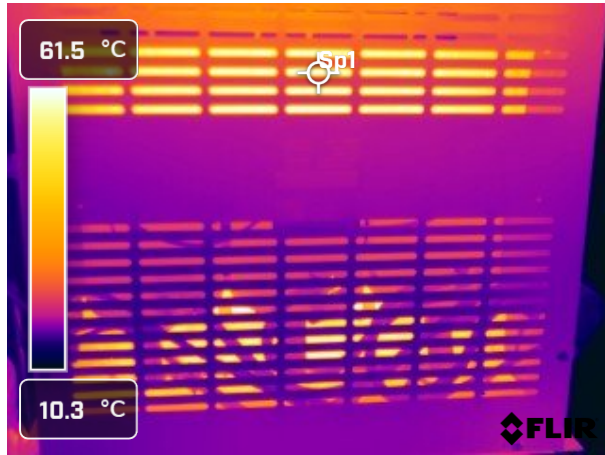
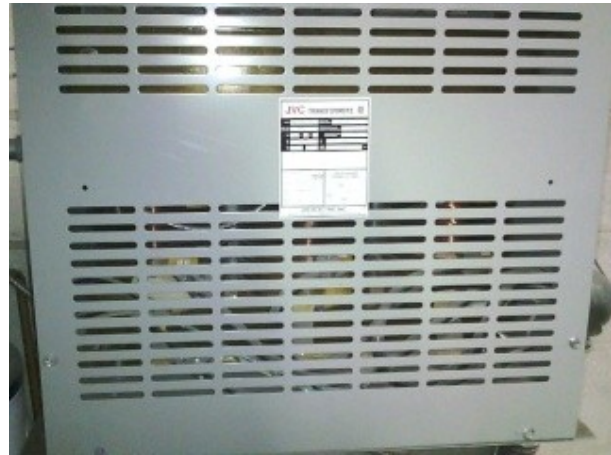
Location: Mezzanine - Transformer					
Equipment	JVC 600V 120/208V 45kva transformer				
Minimum temp.	10.0 °C				
Maximum temp.	65.5 °C				
Measurements:	No hot spots detected <table border="1" style="margin-left: auto; margin-right: auto;"> <thead> <tr> <th colspan="2">Measurements</th> </tr> </thead> <tbody> <tr> <td>Sp1</td> <td>59.9 °C</td> </tr> </tbody> </table>	Measurements		Sp1	59.9 °C
Measurements					
Sp1	59.9 °C				
Visual Inspection Notes:	No anomalies found				
Corrective Action:					
Created	2026-02-10 11:52:43 AM

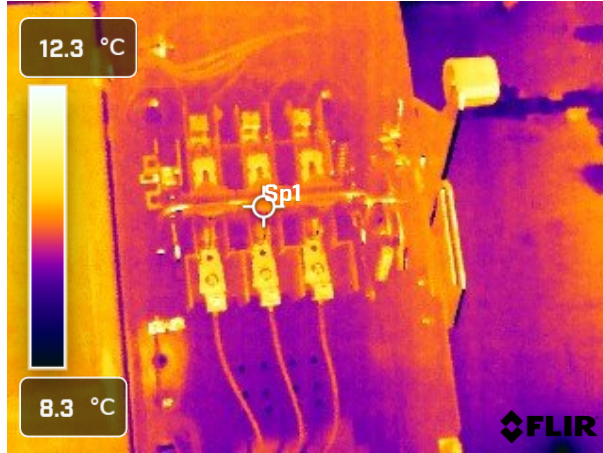
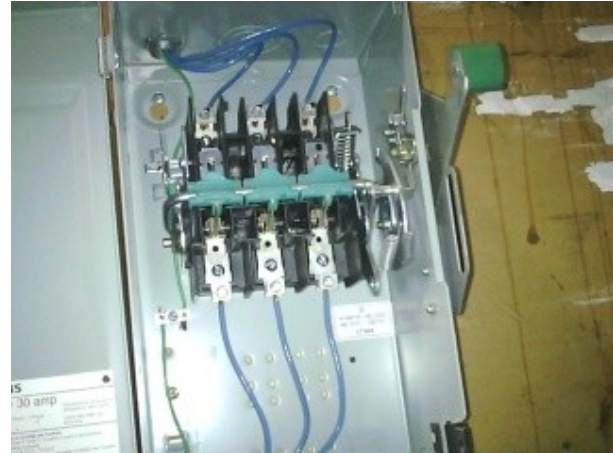
Location: Bay Door Distribution - Transformer Disconnect					
Equipment	<i>Siemens 600V 30A non fused disconnect</i>				
Minimum temp.	6.4 °C				
Maximum temp.	15.5 °C				
Measurements:	No hot spots detected				
	<table border="1"> <thead> <tr> <th colspan="2">Measurements</th> </tr> </thead> <tbody> <tr> <td>Sp1</td> <td>10.6 °C</td> </tr> </tbody> </table>	Measurements		Sp1	10.6 °C
Measurements					
Sp1	10.6 °C				
Visual Inspection Notes:	No anomalies found				
Corrective Action:					
Created	2026-02-10 12:00:17 PM

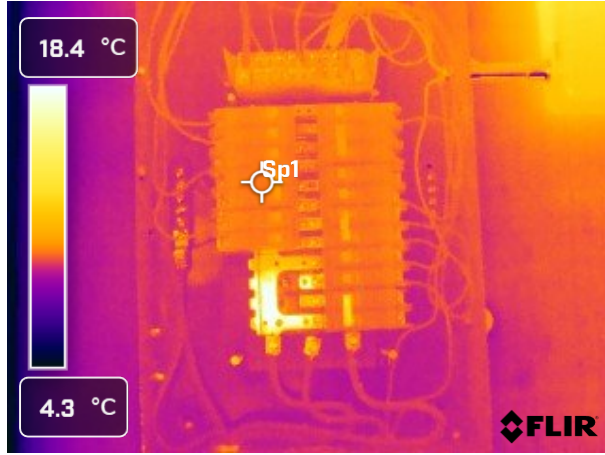
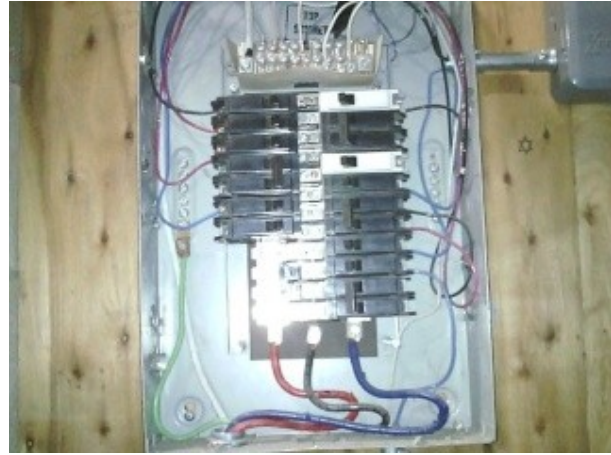
Location: Bay Door Distribution - Panel A					
Equipment	<i>Sylvania 120/208V 125A breaker panel</i>				
Minimum temp.	4.0 °C				
Maximum temp.	23.0 °C				
Measurements:	<p>No hot spots detected</p> <table border="1" style="margin-left: auto; margin-right: auto;"> <thead> <tr> <th colspan="2">Measurements</th> </tr> </thead> <tbody> <tr> <td>Sp1</td> <td>10.4 °C</td> </tr> </tbody> </table>	Measurements		Sp1	10.4 °C
Measurements					
Sp1	10.4 °C				
Visual Inspection Notes:	No anomalies found				
Corrective Action:					
Created	2026-02-10 12:00:06 PM
