Jul 28th, 2026

294 Addison Drive, Kissimmee, FL, 34759

# Home Inspection Report

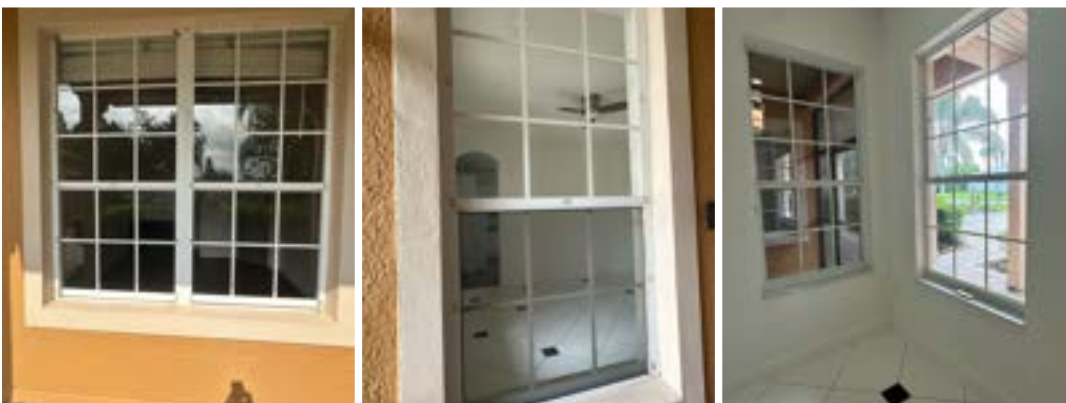
## 2.3 WINDOWS

The exterior components of the home were visually inspected and were found to be in generally good condition at the time of the inspection. The exterior wall coverings appeared to be properly maintained with no visible signs of significant deterioration. Site grading around the foundation appeared to provide adequate drainage away from the structure. No visible evidence of moisture intrusion or water penetration was observed on the exterior surfaces. The screened lanai, landscaping, and driveway were observed to be in satisfactory condition with no significant deficiencies noted. Continued routine maintenance is recommended to preserve the condition of these components. THE WINDOW DOES NOT HAVE AN INSECT SCREEN INSTALLED.

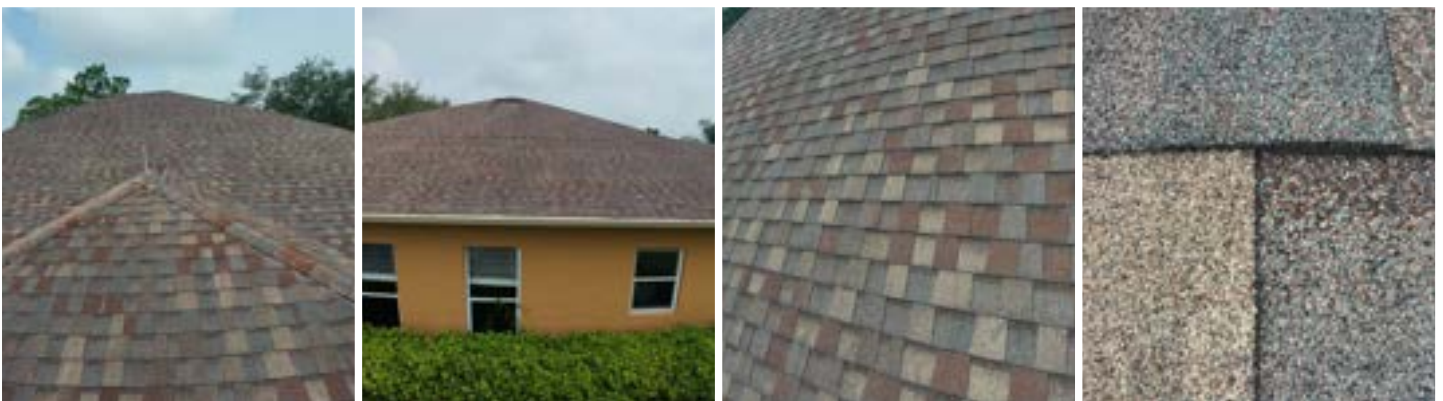
### 3.1 TYPE

The asphalt shingle roof was visually inspected and appeared to be in generally good condition at the time of the inspection. No lifted, damaged, or significantly deteriorated shingles were observed. Based on available information, the roof covering was reportedly replaced in 2018. The gutters were observed to contain an accumulation of leaves and debris, which may impede proper drainage if not addressed. Recommend cleaning the gutters and maintaining them on a regular basis to help ensure proper water runoff and reduce the potential for overflow or water-related damage. No significant deficiencies were observed with the roof covering at the time of the inspection. Continued routine maintenance and periodic monitoring are recommended to help maximize the service life of the roof.
