SUMMARY

1234 Main Street Cherry Hill NJ 08002

Buyer Name
03/22/2026 9:00AM

Brian Maute
InterNACHI Certified & NJ Licensed Home
Inspector
Vivid Home Inspections
(609) 922-7456
inspectionsbyvivid@gmail.com

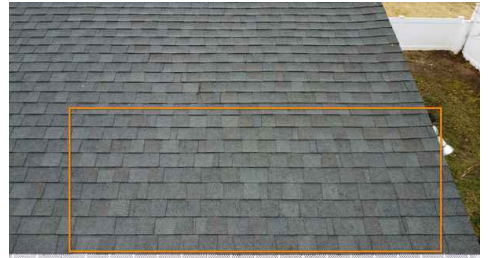
The roof covering exhibited excessive loss of surface granules. Granules serve as a protective layer that shields the underlying material from ultraviolet exposure and normal weathering. When granule loss becomes pronounced, the roofing material may deteriorate more rapidly and become more vulnerable to damage. This condition can shorten the expected service life of the roof covering over time.

Recommendation

Contact a qualified roofing professional.

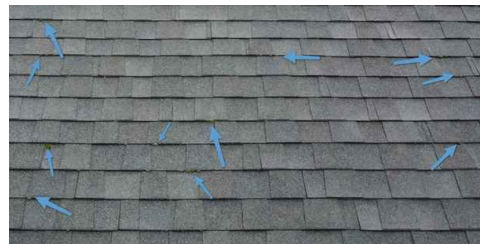
Moss and lichen growth were observed on the roof covering. Organic growth can retain moisture against the surface of the roofing material and may contribute to gradual deterioration over time. In some cases, root-like structures can lift or separate roofing materials as growth expands. Regular maintenance and cleaning can help manage the condition and support the longevity of the roof covering.

Recommendation

Contact a qualified roofing professional.

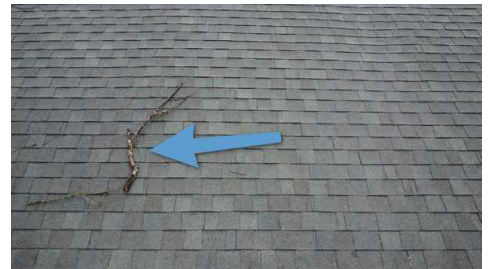
Tree debris was observed on the roof surface. Accumulated leaves, branches, and organic material can retain moisture against the roofing material and may contribute to premature deterioration over time. Debris can also obstruct proper drainage and interfere with water runoff. Routine removal of roof debris helps maintain proper performance and prolong the service life of the roofing system.

Recommendation
Contact a qualified professional.

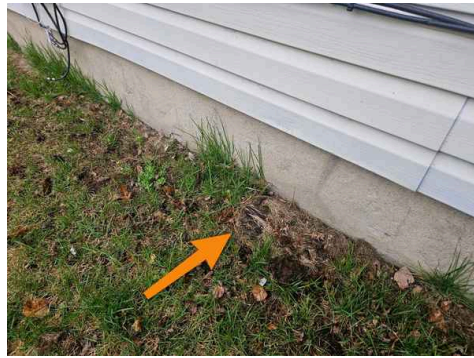
Right Middle

Evidence was observed indicating that a tree was previously located in close proximity to the structure. Tree roots near foundations can affect soil stability and may contribute to localized settlement or movement over time. Although the tree has been removed, remaining root systems may continue to decompose and influence soil conditions. Monitoring of the surrounding soil and foundation area is recommended to identify any future changes.

Recommendation
Contact a qualified landscaping contractor

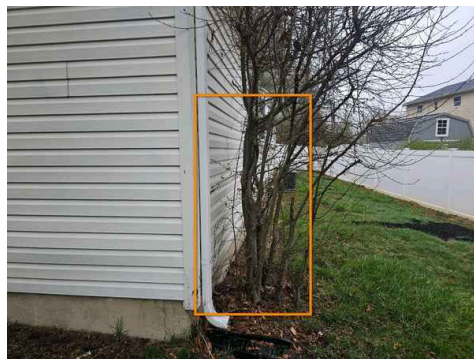
Rear

A tree was observed located in close proximity to the structure. Trees situated near foundations and exterior walls can influence soil moisture conditions and may contribute to root-related soil movement over time. Overhanging limbs may also deposit debris on roof surfaces and increase maintenance requirements. Maintaining appropriate distance between trees and the structure can help reduce potential impact on exterior components and drainage patterns.

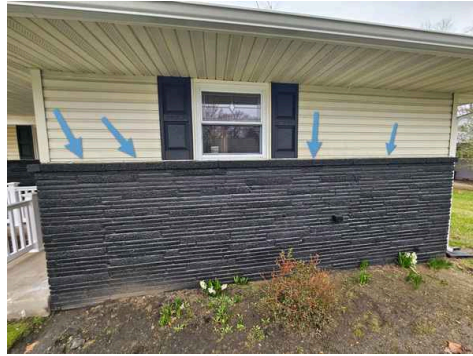
Sealant at various siding and trim joints was observed to be cracked, separated, or deteriorated. Gaps were visible at certain transitions around penetrations and trim interfaces. Deteriorated caulking can allow moisture and air intrusion at exterior wall assemblies. Routine maintenance of sealant joints helps preserve the performance of siding and trim materials over time.

Front - Along the front edge where the vinyl siding meets the stone veneer.

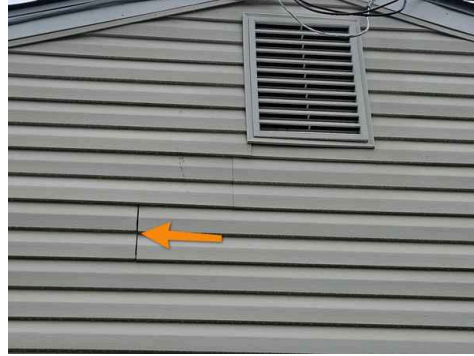
Left

Gaps were observed between sections of the exterior siding material. Open seams and separation were visible at certain joints and transitions. Gaps in siding can allow moisture, air, or pests to enter the wall assembly if not properly sealed or overlapped. Continued exposure at these openings may contribute to deterioration of underlying materials over time.

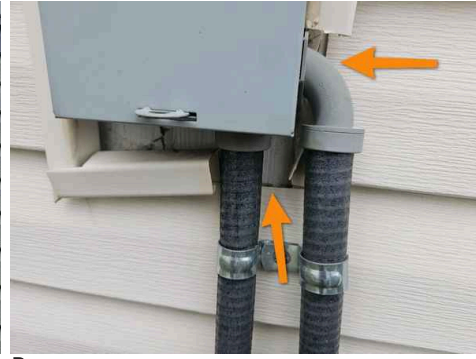
Rear

J-channel trim was not observed at one or more siding termination points where it is typically installed. The siding edges appeared unfinished or not properly secured at openings or transitions. Missing J-channel can allow moisture to enter behind the siding and may affect the overall fit and appearance of the cladding. Proper termination components help manage water and support the siding system.

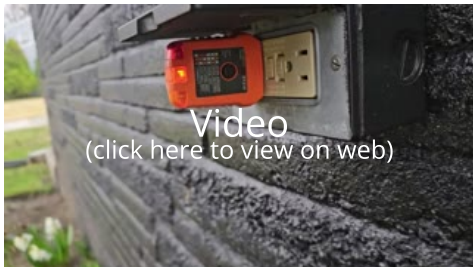
Front

The exterior GFCI receptacle did not respond properly when tested at the time of inspection. Activation of the test function did not interrupt power as expected. A GFCI that does not operate as intended may not provide proper ground-fault protection in exterior locations. Further evaluation and correction are recommended to restore proper protective function.

Recommendation
Contact a qualified electrical contractor.

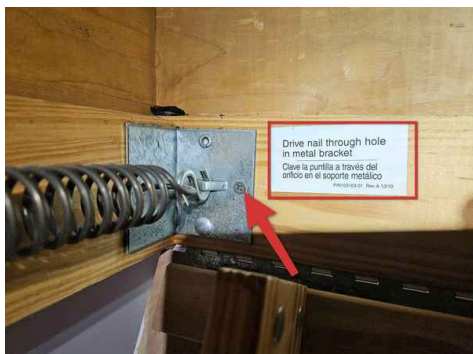
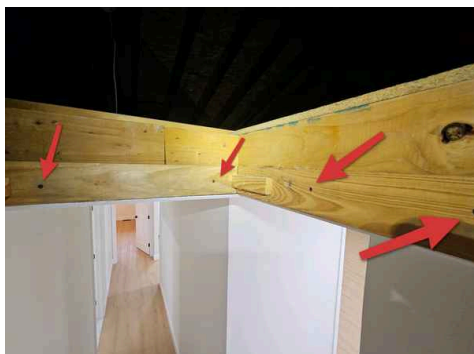
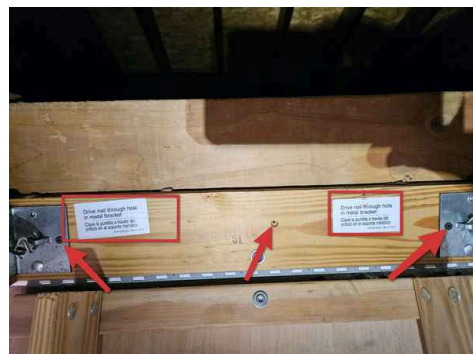
Improper fasteners used to install the folding attic ladder

Recommendation

Contact a qualified general contractor.

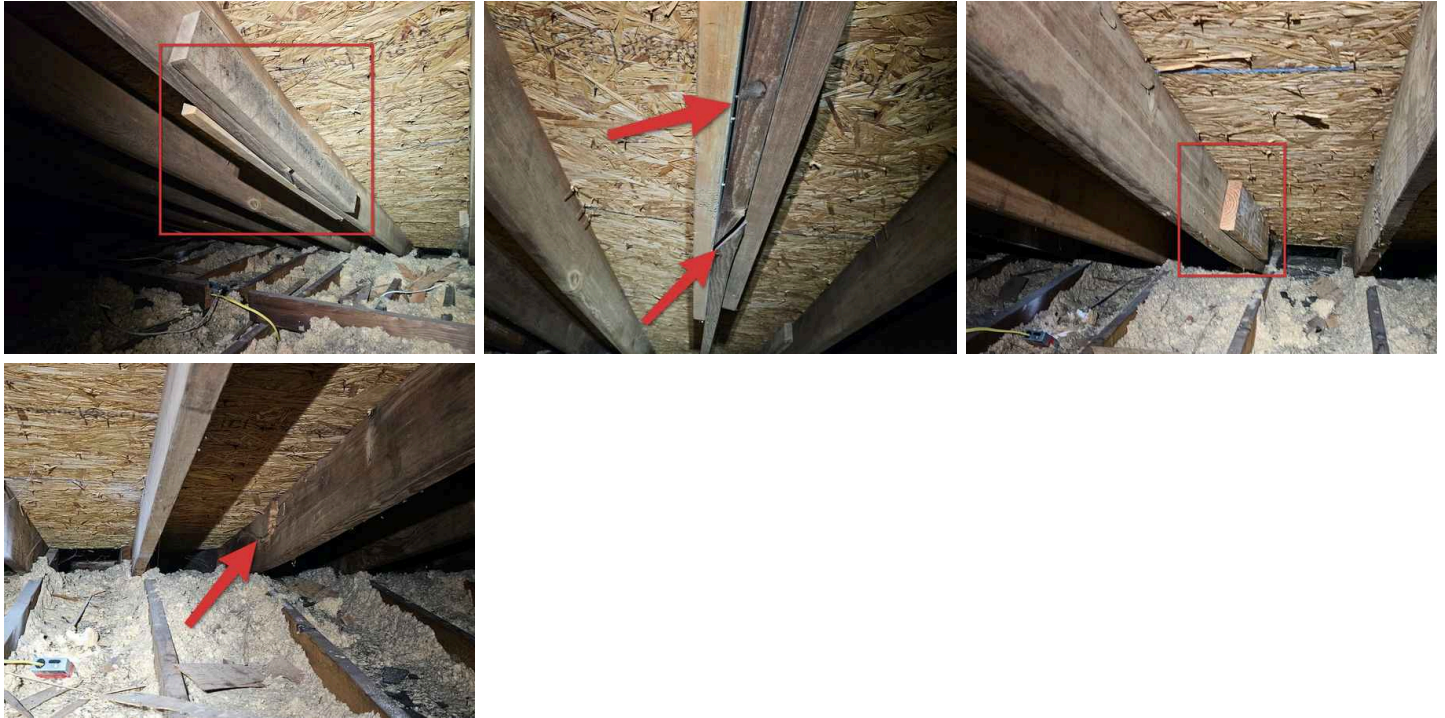
A structural framing member in the attic had been sistered with an additional member, but the installation appeared to be incomplete or improperly secured. Sistering is commonly used to reinforce damaged or weakened framing members. When reinforcement members are not properly fastened or do not extend the full length of the original member, the repair may not provide the intended structural support. Improper reinforcement may allow continued movement or deflection of the framing. Further evaluation may help determine whether improved reinforcement is needed.

Recommendation
Contact a qualified structural engineer.

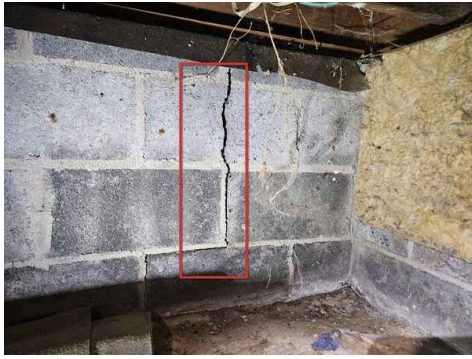
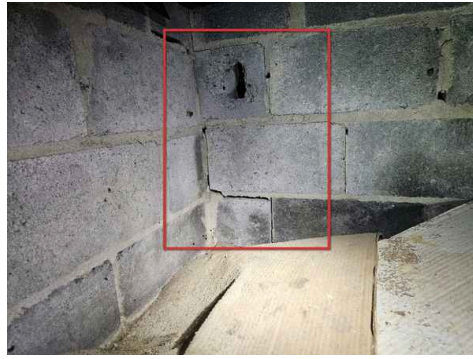
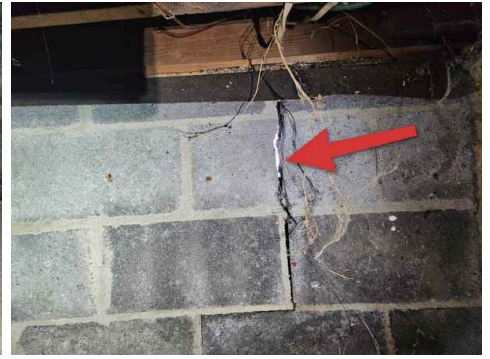
A significant crack was observed in the foundation wall within the crawlspace at the time of the inspection. Large foundation cracks may indicate structural movement or settlement and can allow moisture to enter the crawlspace area. Continued movement or moisture intrusion may affect the performance of the foundation and adjacent structural components over time. Further evaluation is recommended to determine the extent of the condition and whether corrective measures are needed.

Recommendation
Contact a qualified structural engineer.

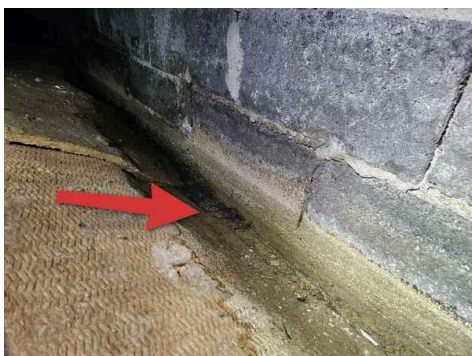
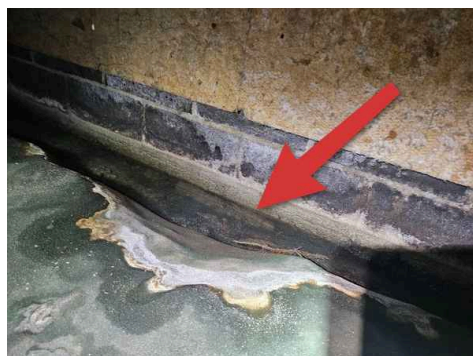
Standing water was observed in the crawlspace at the time of the inspection. The presence of pooled water beneath the structure can contribute to elevated moisture levels that may affect wood framing, insulation, and other materials located in the area. Prolonged moisture exposure may lead to deterioration of structural components and can create conditions favorable for biological growth or pest activity. Further evaluation is recommended to determine the source of the water and to address drainage or moisture management concerns.

Recommendation
Contact a qualified waterproofing contractor

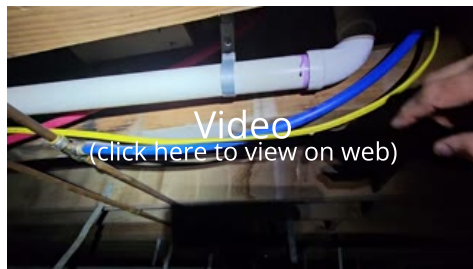
An active leak was observed at a section of the drain piping during the inspection. Leakage from drain lines can allow wastewater to escape into surrounding areas and may contribute to deterioration of nearby building materials if the condition continues. Continued moisture exposure may also create conditions that promote material damage or biological growth. Drain piping is intended to safely carry wastewater away from the home without leakage. Further evaluation and repair of the affected drain line is recommended.

Recommendation
 Contact a qualified plumbing contractor.

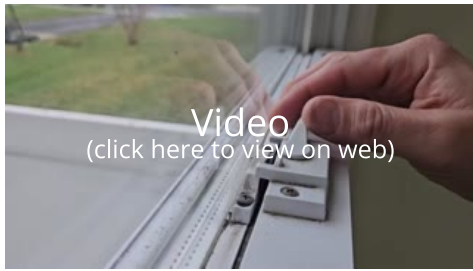
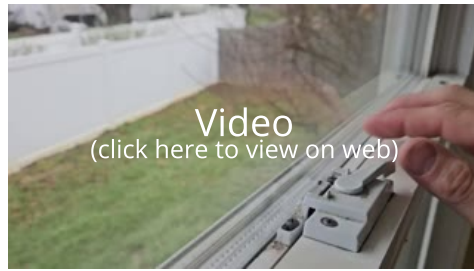
Rear Bedroom

The window did not latch or lock properly during testing. This condition may affect security and proper sealing of the window. The issue may be related to hardware failure or alignment concerns. Repair or replacement of components may be needed.

Recommendation
Contact a qualified window repair/installation contractor.

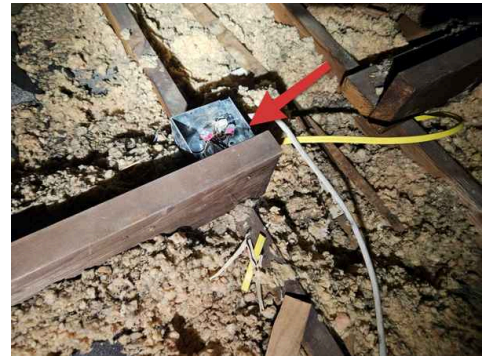
A junction box was observed to be open without a cover. Open boxes may expose wiring connections. This condition may present a safety concern and should be corrected.

Recommendation
Contact a qualified electrical contractor.

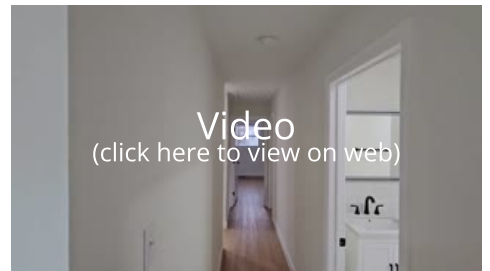
Hallway

The light did not operate during testing. This condition may be due to a failed bulb, faulty fixture, switch issue, or wiring concern. The exact cause was not determined at the time of inspection. Further evaluation may be needed to restore proper function.

Recommendation
Contact a qualified electrical contractor.

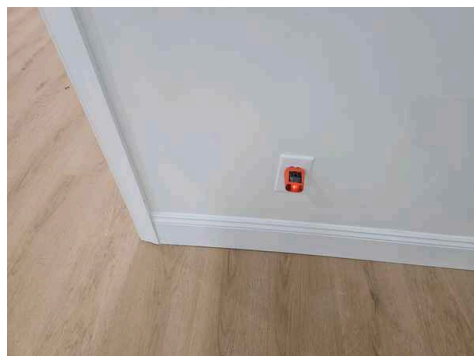
Foyer

Testing indicated an open ground condition at the outlet. This condition may affect the performance of connected devices. The issue may be related to wiring configuration. Further evaluation is recommended.

Recommendation
Contact a qualified electrical contractor.

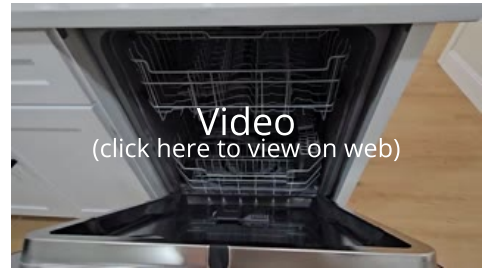
DISHWASHER – IMPROPERLY SECURED / NOT MOUNTED

The dishwasher was observed to be loose or not properly secured within the cabinet opening. Movement was noted when the door was operated. A dishwasher should be firmly mounted to prevent shifting during use. An unsecured unit may place stress on plumbing and electrical connections. Securing the appliance is recommended.

Contact a qualified general contractor.

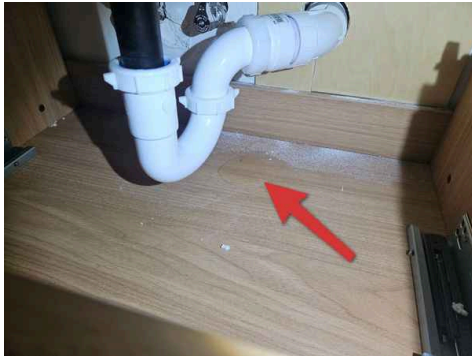
Bathroom 2 - See video

BATHROOM SINK – DRAIN LEAKING

Leakage was observed at the drain components beneath the bathroom sink during inspection. Water was noted at or around the piping connections. Leaks in this area can contribute to damage of cabinetry and surrounding materials over time. Continued leakage may lead to further deterioration. Repair is recommended.

Contact a qualified plumbing contractor.
