Inventory & Check In Report

Pure Inventra Sample Report

Inventory & Check In

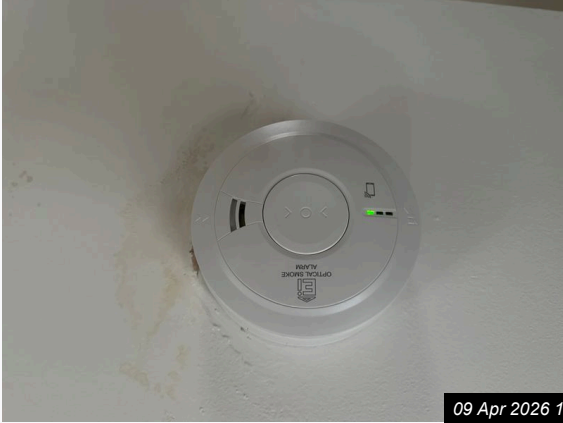
Ref #3.2

Ref	Name	Location Room & Floor	Test Result
3.1	Smoke Alarm	Floor 1 Entrance hall	Alarm tested Alarm heard Expiry date not seen
3.2	Additional Photos

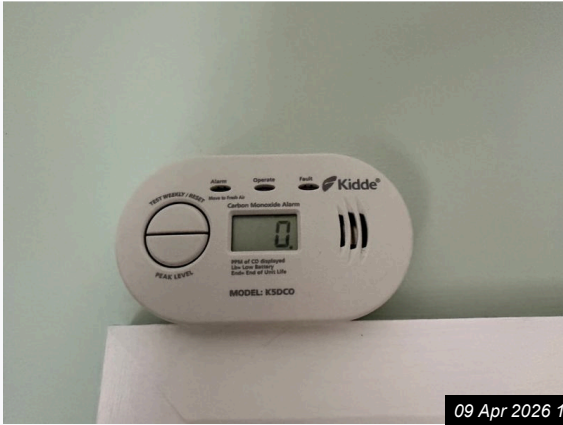
Ref #4.2

Ref	Name	Location Room & Floor	Test Result
4.1	Carbon Monoxide Alarm	Floor 1 Kitchen	Alarm tested Alarm heard Expiry date not seen
4.2	Additional Photos

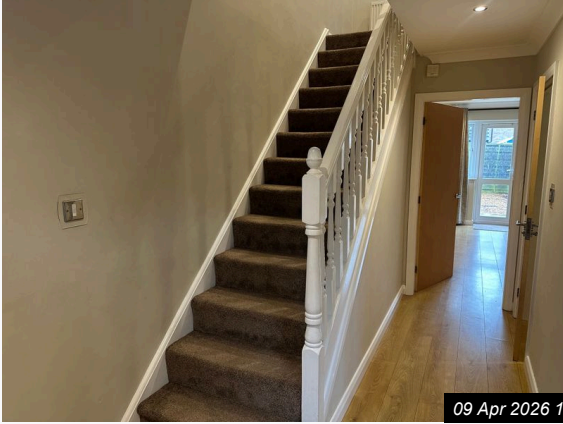
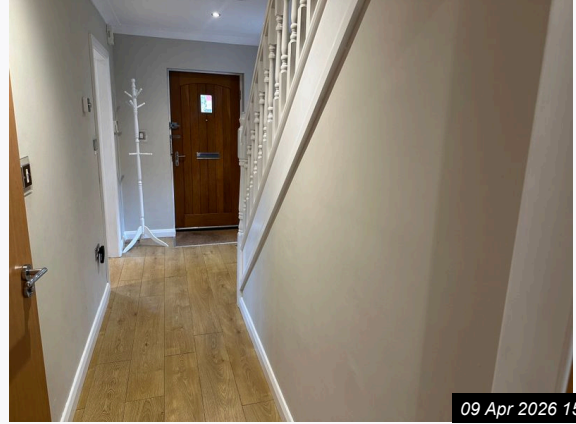
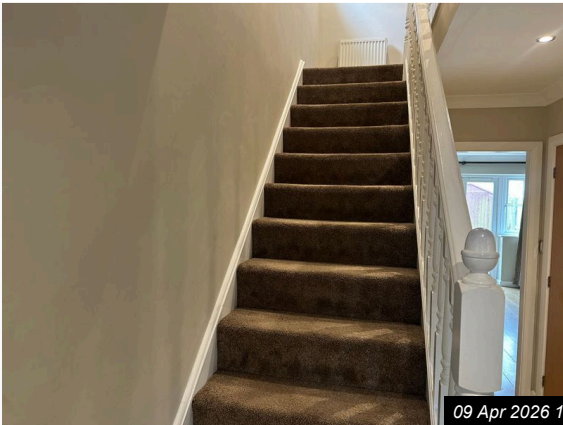
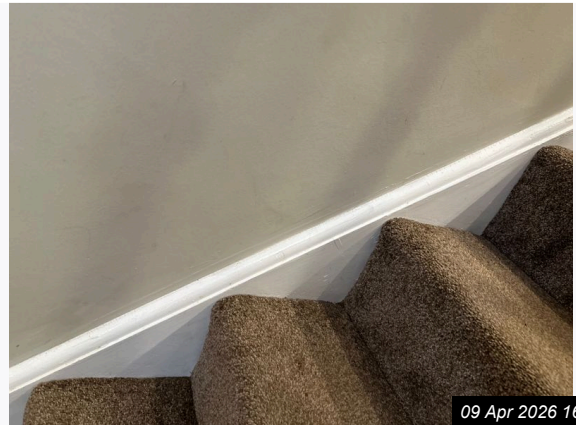
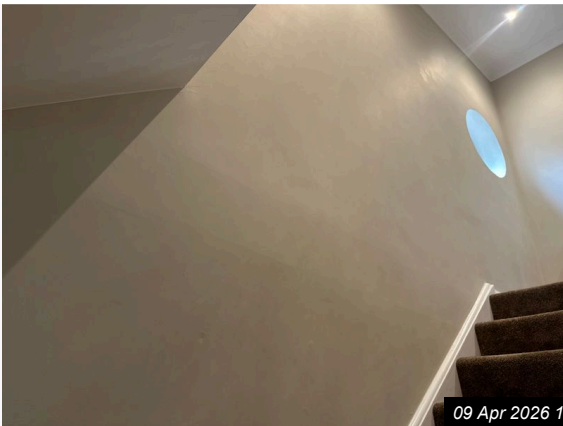
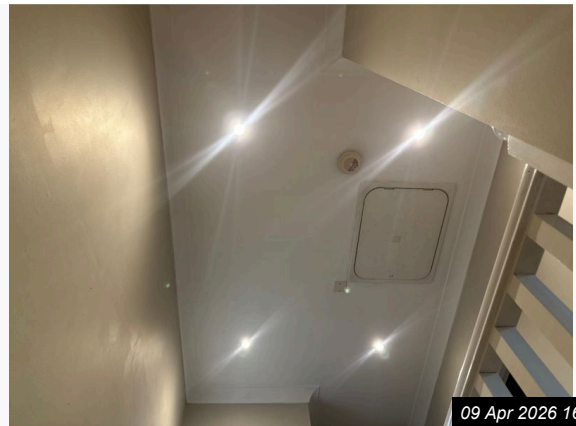
Ref #6.14

6.5	Walls	Painted plaster walls in a light neutral tone throughout the hallway / landing areas	In overall good order Uneven finish visible Minor scuff marks noted near the staircase

6.6	Skirting and Woodwork	White painted skirting boards with white painted staircase banister and balustrade	In overall good order Minor scuffs to skirting noted

6.7	Flooring	Combination of light wood laminate to parts of the hallway and brown / beige carpet to the hallway / landing and staircase	In overall good order Laminate with no visible damage Carpet in good order Some general wear and no major stains

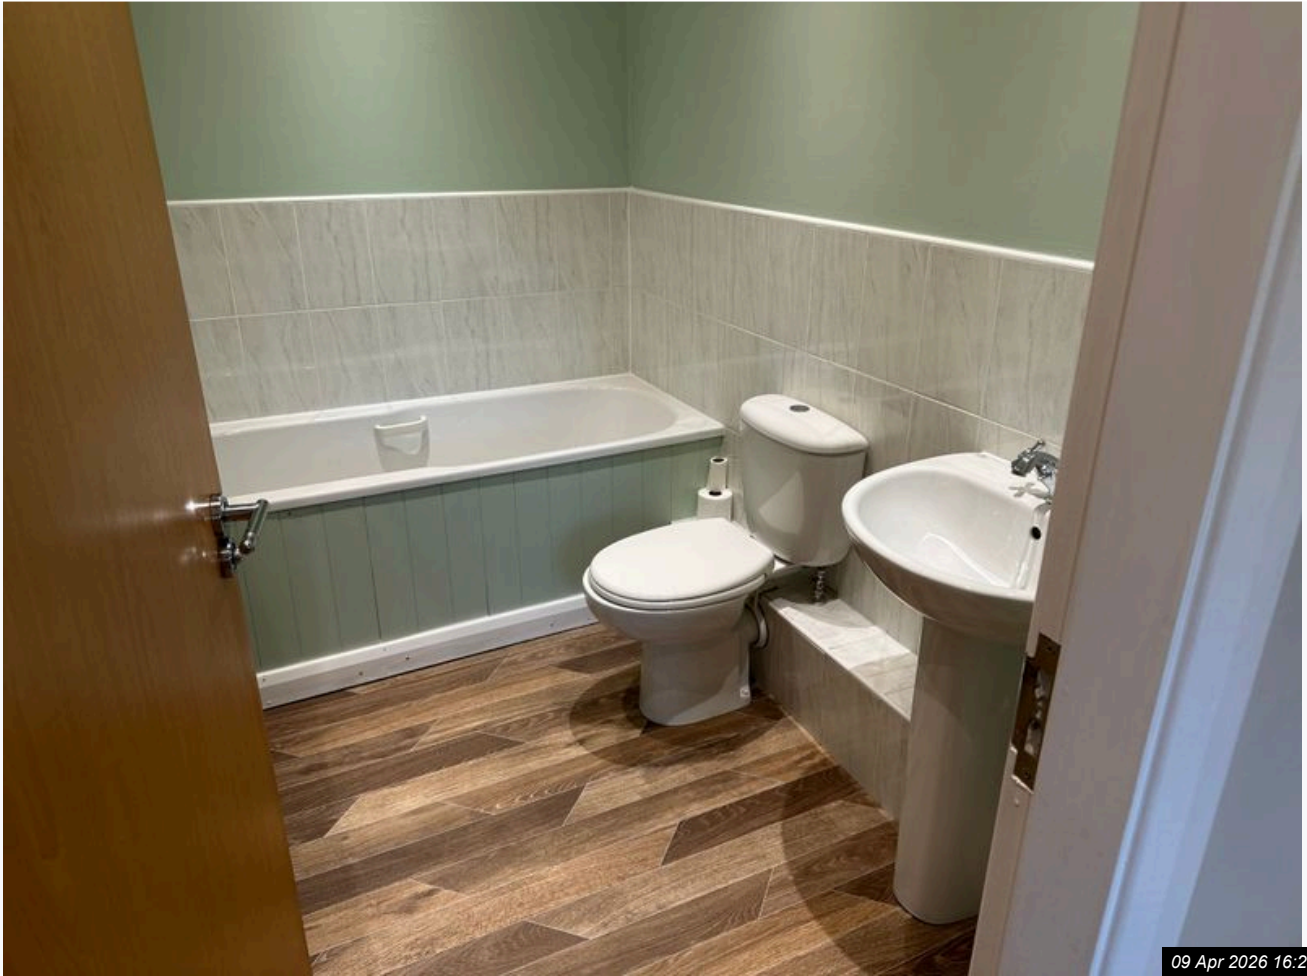
Ref #14

Ref	Name	Description	Condition
14.1	Door	Light wood laminate door with silver lever handle and white frame	In overall good order Clean with no visible marks, scratches, or damage
14.2	Ceiling	White-painted flat / smooth ceiling	In overall good order Clean with no visible stains or defects
14.3	Lighting	Multiple recessed ceiling spotlights installed within the ceiling	As fitted In overall good order Lights appear functional with no visible issues
14.4	Walls	Light green painted walls with white tiled sections around the bath and sink areas	In overall good order Evenly painted with no visible marks or damage
14.5	Skirting and Woodwork	White skirting boards running around the perimeter of the room	In overall good order Clean and intact
14.6	Flooring	Light wood-effect vinyl flooring	In overall good order No visible damage or wear

14.8	Sockets and Switches	Wall mounted white plastic Shaver's Only socket	As fitted In overall good order Not fully tested No visible damage or discolouration

14.12	Furnishings	Wall-mounted mirrored cabinet positioned above the radiator	In overall good order No visible damage or wear
14.12.1	-	White toilet roll holder mounted on the wall beside the WC	In overall good order No visible damage

14.12.2	-	Grey plastic waste paper bin	In overall good order
14.13	Miscellaneous	White ceiling vent / grille located near the recessed lights	As fitted In overall good order Not tested No visible damage

14.13.1	-	Assorted WC rolls	In overall good order
14.13.2	-	1 skirting mounted chrome and black rubber doorstop	In overall good order
14.14	Additional Photos
