# ***MH INSPECTIONS LLC***

## **Property Inspection Report**

9 Northumberland Drive, Shoreham, NEW YORK 11786

Date of Inspection: 6/19/2026 Time: 10:00AM

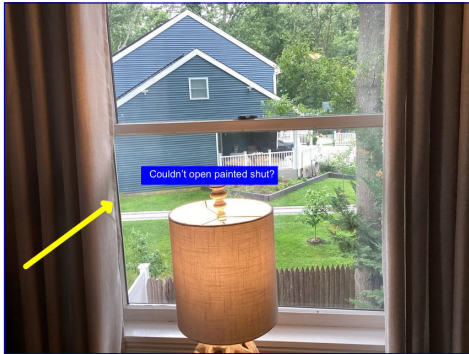
COULDN'T INSPECT PAINTED CLOSED
