Customer Information		Report#: 21520-RE	Date: 4/21/2026
File #: 850 Jerrys Lane	Customer: Austin Trust Company	Location: Residential 850 Jerrys Lane Buda TX 78610	
Attention: Tawanda Bishop	Phone: 512-478-2121 x 125

Type of Service		
Inspection		Estimated Repair Cost
Trust Residential Property Assessment – Whole House (TREC)	<input type="checkbox"/> Clear <input checked="" type="checkbox"/> Not Clear	\$10,400.00

TRUST PROPERTY PRELIMINARY LIMITED VISUAL ENVIRONMENTAL SURVEY

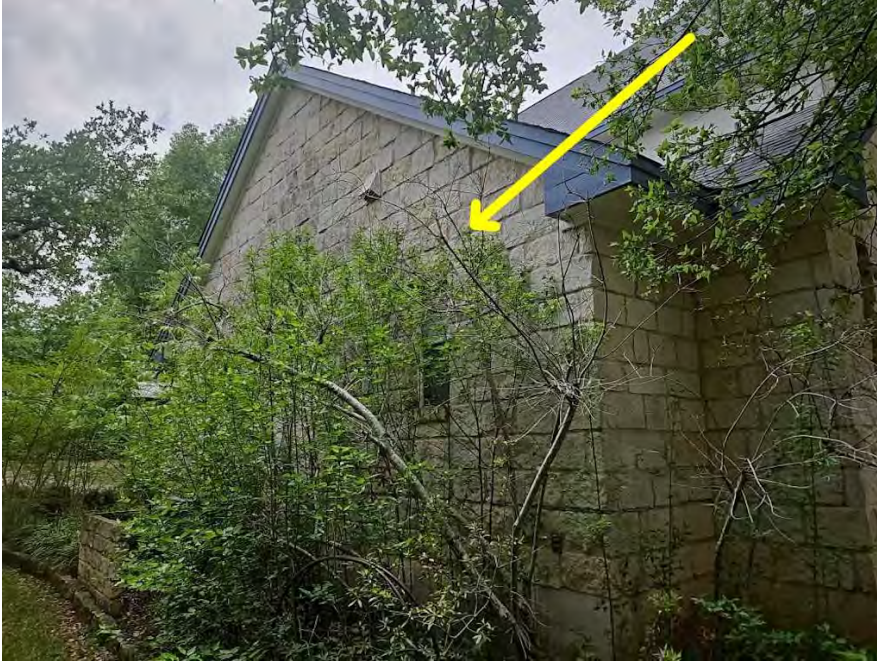
Line Item #: **I.B.**

Description:
Vegetation is in contact with the structure.

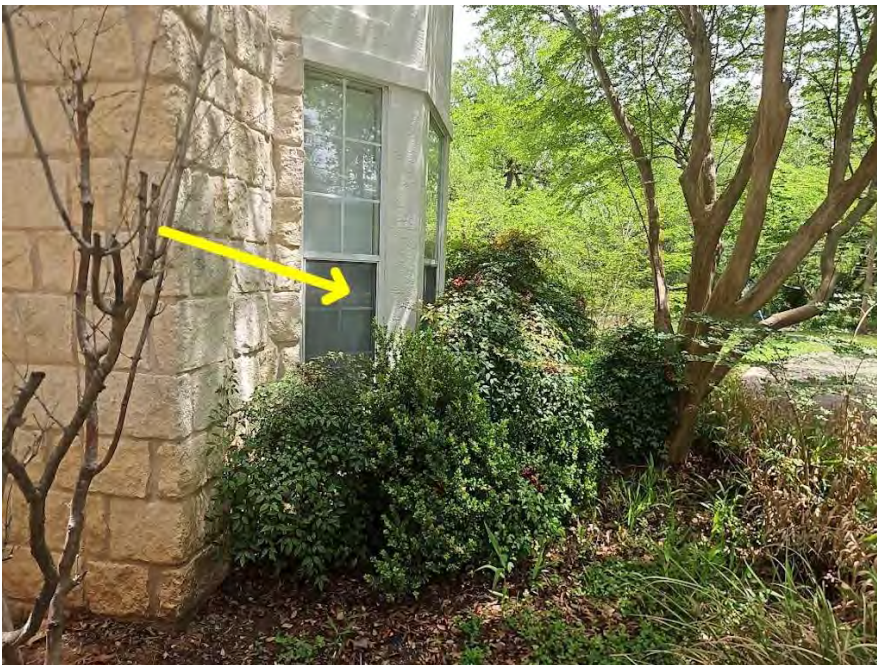
Line Item #: **I.B.**

Description:
Vegetation is in contact with the structure.

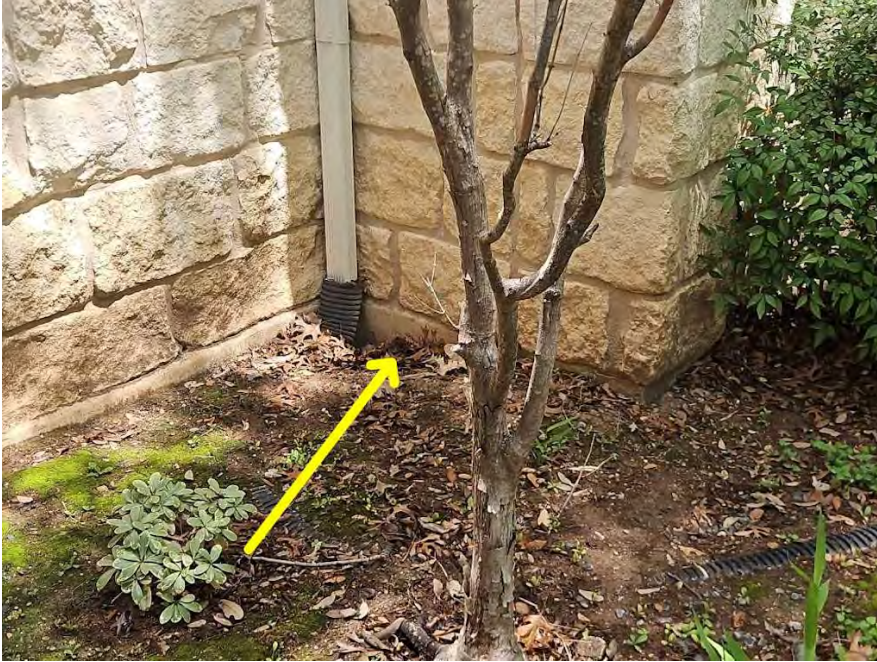
Line Item #: **I.B.**

Description:
Uneven grading at the right front.

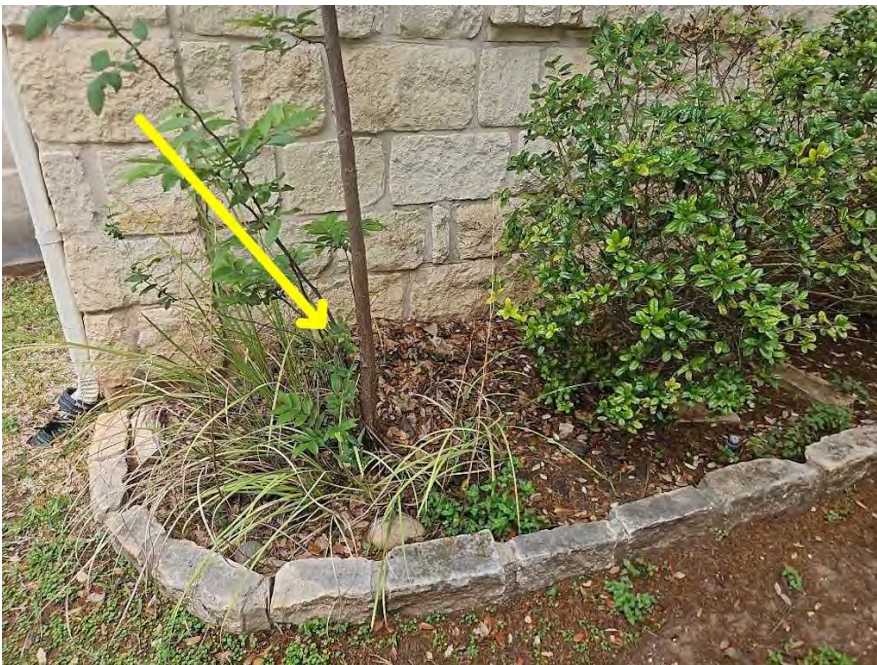
Line Item #: **I.B.**

Description:
Grade is too high at the front left.

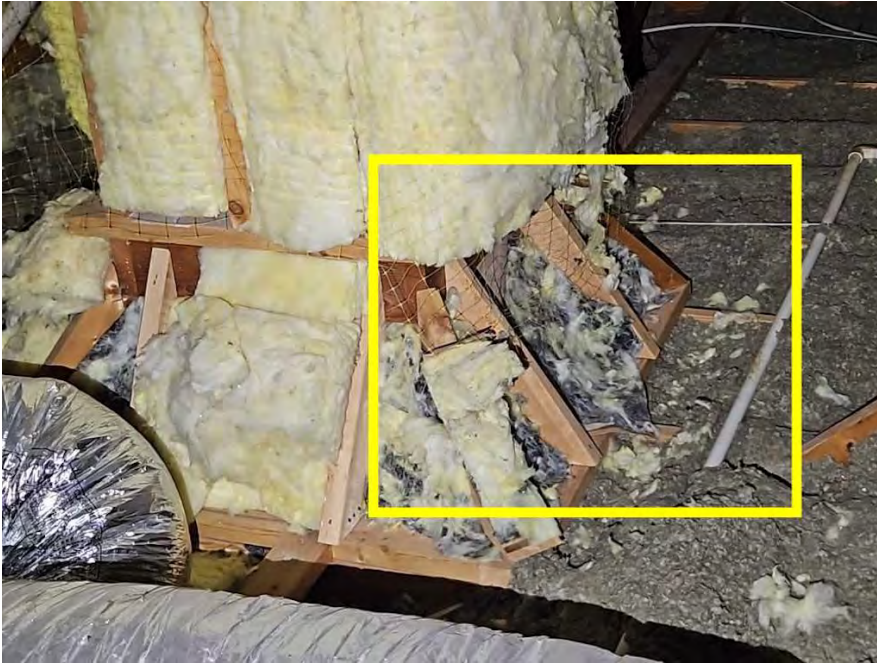
Line Item #: **I.D.**

Description:
Suspected mold/organic growth in the attic above the master closet.

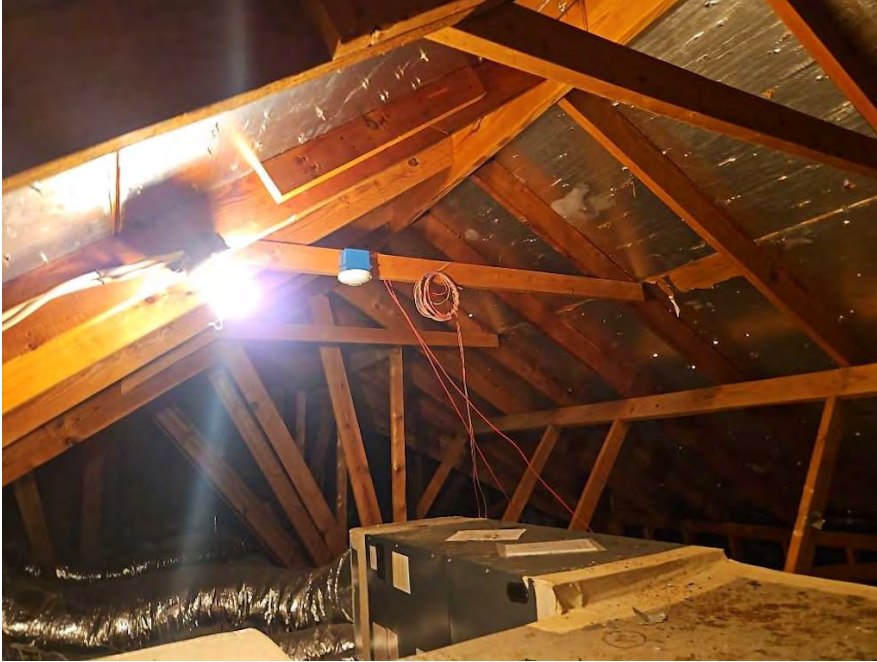
Line Item #: **I.D.**

NOTE: Limited inspection of attic due to design, ductwork, and insulation.

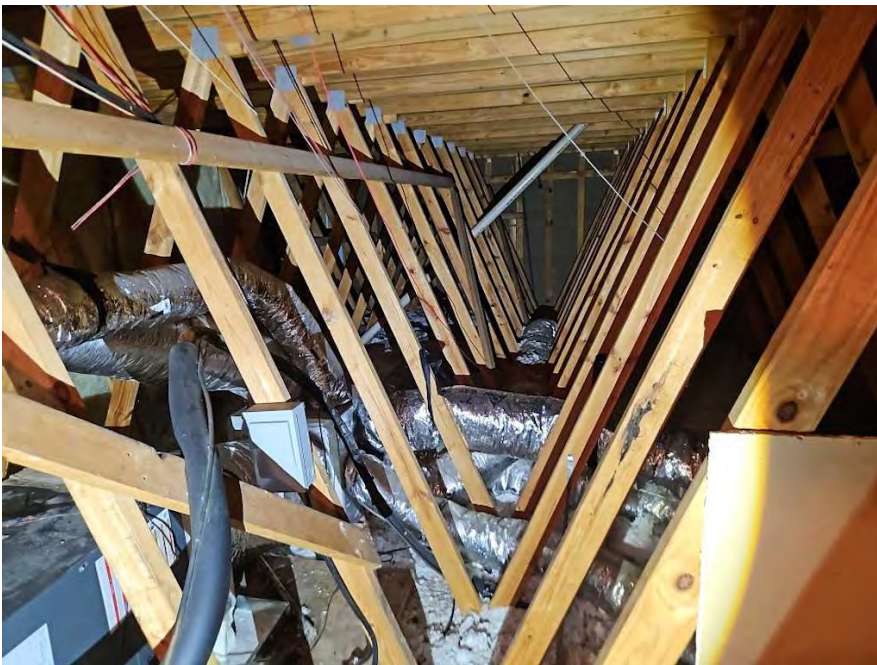
Line Item #: **I.D.**

NOTE: Limited inspection of attic due to design, ductwork, and insulation.

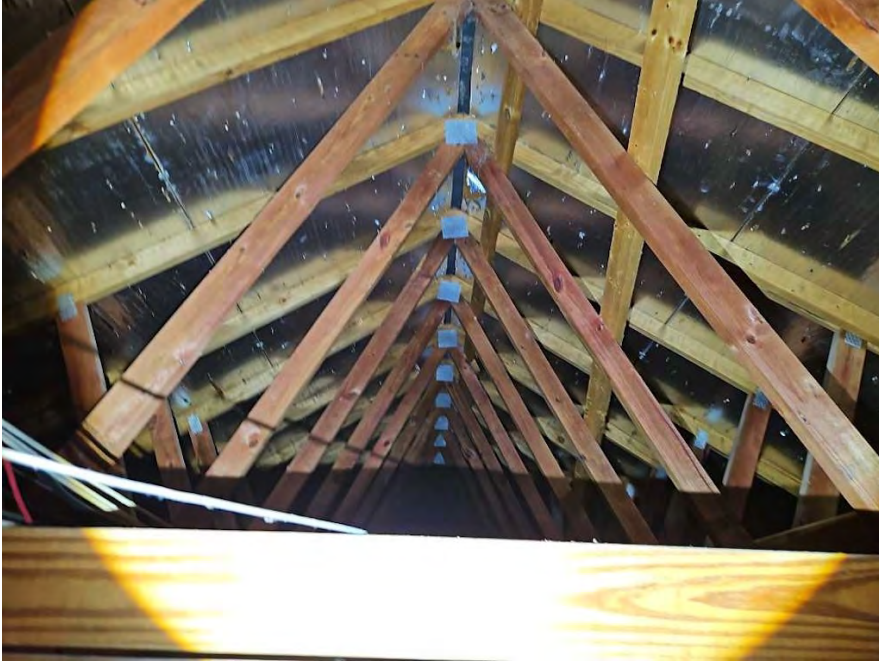
Line Item #: **I.D.**

NOTE: Limited inspection of attic due to design, ductwork, and insulation.

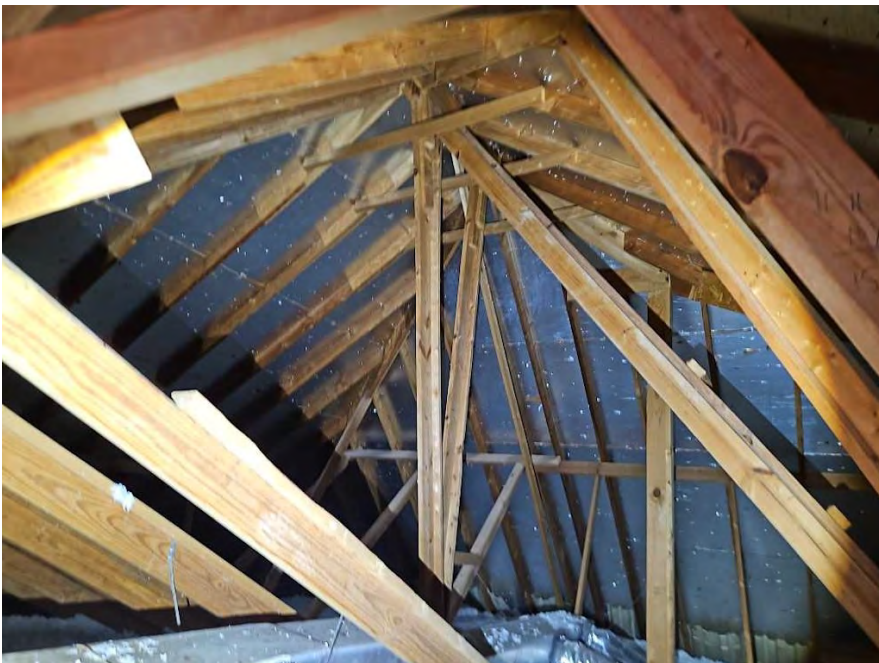
Line Item #: **I.D.**

NOTE: Limited inspection of attic due to design, ductwork, and insulation.

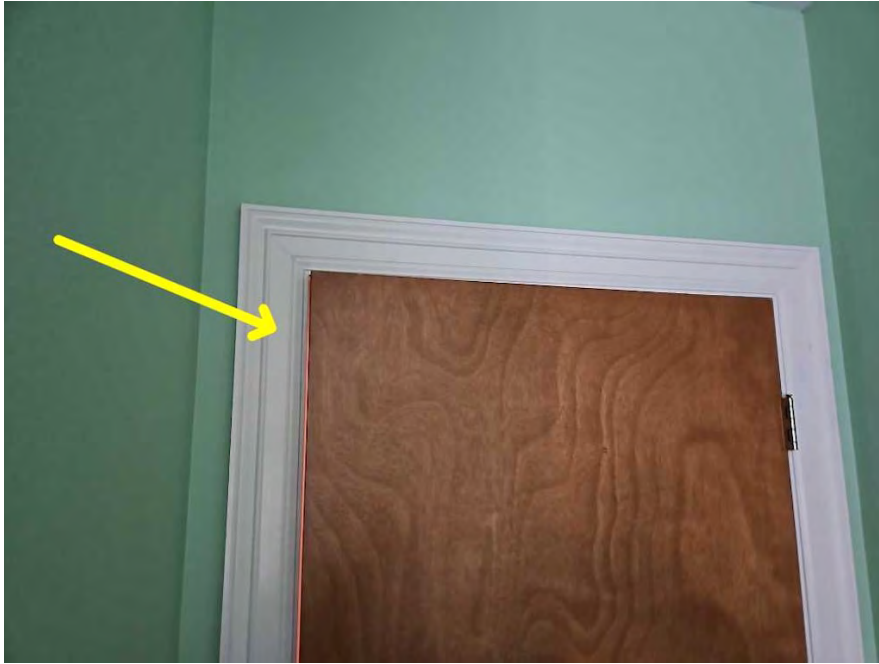
Door is not square in the frame and rubs the jamb at the upstairs front left bedroom.

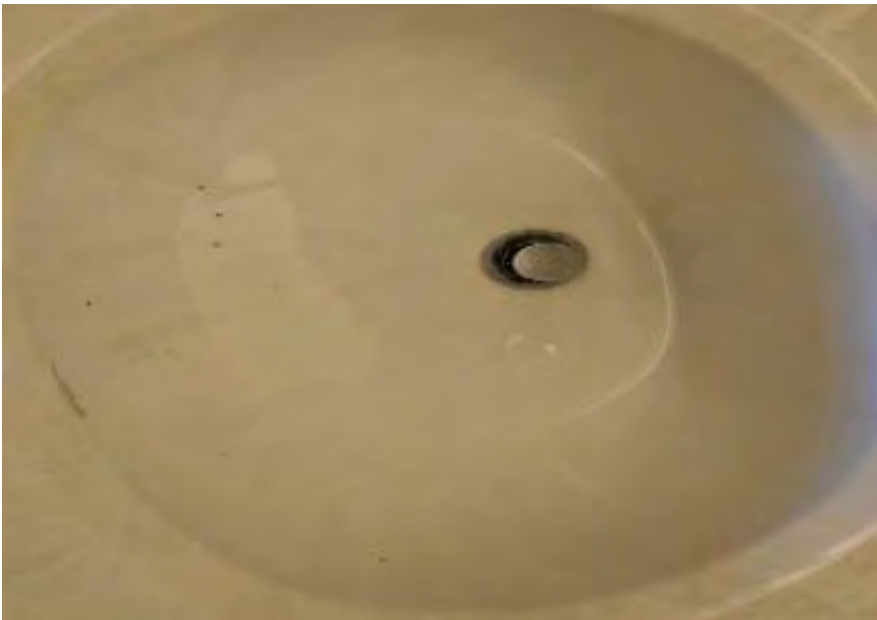
Slow drain at the upstairs rear right bathroom sink.

1. Qualified plumbing contractor to determine cause and correct as determined necessary, but not limited to, the slow drain at the upstairs rear right bathroom sink.

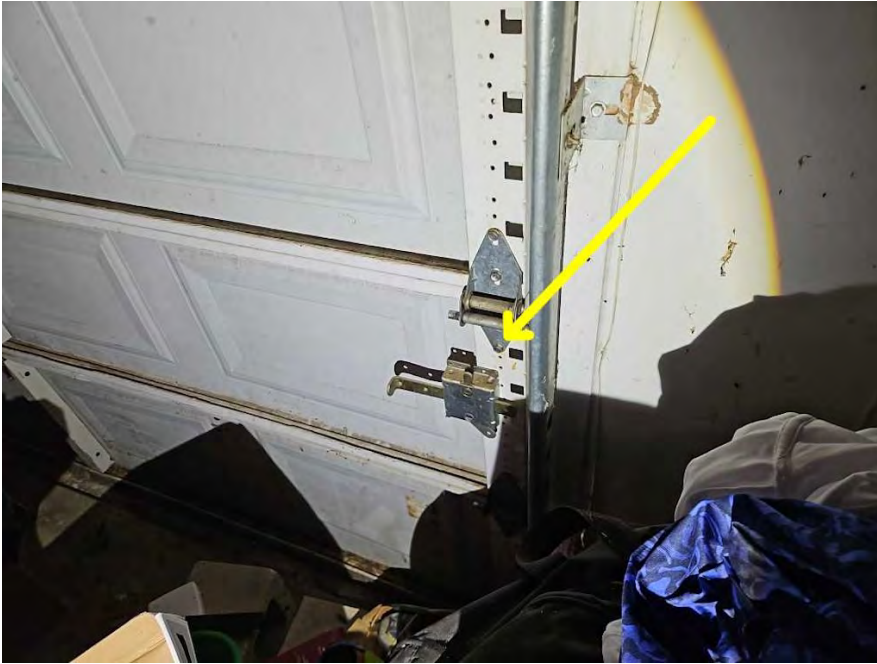
Line Item #: **V.G.**

Description:
Manual door locks have not been disabled at the overhead door.

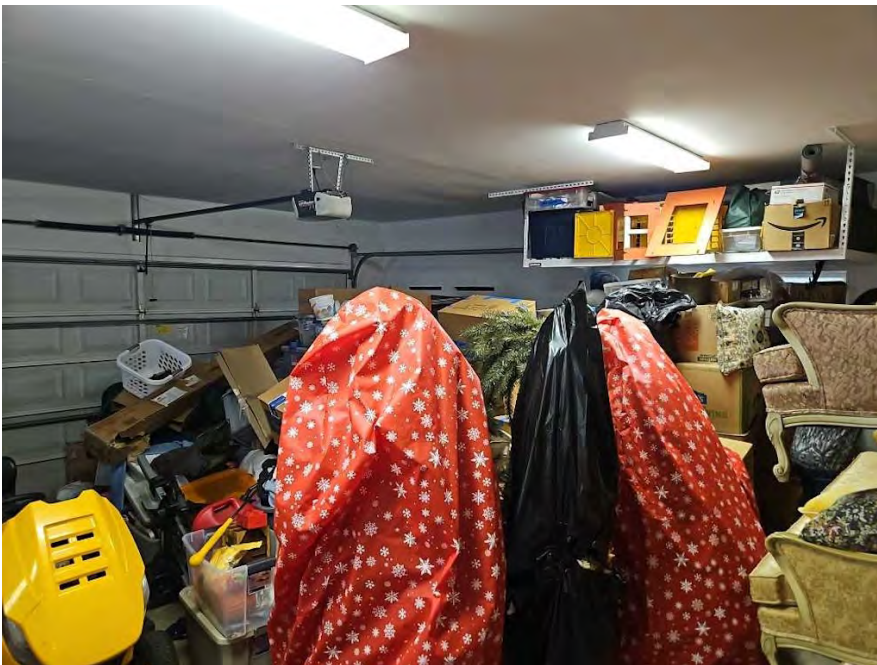
Line Item #: **V.G.**

Description:
NOTE: Limited inspection of garage due to excessive storage.

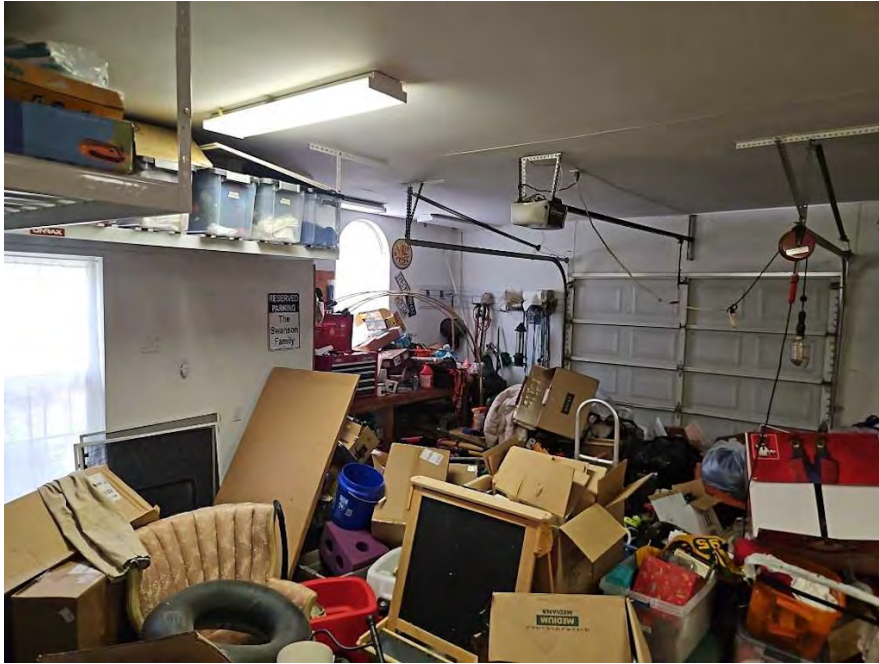
Line Item #: **V.G.**

Description:
NOTE: Limited inspection of garage due to excessive storage.

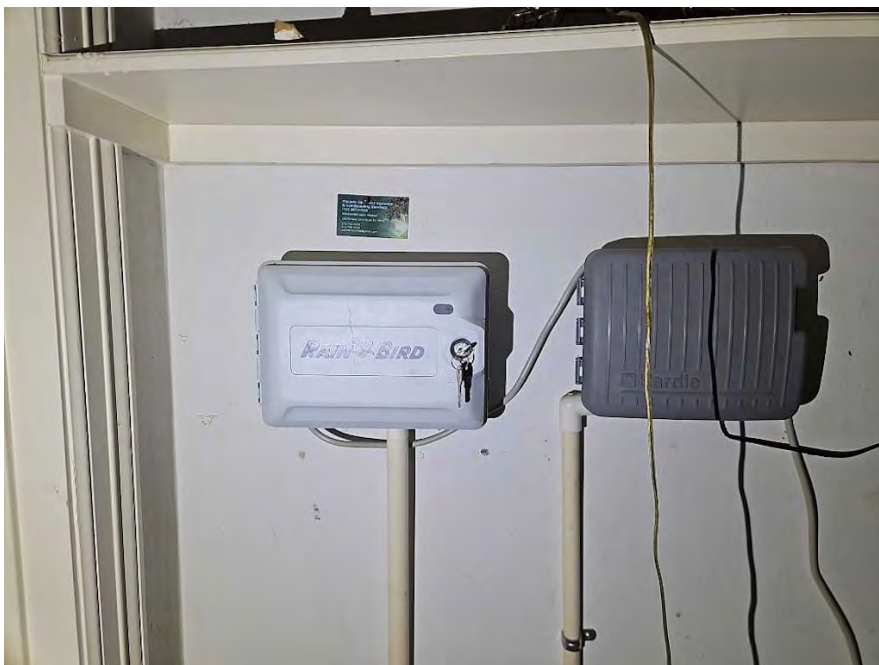
Line Item #: **VI.A.**

Description:
NOTE: Sprinkler system is nonfunctional per the owner.

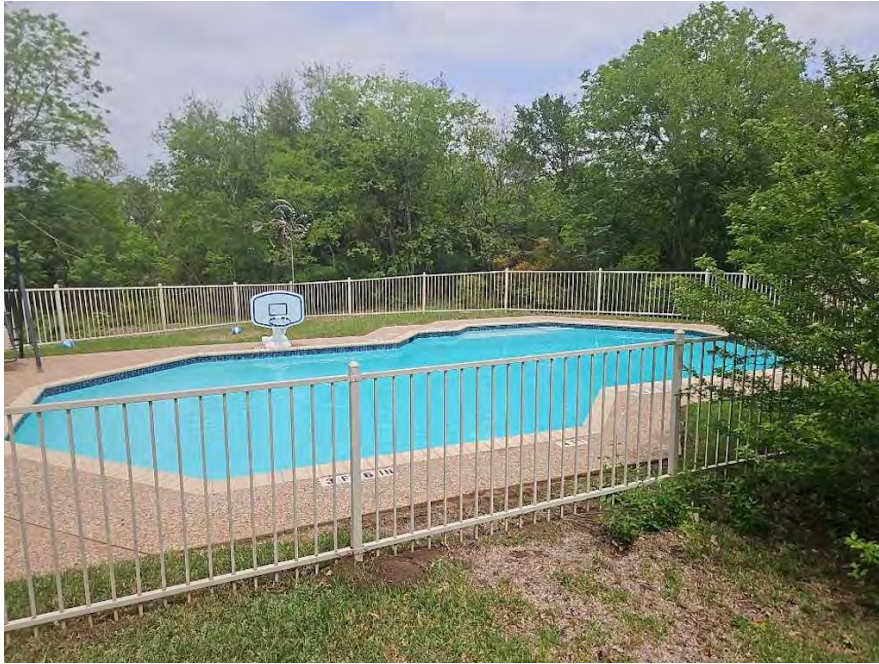
Line Item #: **VI.B.**

Description:
NOTE: Pool was not inspected.
Inspection was not requested.
