# ***MH INSPECTIONS LLC***

## **Property Inspection Report**

9 Northumberland Drive, Shoreham, NEW YORK 11786

Date of Inspection: 6/19/2026 Time: 10:00AM

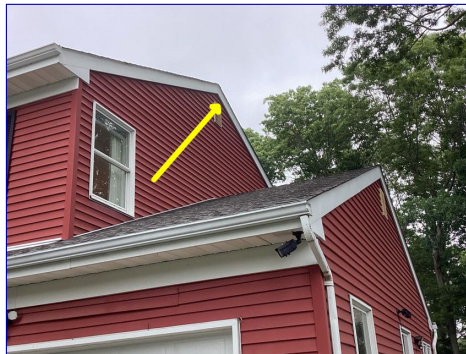
ATTIC VENT

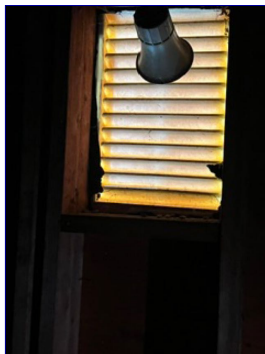
ATTIC VENT

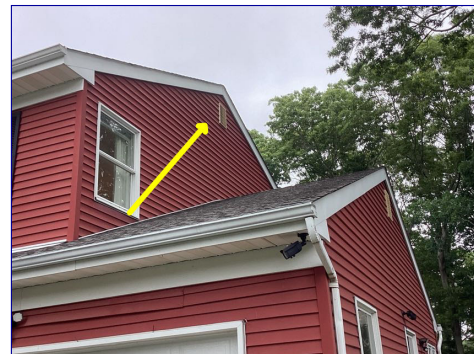
ATTIC VENT

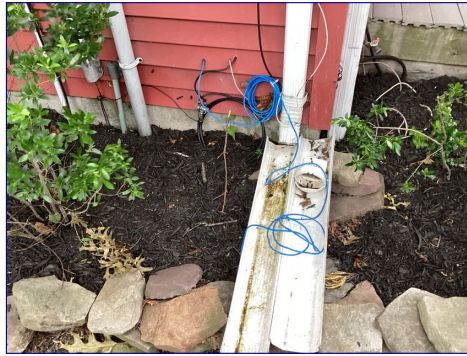
DRAINAGE SHOULD BE EXTENDED AWAY FROM FOUNDATION TO PREVENT DAMAGE AND WATER INTRUSION INTO BASEMENT SEE SPLASH BLOCK AT OTHER GUTTER LOCATION

- The gutters are dirty. Recommend cleaning the gutters to ensure proper water flow to the downspouts.
- The gutter downspouts don't direct water far enough away from the house. Recommend adding downspout extensions (5-6' extensions recommended) to discharge away from the home.

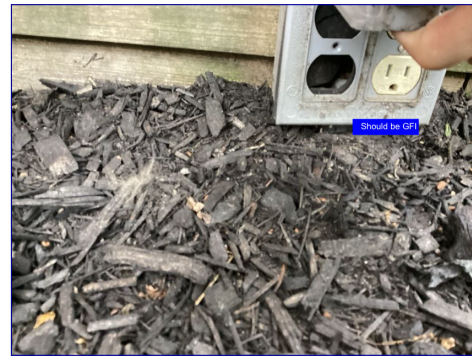
should be GFI for exterior outlets subject to rain

- GFCI receptacles are not installed at outdoor locations, which is a safety concern. Recommend a licensed electrician install GFCI receptacles.

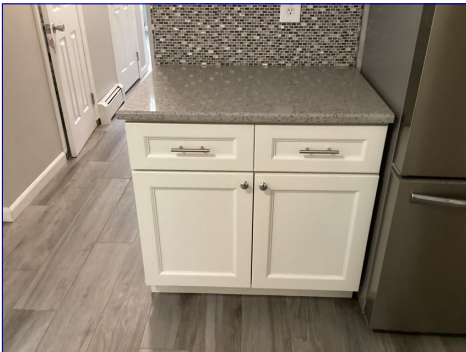
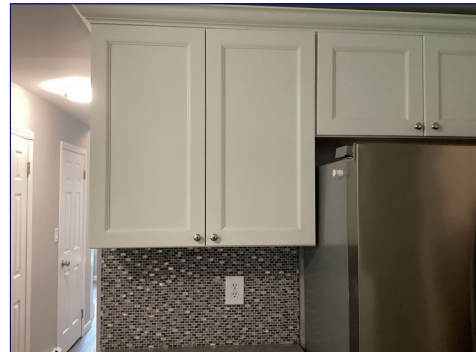
DRAW DOESN'T CLOSE FULLY

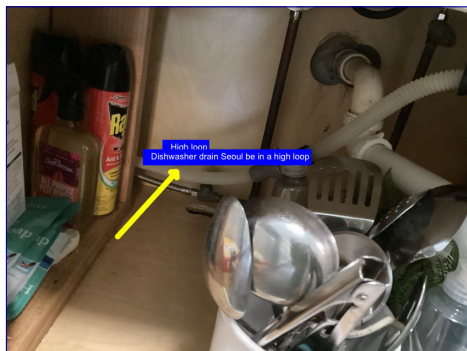
## 4. Plumbing

DISHWASHER DRAIN SHOULD BE IN HIGH LOOP

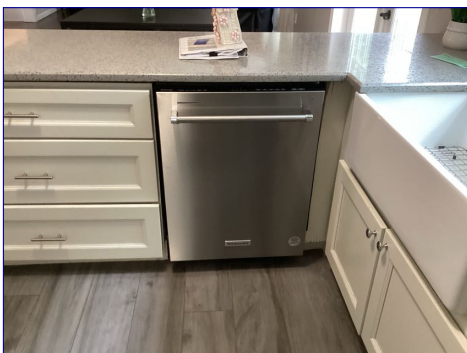
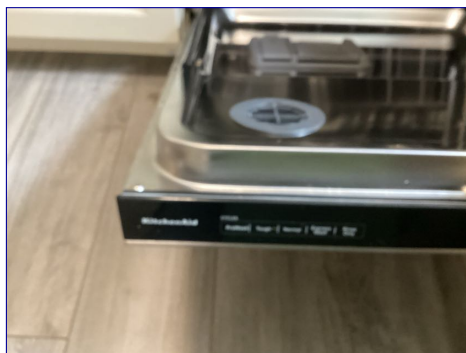
- The dishwasher drain line is not looped beneath the countertop, which is a potential safety concern. Recommend a qualified contractor repair.
- There are no GFCI receptacles installed in the kitchen, which is a safety concern. Recommend a licensed electrician install GFCI receptacles.
- GFCI receptacles are not installed within six feet of water in the kitchen. This is a safety concern. However, at the time the home was built, installing GFCI receptacles were not part of the standard building requirements. Recommend upgrading the GFCI receptacles to current standards for increased safety.

DISWASHER MADE IN 2024

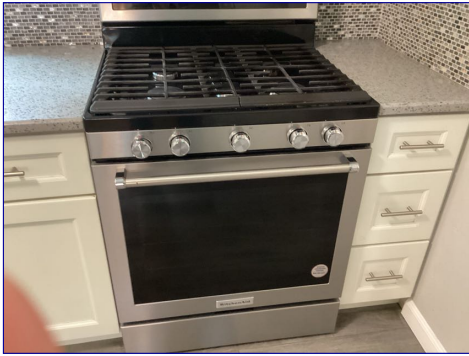
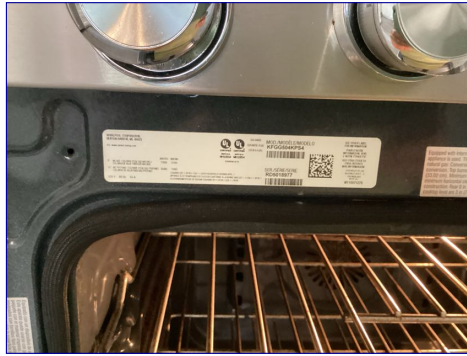
OVEN/STOVE MADE IN 2024

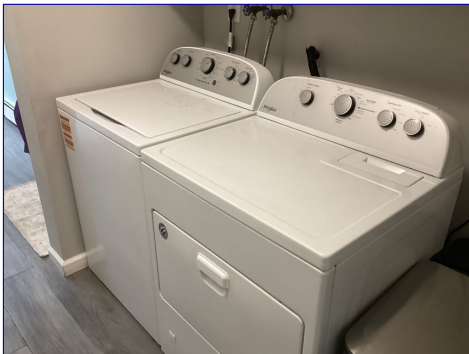
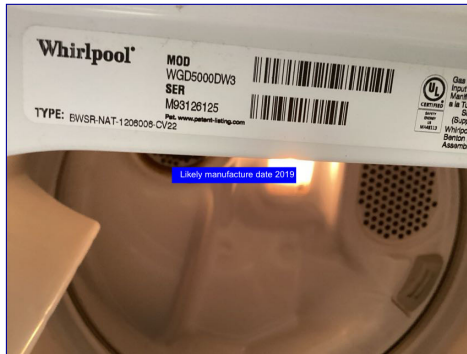
laundry dryer made in 2019

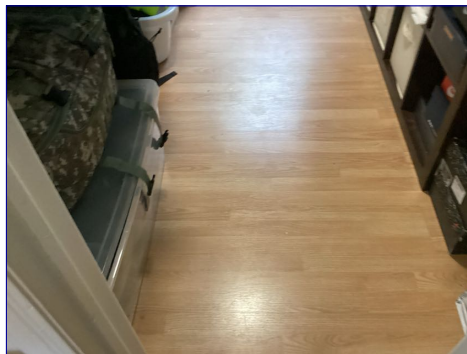
LAMINATE SEPERATING

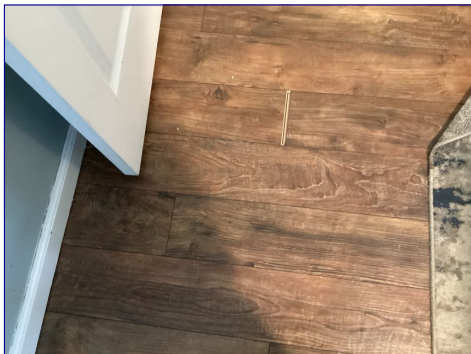
LAMIANTE FLOOR SEPERATING

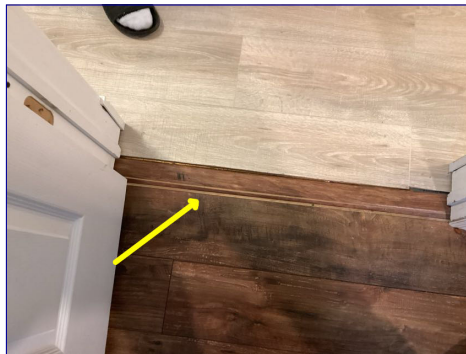
FLOOR FALLING SHORT OF SADDLE

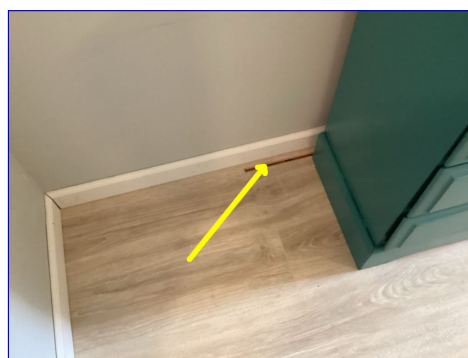
SPERATING FLOORING

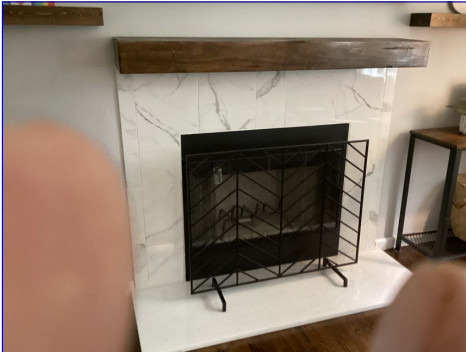
MUST GO INSIDE FIREPLACE TO OPEN AND CLOSE  
FLU-NO DEVICE ON EXTERIOR

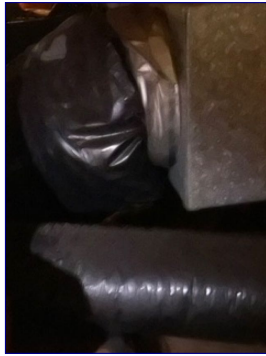
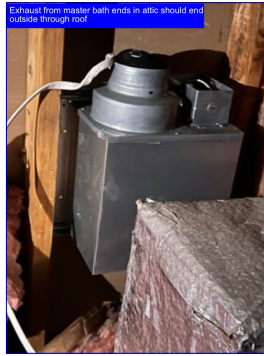
VENT SHOULD NOT TERMINATE IN  
ATTIC SHOULD EXTEND TO  
EXTERIOR F HOME
